## 9 | IA1 Central Drainage Route West

### 9.1 Drainage Issues

# 10 | IA1 Central Drainage Route East

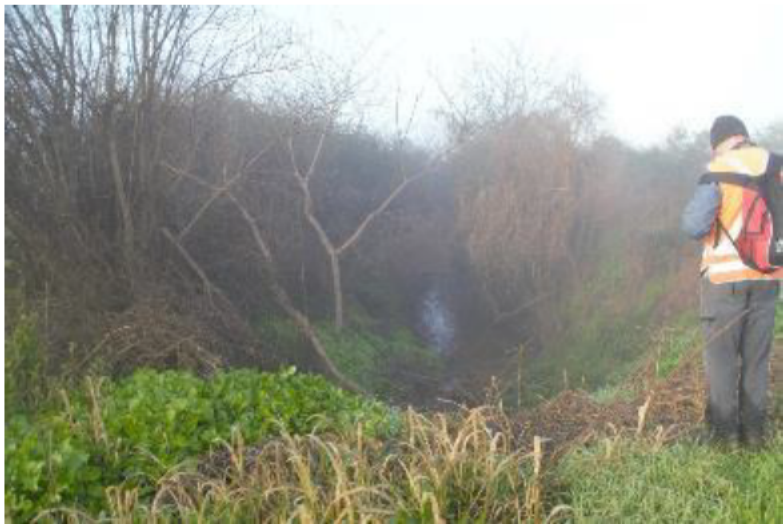
Photo 147

Where standing water was creating problems for property owners was on the southern branch immediately east of Cupitts Lane where there was standing water across the paddocks. This appears to be caused by the ill-defined outlet from the body of standing water (Photo 144 and Photo 145) as well as siltation further downstream in the channel which may have been triggered by a willow growing from the bank into the channel (Photo 147).

The removal of the willow and the accumulated silt along with the creation of a better defined and larger capacity outlet from the standing water area should relieve the drainage problem in this area.

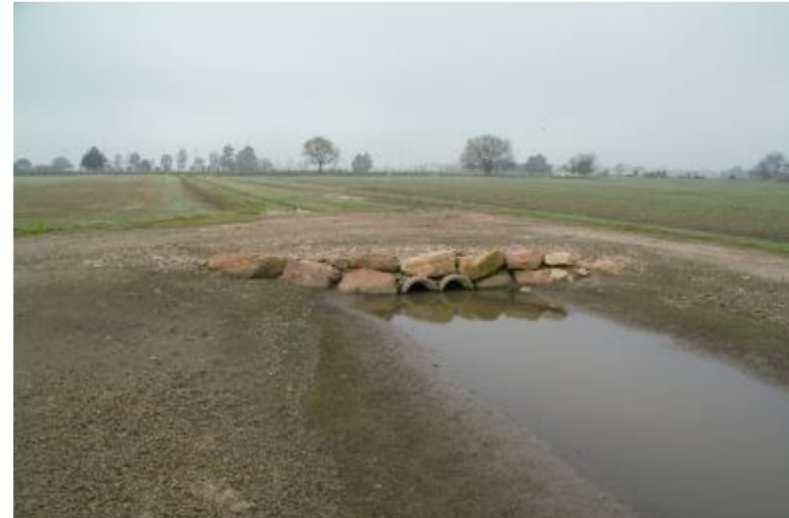
Photo 171

There is a drain through a turf paddock east of Onus Lane which marks the beginning of this drainage line (Photo 171). The drain heads east and after a pipe crossing is full of grass (Photo 172) and no flow could be detected. When it reaches the property boundary there is a raised access road embankment on the neighbouring property and the drainage diverts north along the western side of this embankment (Photo 173). It passes under the embankment via a pipe (Photo 174) which is not sufficiently lower than the surrounding paddocks for them to completely drain.

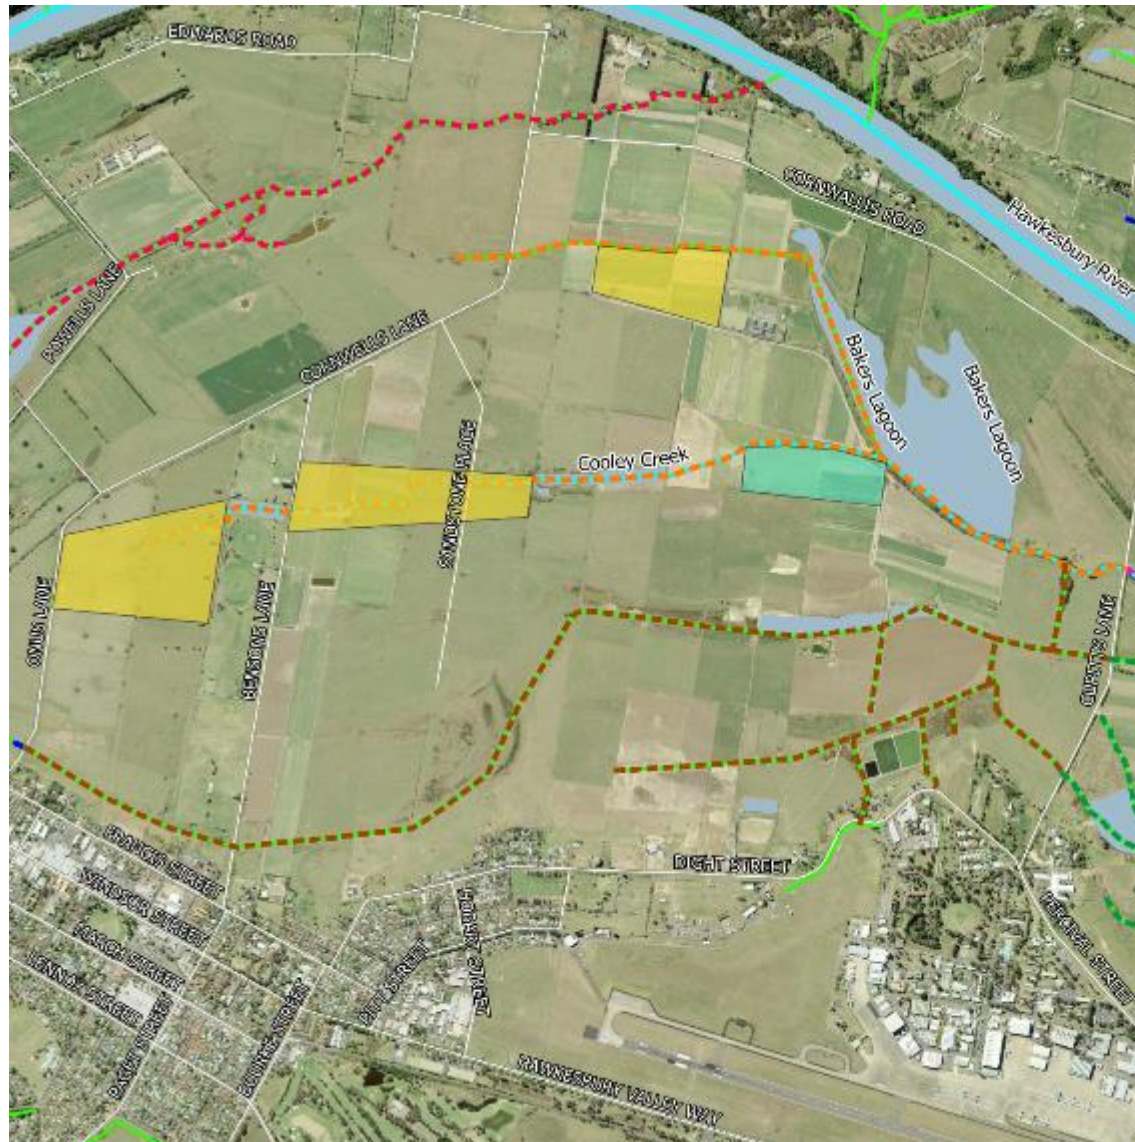
Figure 84: Solutions for IA1CW

It is principally the paddocks upstream of Bakers Lagoon which have significant drainage problems in IA1CW. There appear to be four contributing factors to the problem:

Firstly, the terrain is extremely flat so that there is very little natural fall. These areas will always drain slowly.

Secondly, turf farming is stripping the topsoil which is lowering the ground level in places to below the top of the drain so water does not drain towards the drain. In some places the drains are so shallow and so much top soil has been stripped that the paddocks are actually lower than the water level in the drains.

Thirdly, the length of the drains have been increased in places by diverting the drainage. This reduces the slope of what are very flat drains and significantly increases the time it takes to drain.

Finally, the water levels in the drains are higher than they should be in places because obstructions have been placed in the way or the drainage infrastructure has silted up. This has included access tracks with undersized culverts or culverts with inverts which are higher than the paddocks which they are draining. The latter could be caused by the paddock level being lowered by turf farming. Erosion from paddocks stripped of turf contributes silt to the drains and the very flat slopes on the drains means that it does not get transported through the drains but settles and fills the drain.

The problems in this section are so extensive, complex and interrelated, it is difficult to identify a single solution or even a combination of measures which will significantly alleviate the problem.

Some paddocks will need to be regraded so that they fall towards the drains. In some places, particularly in the upper reaches, this might only be possible by filling the paddocks with imported soil.

Where possible, the channels should be straightened and right-angled deviations removed. Again, this may be a challenge in places where the flow path has been deviated around an obstruction which can no longer be moved.

Similarly, where the inverts of culverts under access tracks are lower than the level of upstream paddocks it may neither be practical to install a lower culvert under an already constructed road or lift the level of an entire upstream paddock.

Finally, even if some of the above measures can be undertaken, the erosion caused by turf farming will keep clogging the drains and turf farming will keep lowering parts of the landscape. It may be that on some parts of IA1CW turf farming is no longer sustainable because adequate drainage cannot be provided in prolonged wet periods.

A detailed survey and drainage improvement concept design would be needed to find a means of improving drainage upstream of Bakers Lagoon, if it is at all possible.

Possible solutions for IA1CW are shown in Figure 84.

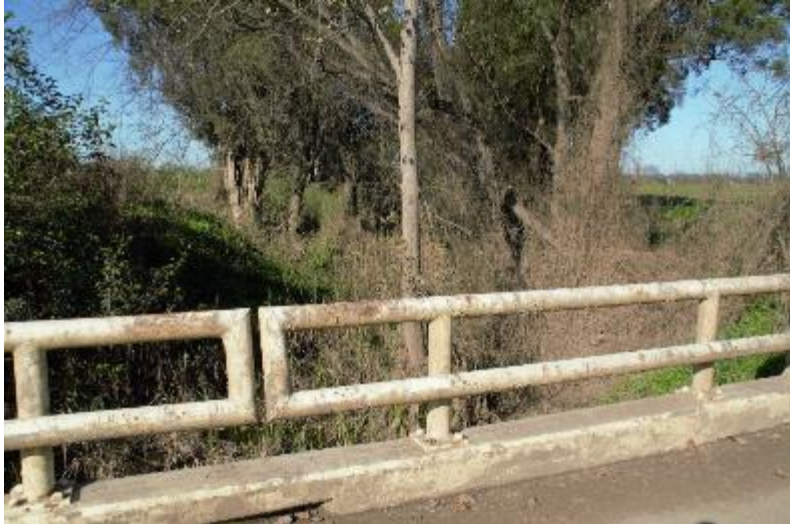
Photo 219

Downstream of Cupitts Lane the channel becomes narrower and the channel and its banks are heavily vegetated (Photo 219) much of which is native vegetation (Photo 220). There is an increase the amount of flood debris deposited in the creek (Photo 221) along with silt which is inhibiting flow. In places the channel is quite clear and predominantly lined with native vegetation although there are occasional large debris items in the creek (Photo 222). There is a crossing of the creek which is piped (Photo 223) and 150m downstream of this there is sediment blocking the drain (Photo 224). Further downstream there is evidence of the bank slumping into the drain (Photo 225). It then passes under an access track through two pipes (Photo 226) downstream of which the water is ponded in the creek (Photo 227).

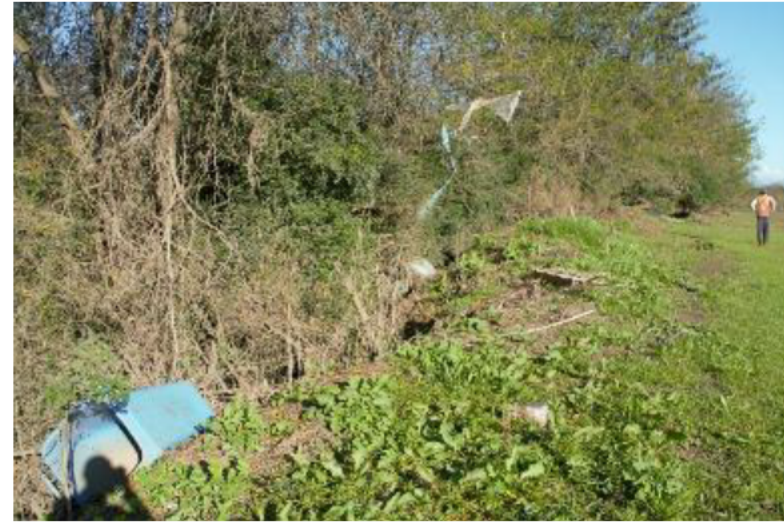
Photo 228

Downstream of here the banks of the creek were so overgrown with Small-leaf Privet, honey locust and other weeds (Photo 228) it was not possible to get close enough to the creek to observe its condition until 400m upstream of Cornwallis Road. At this location the channel is choked with weeds (Photo 229) and littered with debris (Photo 230). This continues under the bridge at Cornwallis Road (Photo 231) and further downstream (Photo 232). As the creek gets closer to the river is becomes deeper and wider and there are several large trees which have been felled and have fallen into the creek. These logs, trees growing in the channel and vines growing over it all has caught a lot of debris (Photo 233 and Photo 234 and Photo 235). Near the river there was no flow in the creek whatsoever nor any ponded water (Photo 236 and Photo 237).
