11 | Investigation Area 2

11.1 Drainage Issues

12 | Investigation Area 3

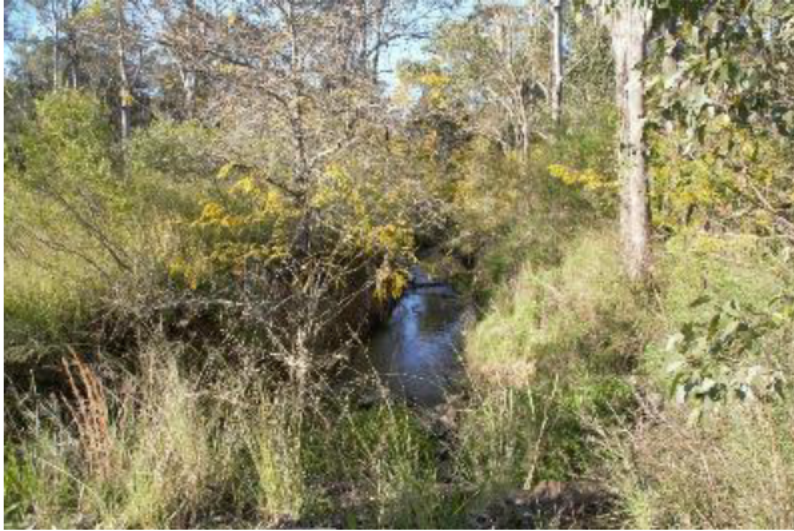
Photo 238

The drainage network in IA2 is within a research facility of the University of Western Sydney and drains into an unnamed creek which flows south into Rickabys Creek (Figure 89). After crossing a high voltage transmission line easement the creek drops steeply through bushland and there did not appear to be anything inhibiting the flow through this part of the creek (Photo 238).

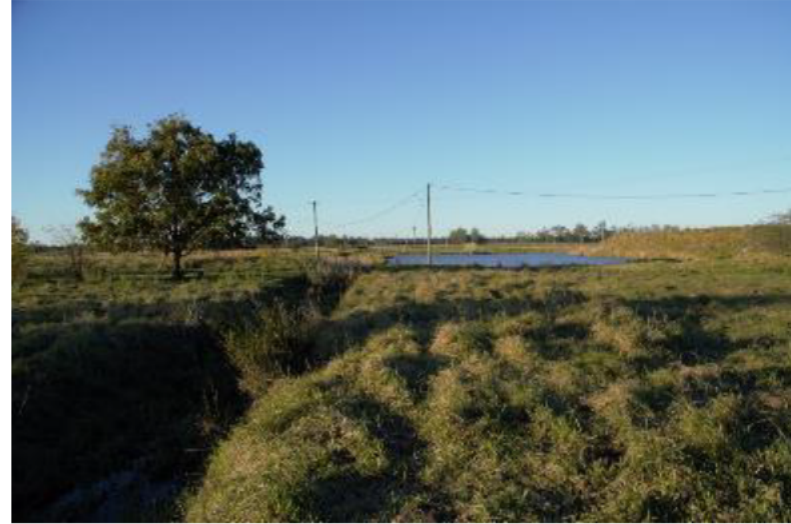
Photo 239

Two dams on the site (Photo 239 and Photo 240) were full and were controlling the water levels in the drains upstream of them. However, the following observations were made of possible improvements to the drainage system.

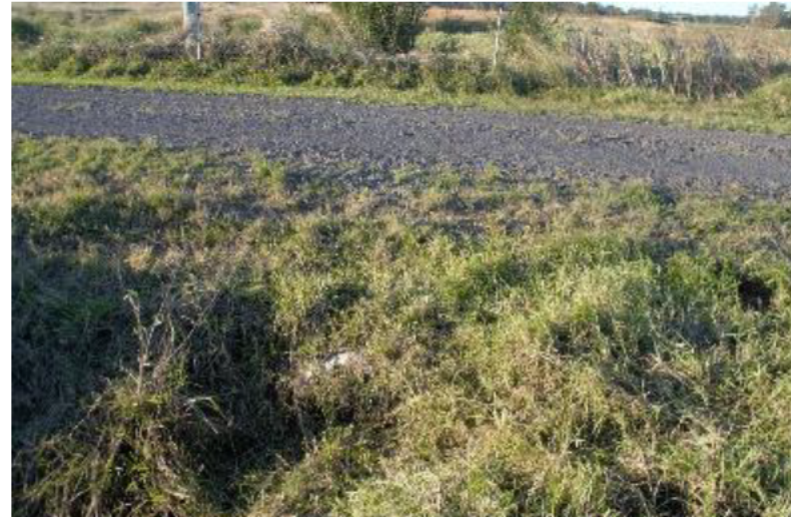
Photo 241

A pipe under an access track appears to be only about 300mm in diameter (Photo 241) and has a capacity much less than the channel. This would be a significant constriction to flow when the channel is more than half full.

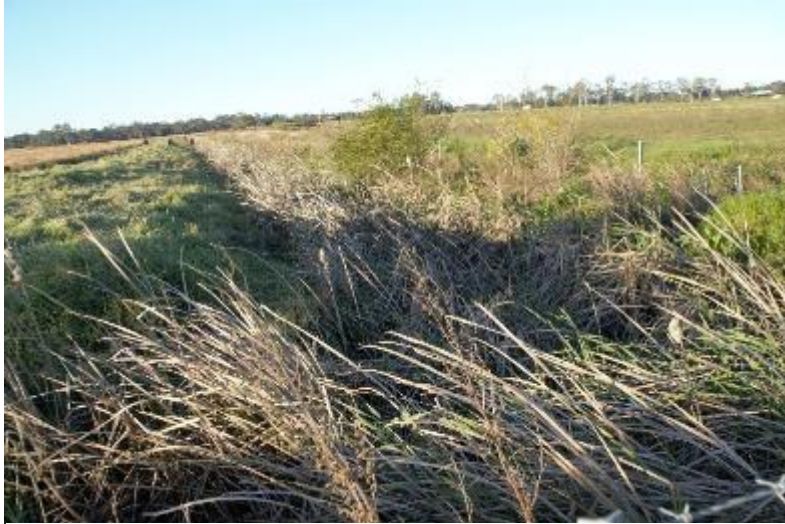
Photo 242

A long length of channel is choked with vegetation (Photo 242) which would slow flow through this reach. However, the vegetation has the advantage of removing nutrients from the runoff from the surrounding paddocks which were stocked with cattle. Periodic partial removal of the vegetation would probably be best compromise between water quality improvement and drainage efficiency.

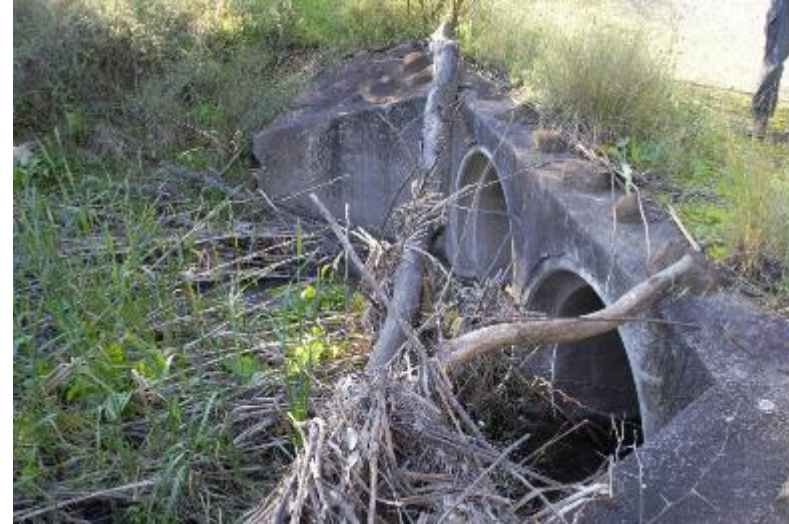
Photo 243

There is some accumulation of sediment and debris in the channel upstream of the culverts running under the transmission line access road (Photo 243). These should be removed to prevent further accumulation causing significant blockage of flow which could in turn lead to overtopping and erosion of the access road.

Blockage of the culverts under the road at the downstream end of IA2 could cause the water in the channel to build up and overflow the road, causing erosion of the road. Where there was some blockage of the pipes with silt and debris, there was no evidence that recent flooding had caused the road to be overtopped and damaged by flooding.

Regular inspection and clearing of the culverts will prevent overtopping of the access road. It is possible that the access track and the culverts under it are the responsibility of the owners of the transmission line and the holders of the easement. This should be investigated to determine who is responsible for keep the culverts and the drain immediately upstream of them clear of debris.

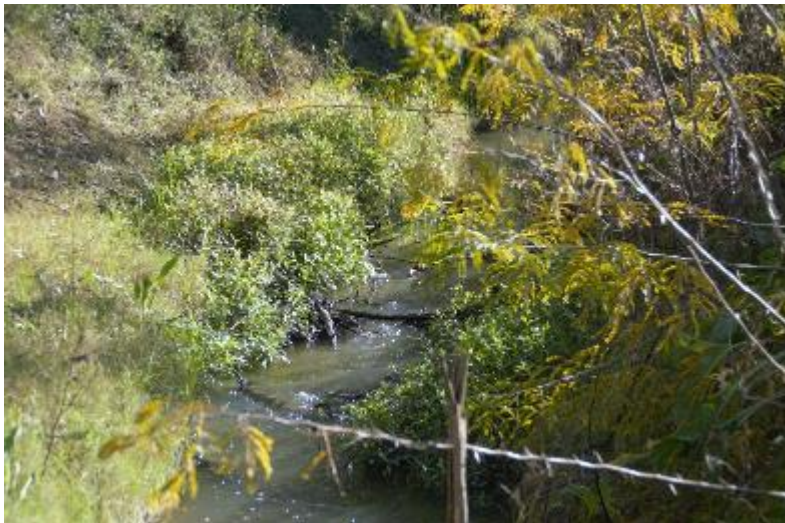
Photo 244

There appears to have been some minor sedimentation and vegetation growth within the channel at few locations (Photo 244 and Photo 245) which is creating minor restrictions to flow in low flow conditions. It appears this may have been caused by some minor bank slumping causing sediment to fall into the drain. These should be monitored and, should the constrictions increase, removal of the vegetation and sediment and stabilisation of the banks should take place.

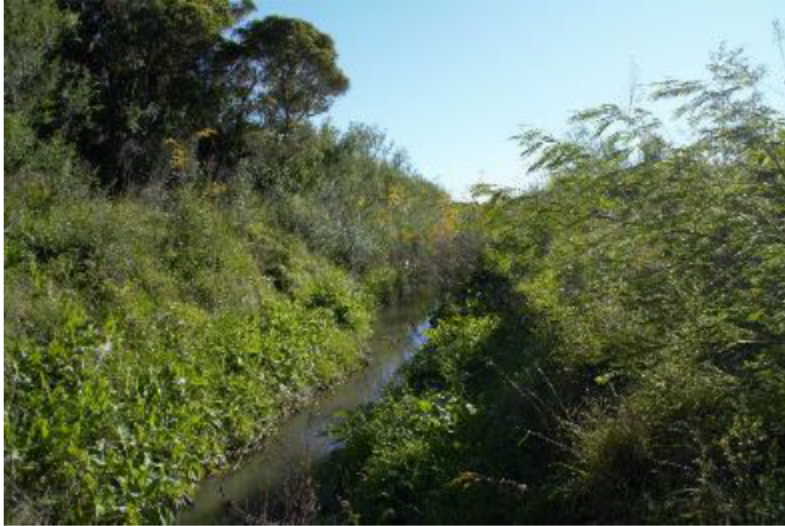
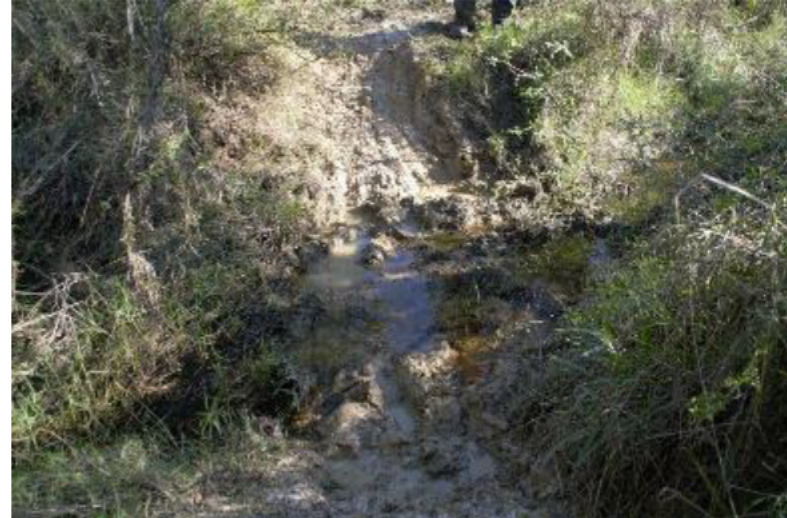
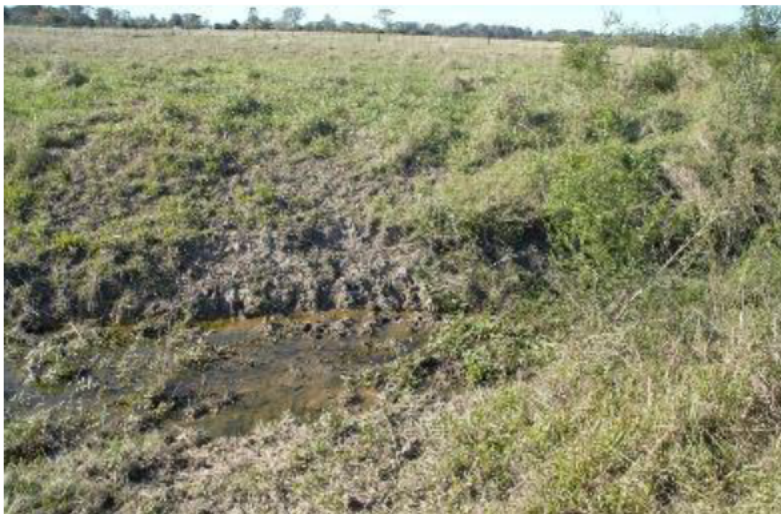
There are a few locations where cattle have been crossing the drainage channel and this has pushed sediment into the base of the channel (Photo 246, Photo 247 and Photo 248). While this constricts flow local under low flow conditions, the channel is so deep at these locations that it would not have an impact on the drainage of the surrounding farmland.

Similarly, the locations where the slumping of channel banks and bank degradation by cattle crossing had caused ponding in the channel, there was no evidence that this had inhibited the drainage of the surrounding paddocks to the extent that additional damage had occurred.

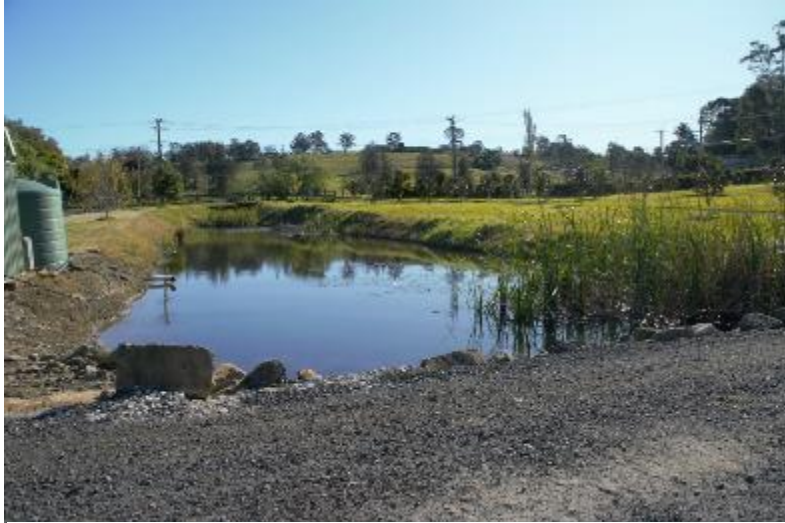
Photo 249

There are four arms to IA3N. The northern most arm runs in a southerly direction on the western side of Hibberts Lane before turning east and flowing under Hibberts Lane into a pond (Photo 249). The inspection commenced downstream of the pond which discharges through a series of pipes under and access road (Photo 250). The property owner advised that during the March event stormwater flows which came down Hibberts Lane overtopped the pond and the road and caused the erosion that can be seen in the photo.

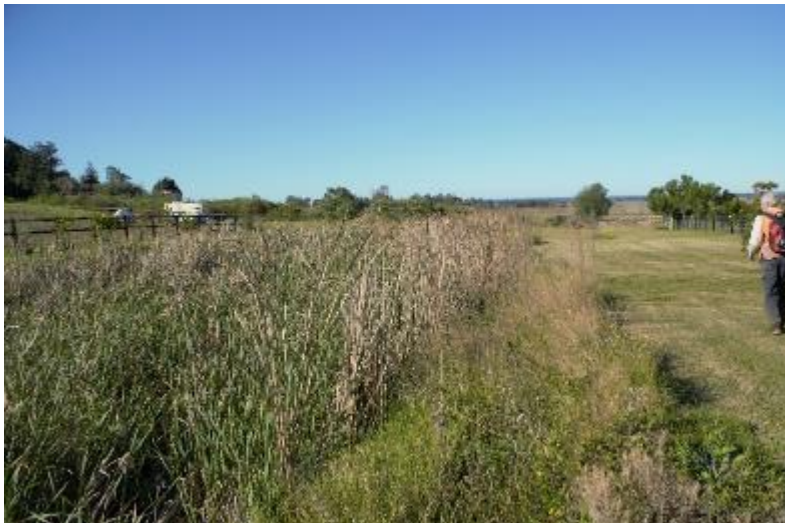
Photo 251

Downstream of the pond is a reed bed (Photo 251) which discharges over an access road and across a paddock (Photo 252) before passing through a pipe under an access road. The inlet to the pipe was partially blocked with debris and flow has eroded a bypass passage under the road to the left of the pipe (Photo 253). Despite there being flow in the channel, the pipe was dry at its outlet (Photo 254). The channel downstream from here is deeply incised (Photo 255) before running across lower, flatter ground (Photo 256). There are numerous piped crossings along this reach with the crossings spaced to facilitate the passage of travelling irrigators over the channel. There are also concrete slabs used as bridges for the irrigators (Photo 257).

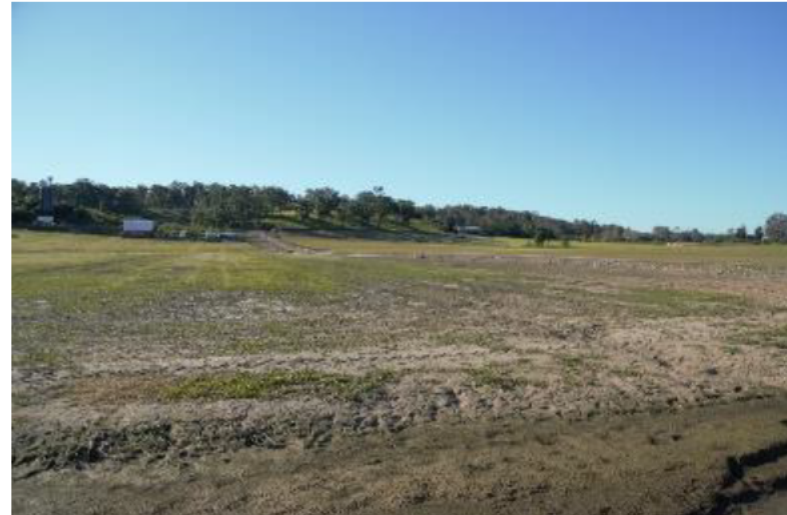
Photo 258

Along this reach there is a long access road raised about 0.5m above the paddock (Photo 258) with a single large pipe through it at the drain (Photo 259). There are several transverse drains (Photo 260) draining into the eastern flowing main drain. The eastern flowing drain terminates in a large pond immediately to the west of Gorricks Lane, which then overflows through culverts under Gorricks Lane and into a wide depression. The depression leads into the upper reaches of Bushells Lagoon.

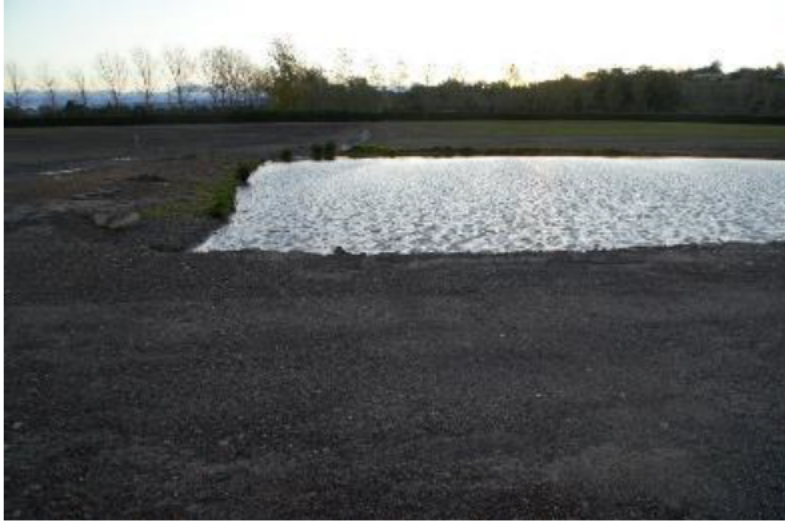
Photo 261

The middle arm begins as a depression running east from Hibberts Lane and into a large pond (Photo 261). That overflows via a culvert and then pipes under and access road on the neighbouring property (Photo 262). It flows north, on the eastern side of the access road (Photo 263) before cutting diagonally across the paddocks with all manner of crossing constructed to accommodate the travelling irrigators (Photo 264) before flowing north into the northern arm.

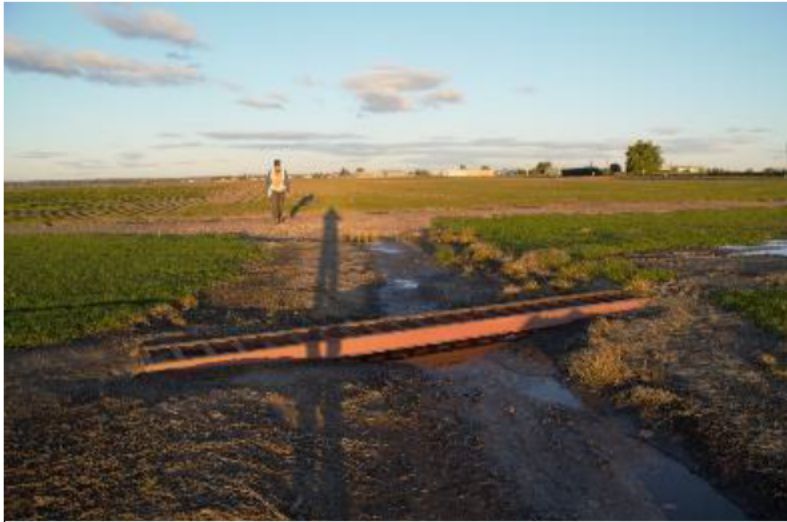
Photo 265

The southern most arm west of Gorricks Lane begins as a shallow depression east of the middle arm pond with low irrigator bridges and small diameter pipes under access tracks (Photo 265). Part way along there is an access road about 1m above the paddock (Photo 266) with a large pipe under it (Photo 267). The drain remains shallow with various irrigator crossings and degrees of siltation within the channel (Photo 268 and Photo 269). In places the pipes under crossings have silted up and the

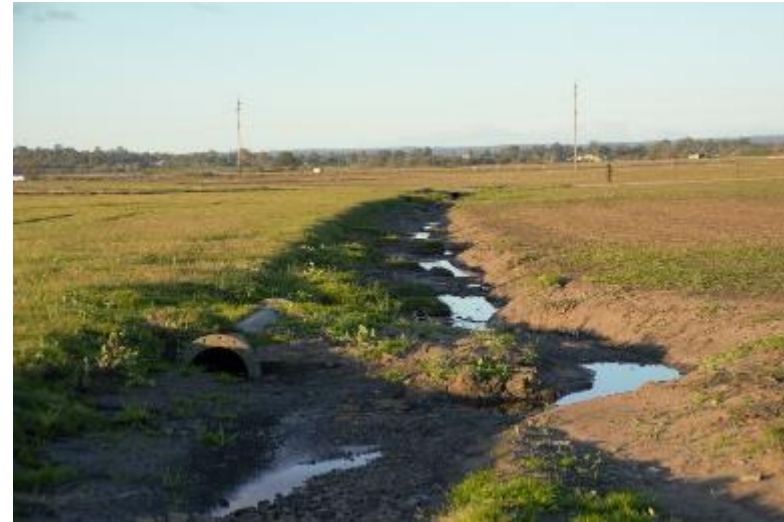
Photo 270

channel has eroded a bypass (Photo 270). Debris has blocked some of the pipe inlets (Photo 271). When this channel reaches Gorricks Lane it heads north on the western side of the road until it reaches the crossing under Gorricks Lane and into Bushells Lagoon.

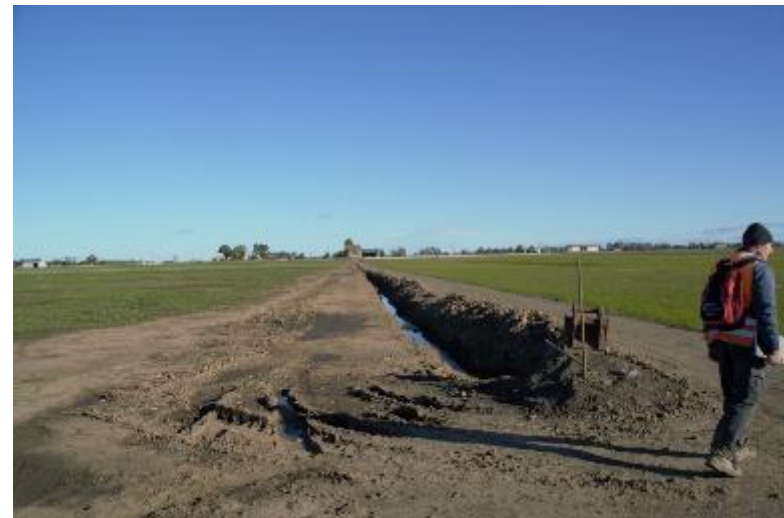
Photo 272

The fourth part of the network is east of Gorricks Lane and consists of a series of shallow drains around the perimeters of turf paddocks (Photo 272, Photo 273) which flow north towards Batchelors Wharf Road. The drain flows west along the southern side of Batchelors Wharf Road (Photo 274) before flowing in pipes under the road (Photo 275) at several locations into a small wetland (Photo 276).

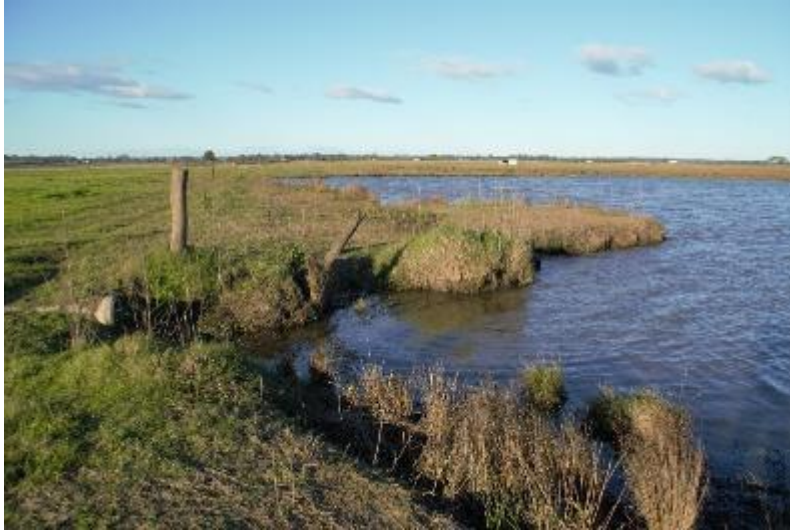
Photo 277

The wetland overflows into Bushells Lagoon via a small pipe. On the day of the inspection the top water level in the wetland was below the invert of the pipe (Photo 277).
