13 | Investigation Area 4

13.1 Drainage Issues

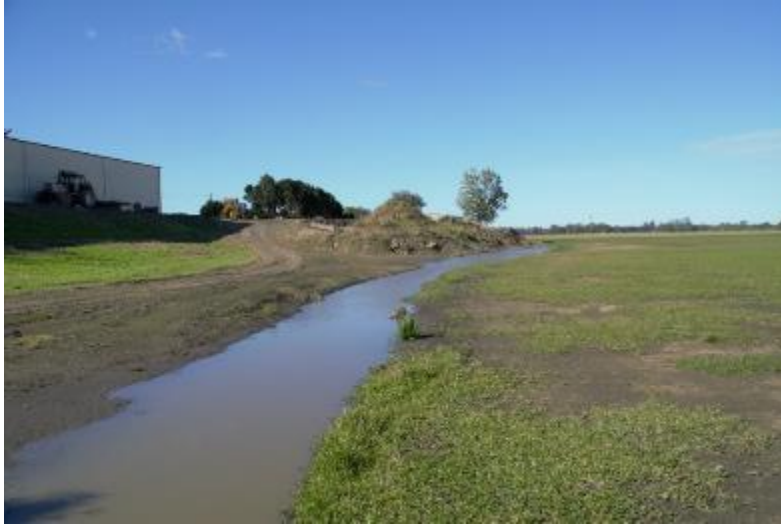
Photo 309

Downstream from here the drain is wide and shallow and full of water (Photo 309) because it has been blocked with fill (Photo 310 and Photo 311). The end of this reach is defined by another major access track with a 600mm pipe under (Photo 312).

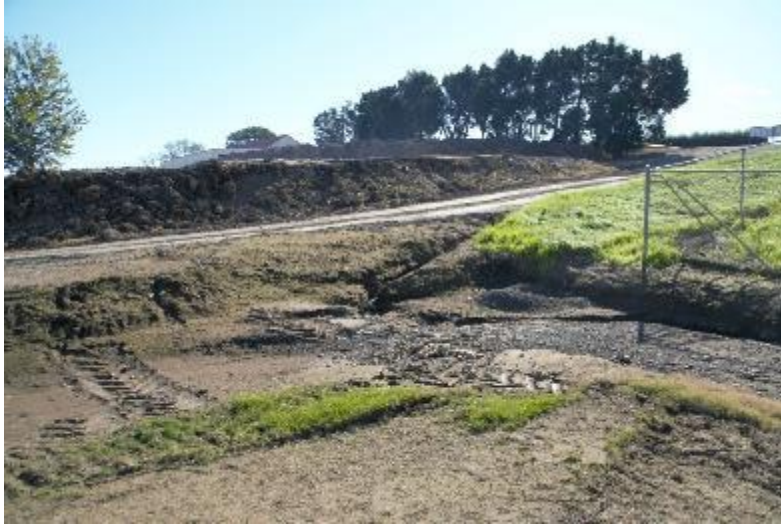
Photo 313

From this point the flow is directed immediately north (Photo 313) and then along a well-defined, shallow drain (Photo 314) before diverting south around a large area of fill (Photo 315 and Photo 316). This whole length is unobstructed by crossings (Photo 317) until it is crossed by another farm access track with two 300mm pipes (Photo 318). From here it continues as a wide, shallow drain which is generally unobstructed (Photo 319) before it has to divert south around what appears to be a stockpile of topsoil (Photo 320) and under a farm access through a 300mm diameter pipe (Photo 321).

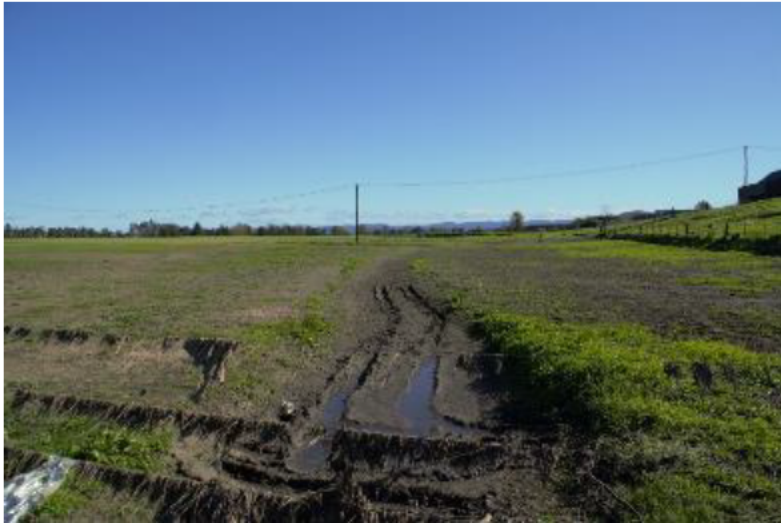
Photo 329

From here the drain is diverted north and then east in a cleared channel (Photo 328) which becomes wider, shallower and more silted downstream (Photo 329). The drain is then a less well defined grassed depression through a paddock (Photo 330) before draining into an area of water which appears to be permanently ponded behind a raised access road embankment (Photo 331). The invert of the 450mm pipe under the access road was above the bed of the pond (Photo 332) and so there was no outflow on the day of the inspection.

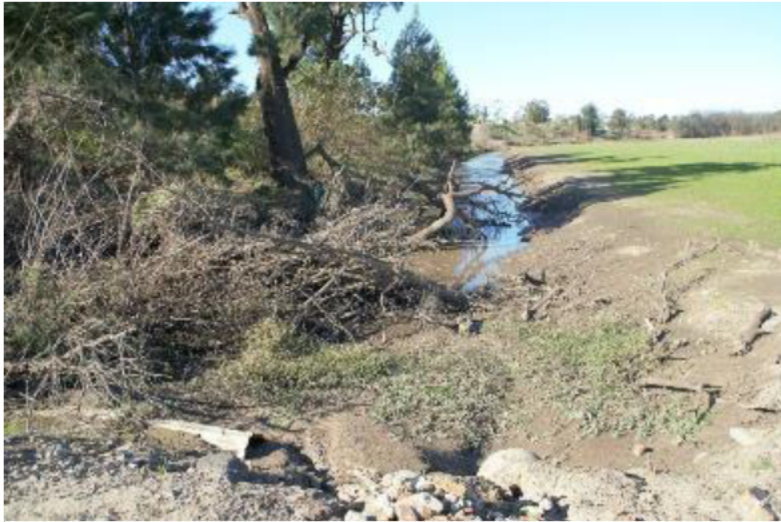
Photo 333

Downstream of the access road the channel is wide and deep but initially littered with large woody debris (Photo 333). Water was ponded in this reach because the pipe under the next access road has its invert above the invert of the channel (Photo 334). There appears to be permanent pump infrastructure to extract water from this pond (Photo 335). Recent earthworks downstream of this outlet appears to force water to pond and overflow the access road (Photo 336 and Photo 337) before following the lowest part of the landscape along the toe of a steep batter of fill (Photo 338). This leads to another pond which appears to be used for water supply (Photo 339). No outlet or spillway for this pond was observed so it must simply overflow across the lowest point of the access track at the eastern end of the pond.

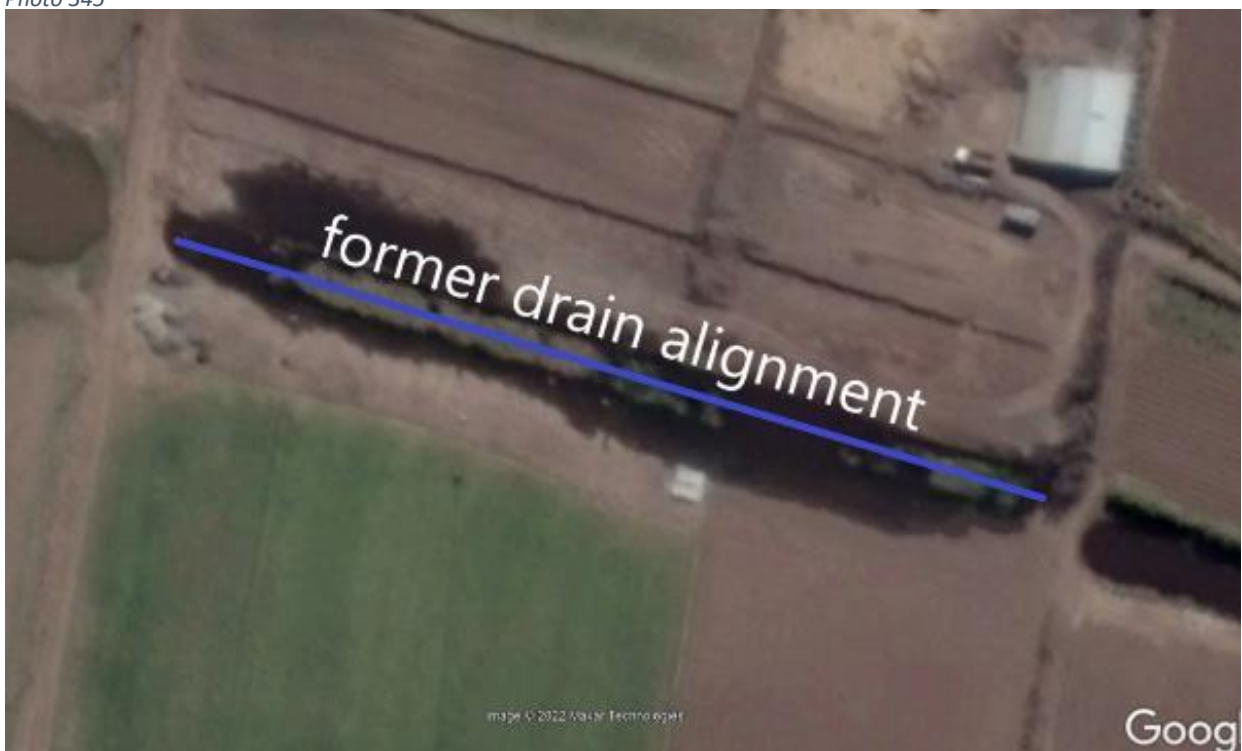
Figure 106: 2017 drain alignment

In 2017 the drain downstream of the damming access road was aligned with the sections of drain upstream and downstream and was a wide pond of water similar to downstream. By 2021 the original drain alignment had been filled in and the drain made narrower and shifted about 15m north. This will mean that any pipe under the road will need to be laid diagonally across the road rather than perpendicular across the road. This will increase its length and the cost of laying it.

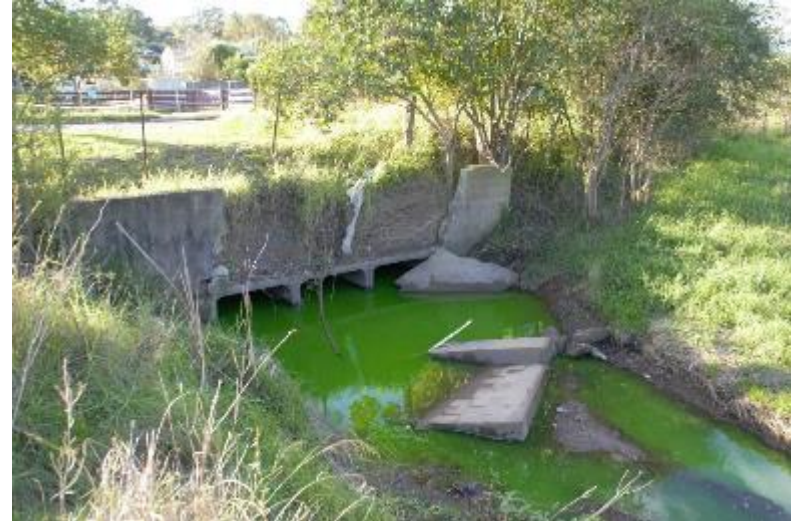
Photo 347

There are two branches of drainage in this area which commence north of King Road and converge in a complex of wetlands which overflow into a deep drain which discharges into the Hawkesbury River. Where the north eastern arm passes under King Road, the flows coming down the channel (according to a property owner) had caused significant damage to the infrastructure upstream (Photo 346) and downstream (Photo 347) of the culvert. There was also a pollution event in the creek on the day of the inspection and this had been reported to Council. A disused crossing downstream has been torn apart by erosion (Photo 348).

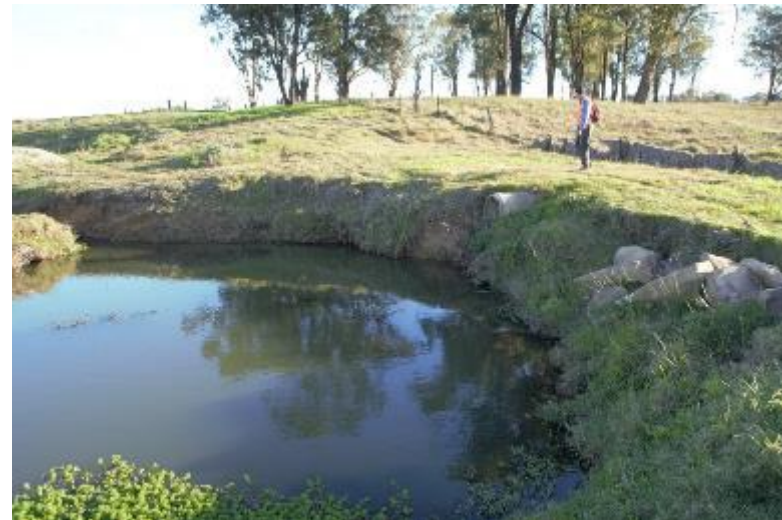
Photo 349

The pipes and drains leading into and out of the wetlands did not appear to be blocked (Photo 349). The wetlands themselves were very full (Photo 350) and the ground surrounding them was saturated but that is to be expected.

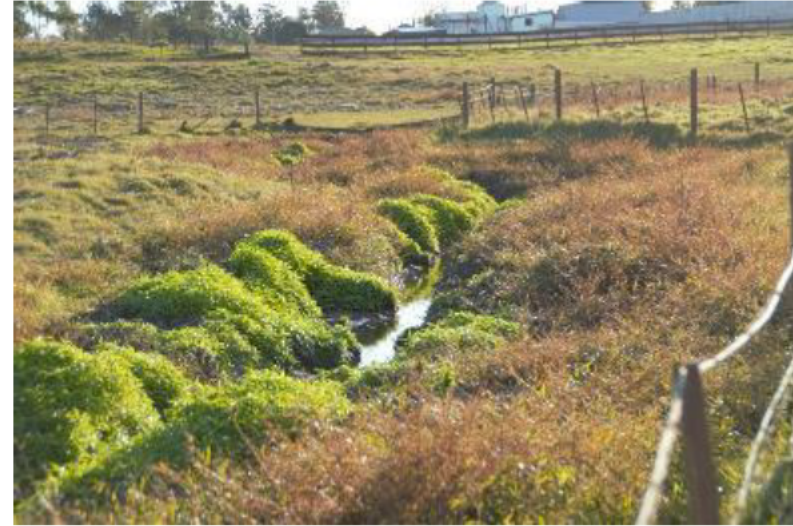
Photo 351

The south western drain leading into the wetlands was choked with weeds along its length (Photo 351).

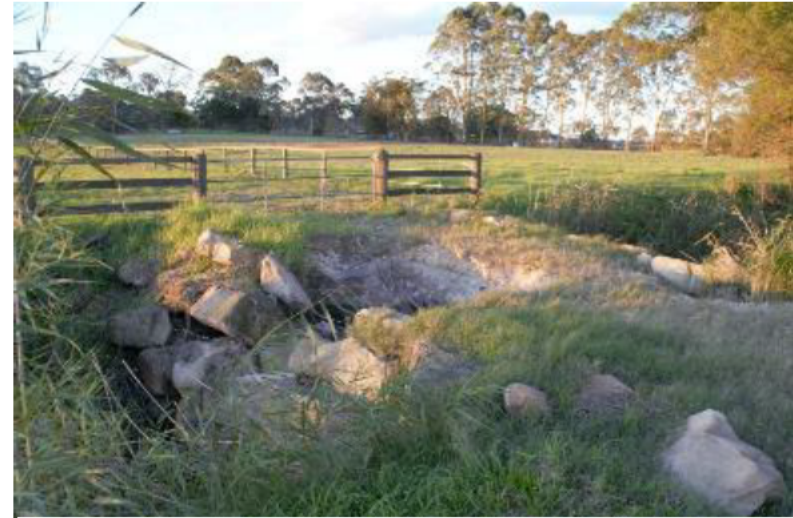
Photo 353

The channel leading out of the wetlands was deep and flowing freely despite thick reed growth along its edges (Photo 352). Once crossing was badly damaged (Photo 353) but this did not appear to be inhibiting flow in the channel at this water level. Further on there were some woody snags (Photo 354).

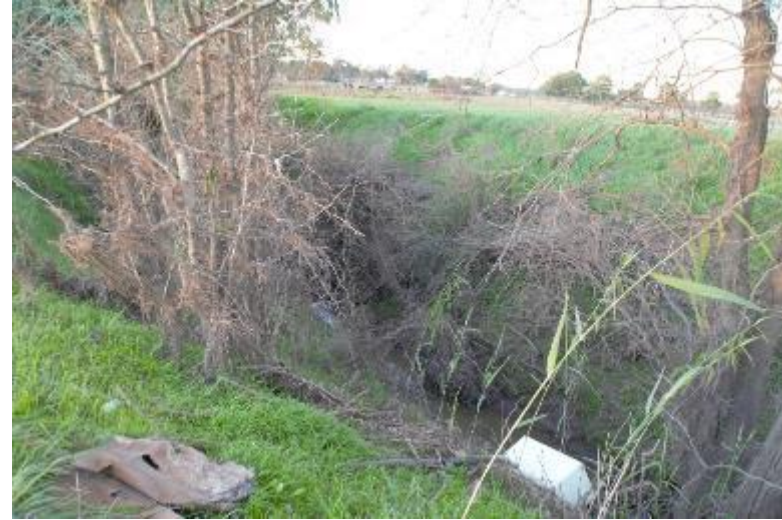
Photo 355

After the channel turns south towards the river it becomes much deeper and is tree lined in places with some flood debris (Photo 355). Closer to the river there is evidence of bank slumping (Photo 356 and Photo 357).

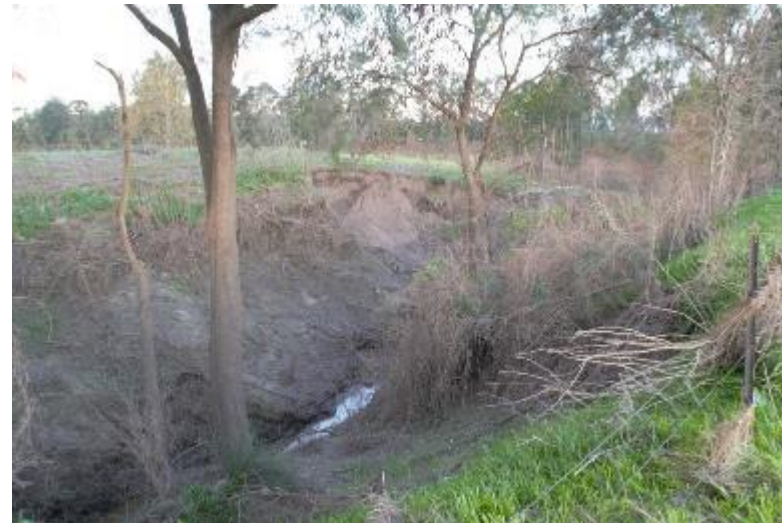
Photo 357

The bank slumping in the lower reaches of the creek is caused by its steep, sparsely vegetated banks in the unconsolidated alluvial sediments which become saturated and then cannot drain fast enough as the river level drops.

While bank slumping could be repaired and mitigated following the principals set out for options to deal with the similar problem in IA1NE, in IA4 there does not appear to be any significant impact caused by the slumping so there is not imperative to undertake works here.

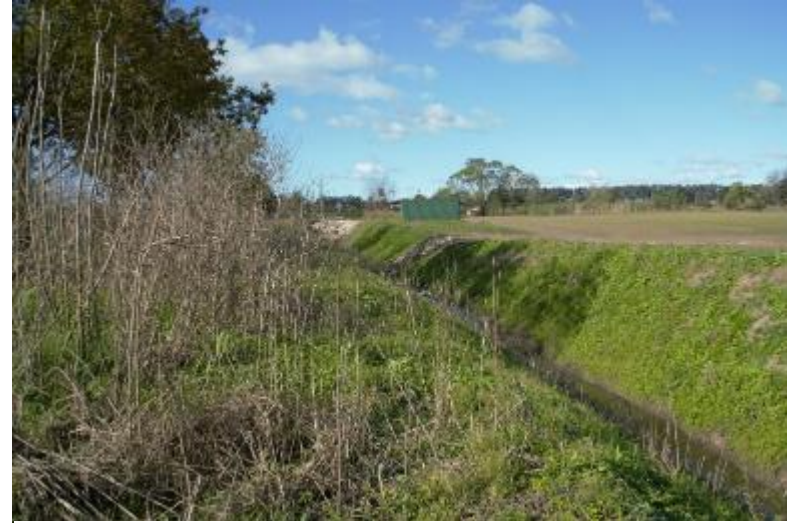
Photo 363

Instead, at this point it turns at 90 degrees and heads east (Photo 363) to Bardenarang Gully into which it discharges through an embankment with pipes at three levels (Photo 364). The pipe outlets are fitted with flood gates (Photo 365). The embankment and pipes appear to be recently installed and this may have been done in response to recommendations in the 2020 Molino Stewart report to Lynwood Country Club.

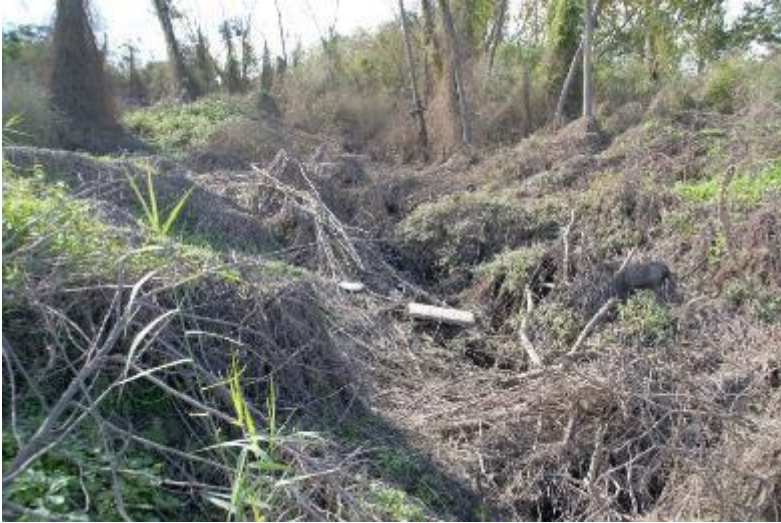
Photo 366

The former creek line to the north is overgrown (Photo 366) and was unable to be followed. It was next observed upstream of Pitt Town Bottoms Road (Photo 367) under which it crosses via two pipes with flood gates (Photo 368), one of which has become detached and the proper functioning of the other appears to be inhibited by sediment and debris. Moving downstream the creek is heavily infested with weeds, particularly privet. There are scattered native trees along the banks (Photo 369) and also woody debris within the creek (Photo 370).
