## Hawkesbury Floodplain Drainage Review

# Hawkesbury Floodplain Drainage Review Final

Client: Hawkesbury City Council

March 2024

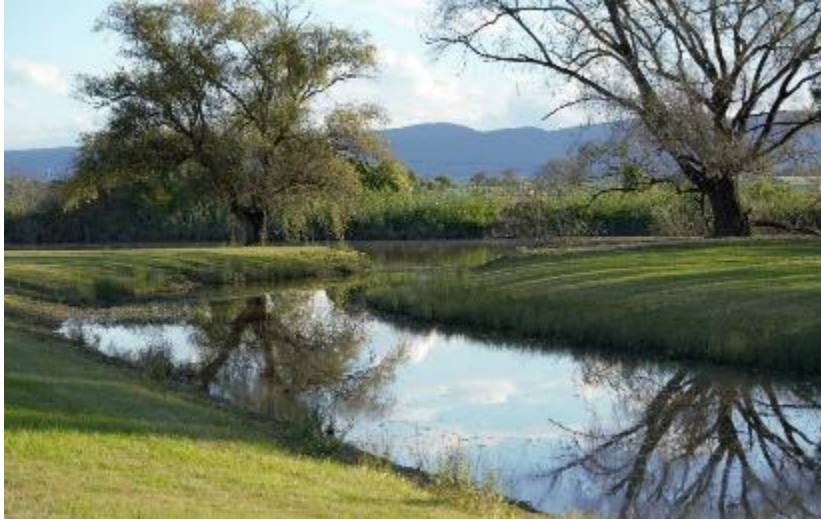
Photo 1

Springwood Road crosses Yarramundi Lagoon which is a natural lagoon which forms part of the main drainage line of IA1NW. Yarramundi Lagoon stretches about 700m south of Springwood Road and about 800m to its north. The lagoon overflows on its eastern side into the drainage line about 650m north of Springwood Road (Photo 1). The locations of each photograph referred to in the text can be found in Figure 9.

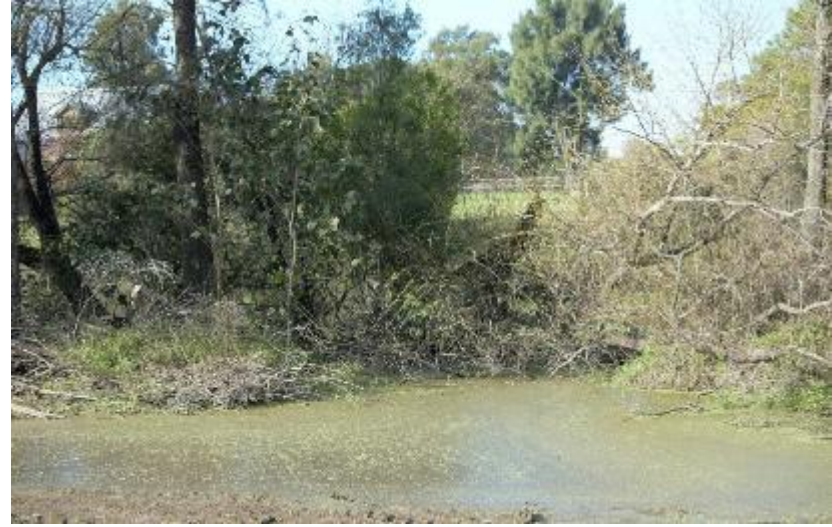
Photo 2

On the day of the May inspection, the level in the lagoon was such that it was flooding a corner of the turf paddock on western side of the lagoon and north of Springwood Road (Photo 2) and much of the grass in this paddock had been killed (Photo 3) from the water level having been elevated for prolonged periods well after the flood had receded. The property owner advised that even though the initial flooding was caused by the floodwaters covering the floodplain, every time there was significant rain in the local catchment the lagoon would rise and flood the paddock and then slowly recede.

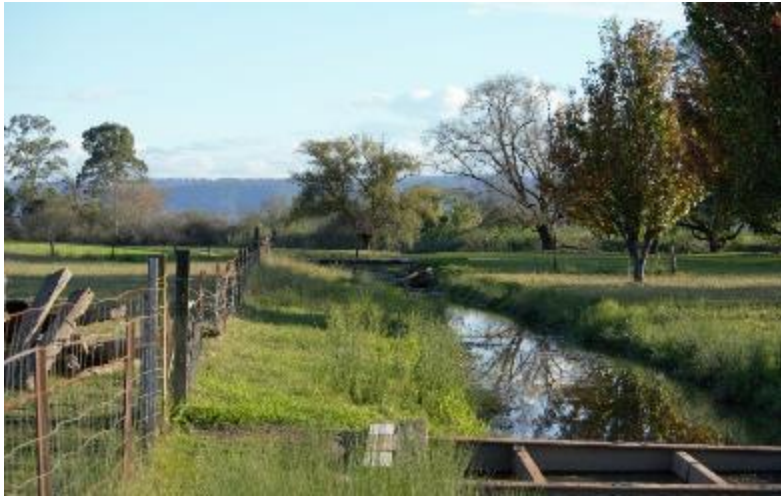
Photo 5

There were a couple of bridges over the outlet channel (Photo 5) but these did not appear to be obstructing flow at this water level. However, further downstream there is an embankment constructed across the drain (Photo 6). Although no pipe through the embankment was discernible on the day of the inspection (Photo 7), it is likely that there is one because the water level was the same on both sides of the embankment. Regardless of the size of the pipe or pipes and how blocked they are, if at all, the maximum flow rate through the pipes will be less than the capacity of the channel and so this will be a choke point in the drainage of the lagoon.

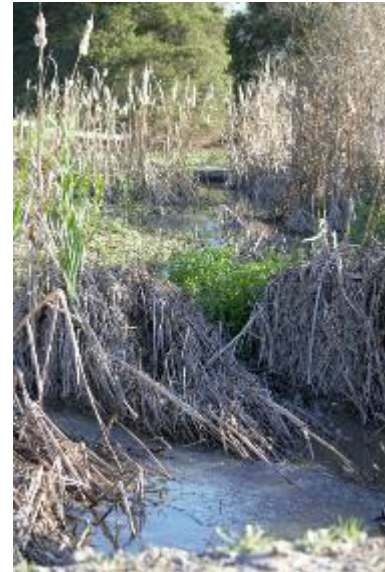
Photo 8

Nevertheless, because the water was the same level on both sides of the crossing and there was no discernible flow in the channel, at the observed water level there must be a choke point further downstream. This was found to be at a location just upstream of another road crossing. There was a collapsed concrete bridge followed by reeds growing in sediment within the channel (Photo 8). There was a change in water level here as the water flowed between the reeds but then it only fell a few hundred millimetres before reaching ponded water which was at the same level as water ponded downstream of the crossing (Photo 9).

The water level in the lagoon which was observed on both the May and July inspections was caused by the accumulation of sediment and reeds within the channel at the location of photo 8.

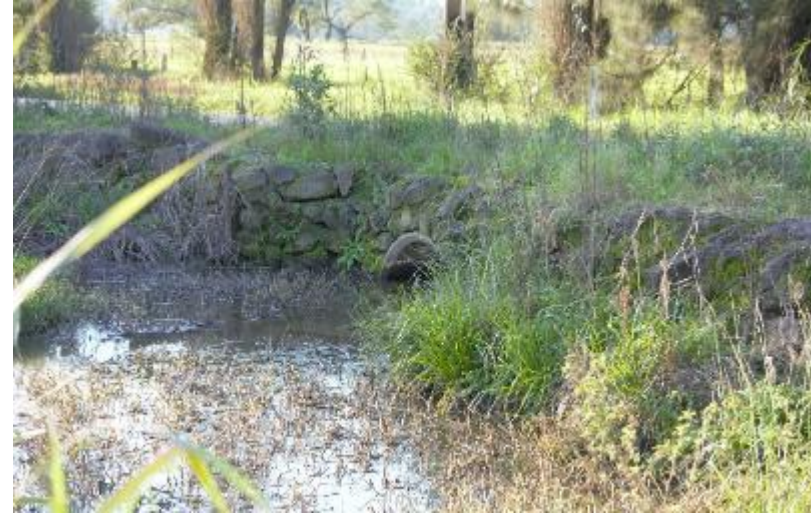
Photo 10

Water was ponded at this level as far as the pipe under Crowleys Lane (Photo 10) where minimal flow was detected. The Crowleys Lane crossing was visited again on 12 July and the water level was a few hundred millimetres higher and slow flow through the pipe was able to be detected (Photo 11).

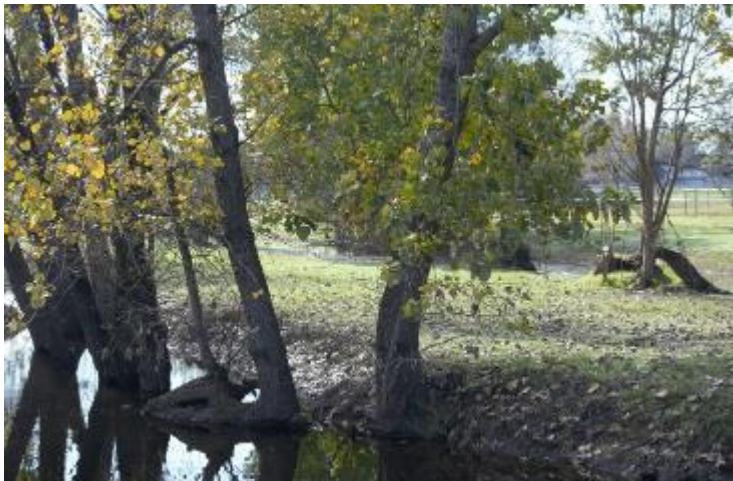
Photo 26

This next water body splits in two around a raised strip running down its centre (Photo 26). There is an access across the lagoon and on one side the water passes under the access and at the observed water level the water passed over the access on the other side (Photo 27 and Photo 28). The ponded water discharges through a pipe under an internal access track before the passing under Old Kurrajong Road through a culvert with three large pipes (Photo 29). There is a fence immediately upstream of the culverts which has caught a lot of debris during the flood. There is ponded water downstream of the culverts which is at the same level as the water upstream (Photo 30). There is an access track across the pond with no pipe discernible but the water is the same level on both sides (Photo 31).

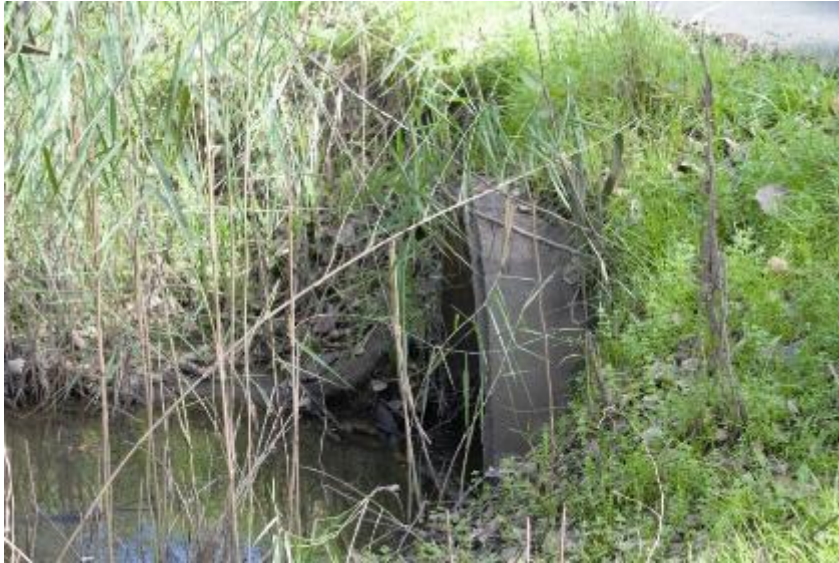
Photo 32

There is a noticeable outflow from this pond via a culvert under Ridges Lane (Photo 32). An open channel flows along the northern side of Ridges Lane and there was a noticeable flow on the day of the inspection in May (Photo 33). It continues in this roadside channel until it crosses back under Ridges Lane which marks the end of IA1NW.

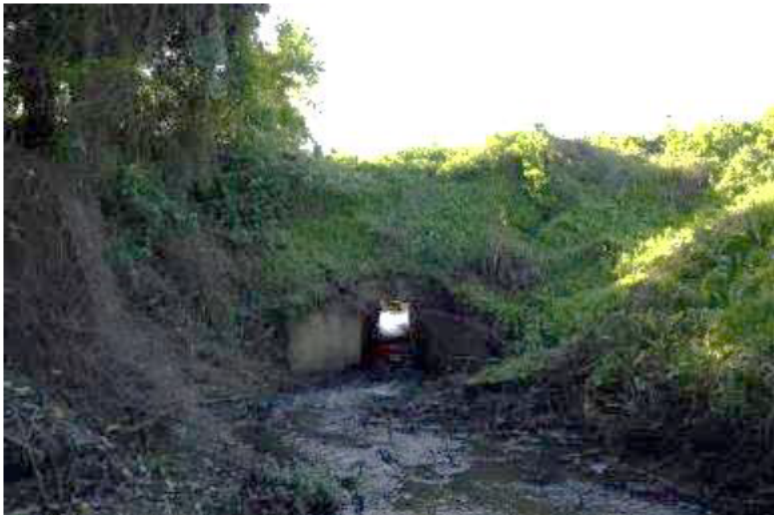
Photo 68

Downstream of these constructions the water was flowing freely through the creek and into a large culvert (Photo 68) which is fitted with floodgates which appeared to be stuck open. This was the same situation on 12 July but there was considerably more flow through the culvert.

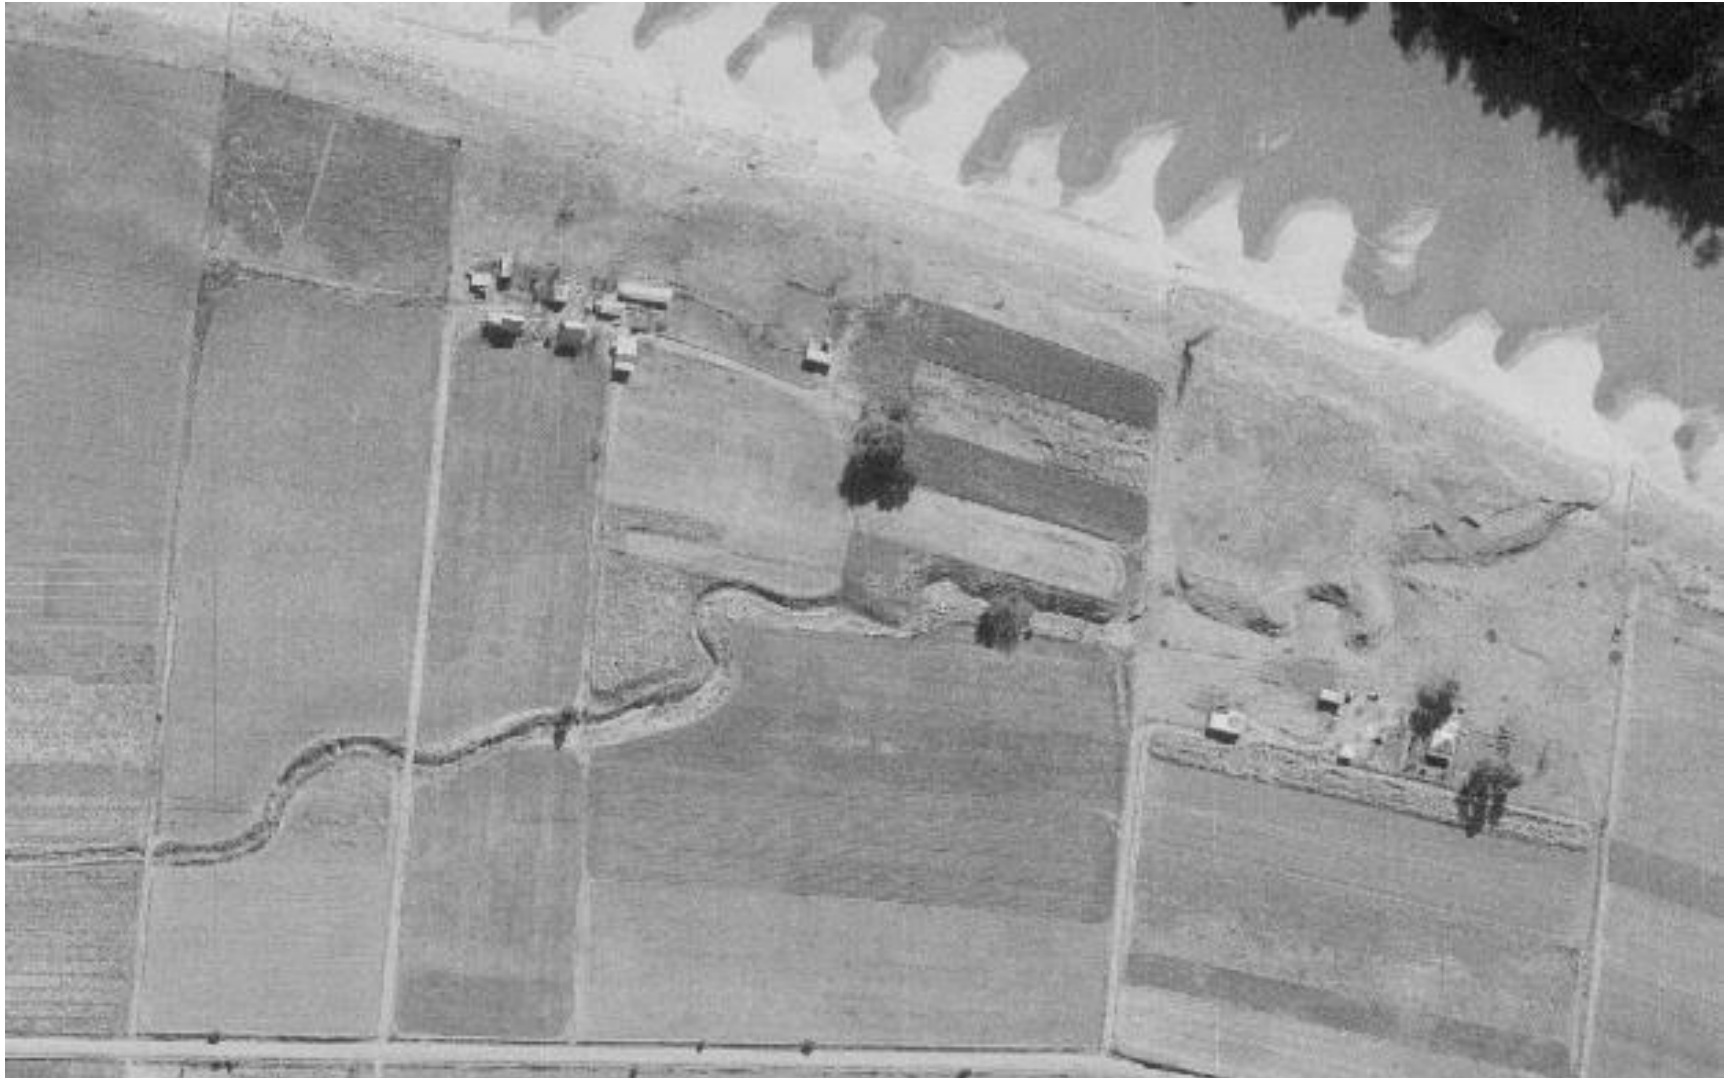
Figure 24: Historical aerial image captured in 1955

A historical satellite image shows little vegetation surrounding the drainage channel in 1955 (Figure 24), suggesting that very little of the native vegetation surrounding the drainage channel could be classified as remnant native vegetation. Rather it seems that majority of the vegetation surrounding the drainage channel has developed since then, whether that be via natural processes or planting.

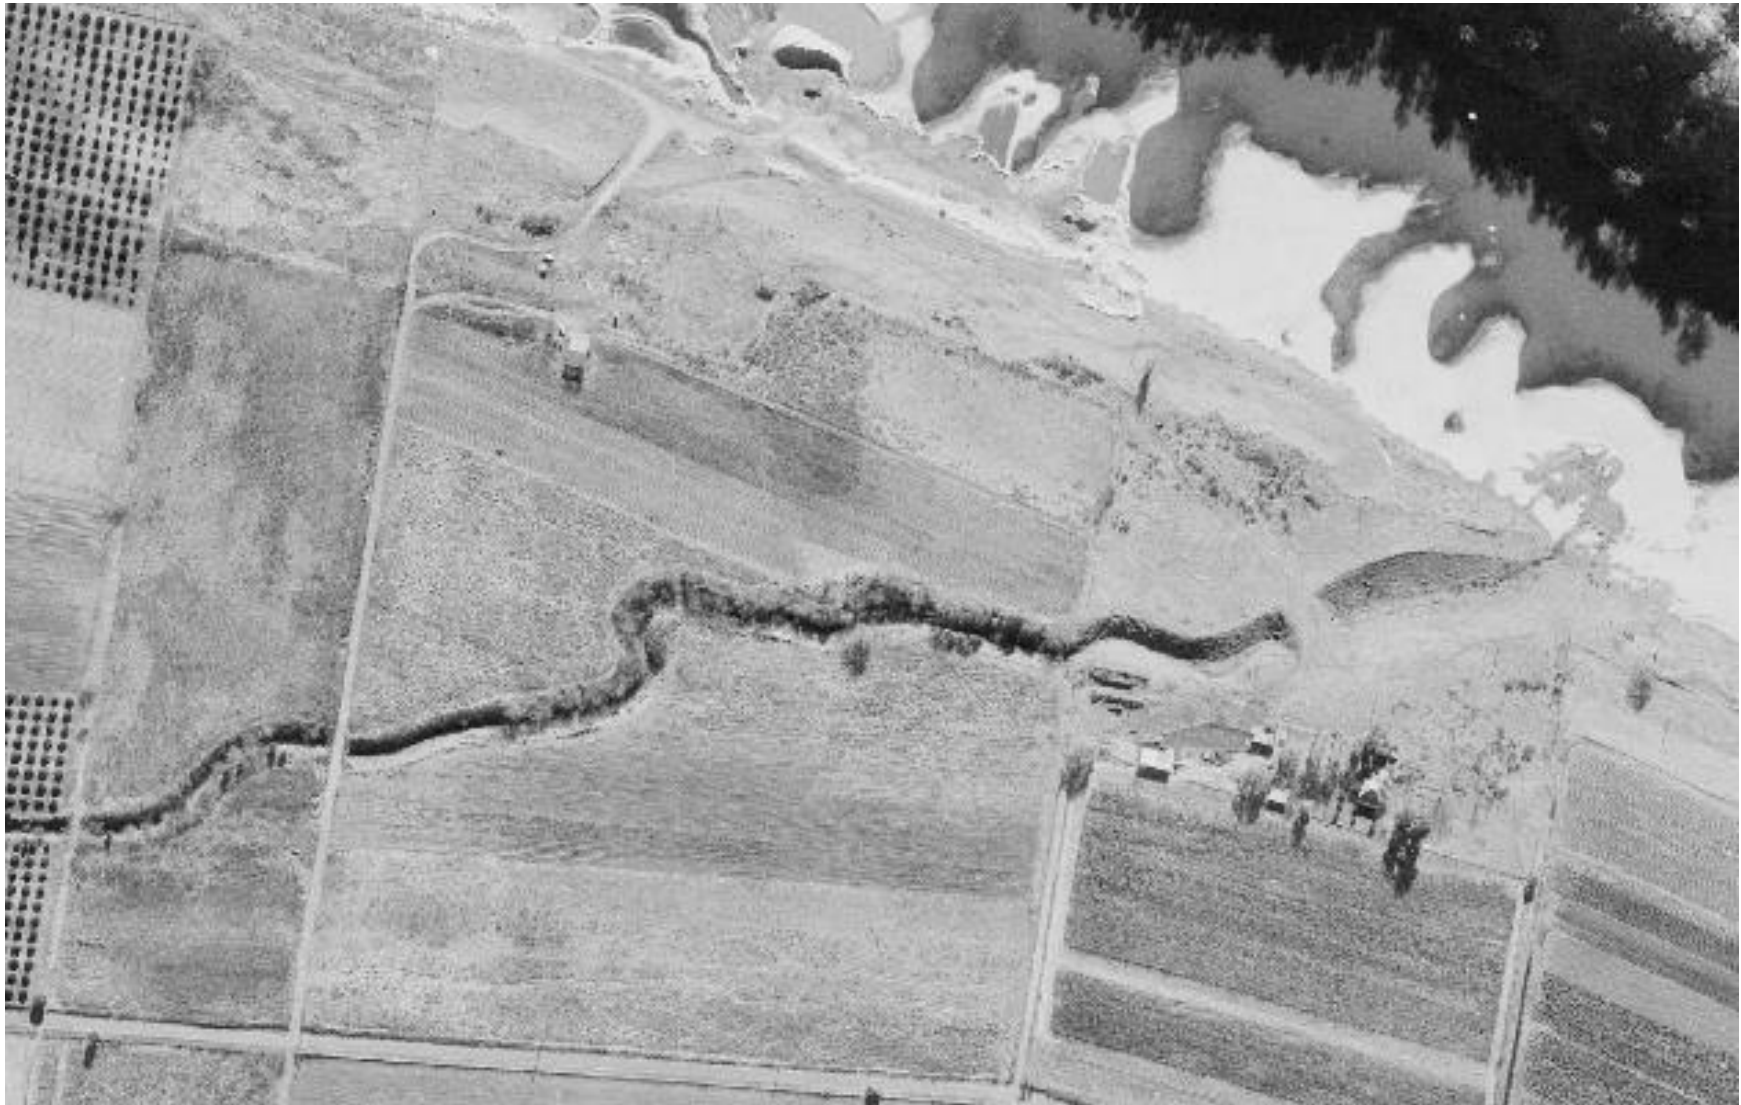
Figure 25: Historical aerial image captured in 1970

In the location of the observed bank collapse the creek is deep because it is penetrating through the natural levee along the river. The banks are steep because it appears that as the land use has moved from grazing to food crop production in the 1970s (Figure 25) and more recently turf farming, efforts have been made to flatten and expand the fields at the expense of flatter creek banks

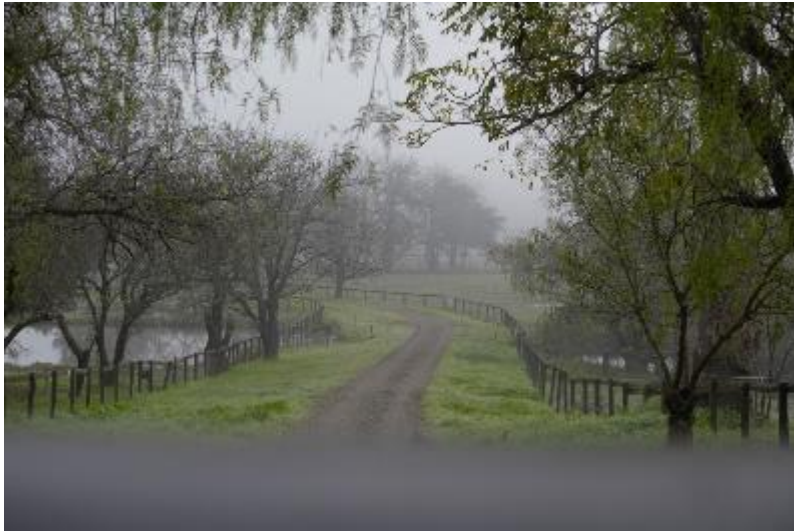
Photo 72

West of Inalls Lane there is a shallow channel full of reeds (Photo 69). Drainage under Inalls Lane is via a piped culvert. East of the road the drain is a weed filled ditch (Photo 70) which discharges into a lagoon (Photo 71 and Photo 72). The lagoon discharges under a farm access road into another lagoon which has a lower water level (Photo 73).

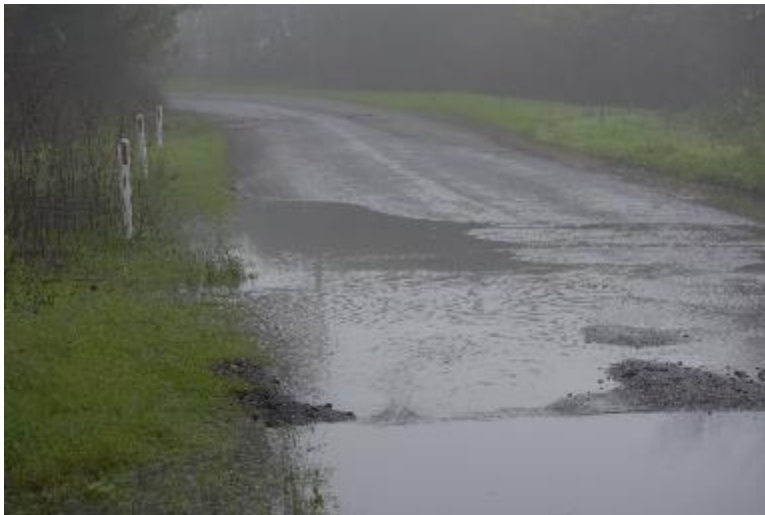
Photo 74

This lagoon is crossed by Kurrajong Road and is divided by a spit of land at Pughs Lagoon Reserve. This lagoon overflows via a pipe under Old Kurrajong Road into Pughs Lagoon which sits at a lower water level (Photo 74). On the day of the inspection in May the water level in the upstream lagoon was so high that there was water over the road (Photo 75) and low discharge through the connecting pipe (Photo 76). However, during the July inspection there was a greater flow through the pipe (Photo 77) and the upstream water level was lower (Photo 78) which suggests that in May the pipe was blocked upstream.

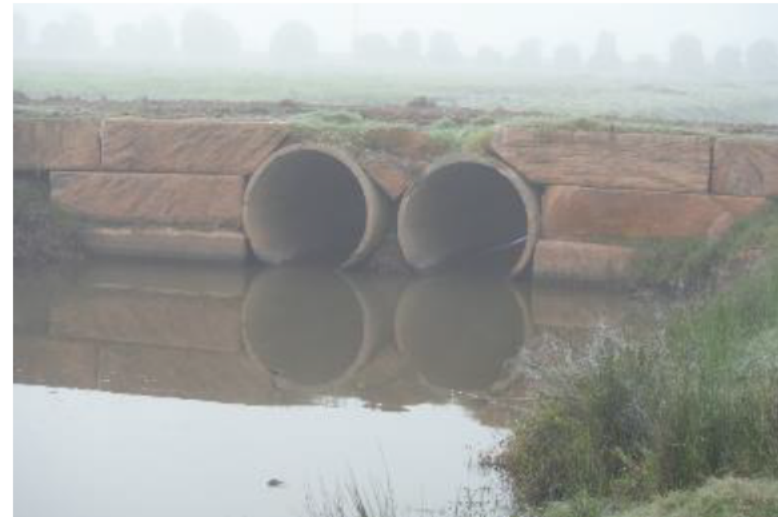
Photo 79

Pughs Lagoon overflows through a drain which passes under a farm access road through two large pipes (Photo 79) and under another farm access road through similar pipes about 150m downstream (Photo 80). There was a noticeable drop in water level and flow from one end of these pipes to the other (Photo 81). This open channel continues through to Onus Lane under which it passes through two large pipes (Photo 82).

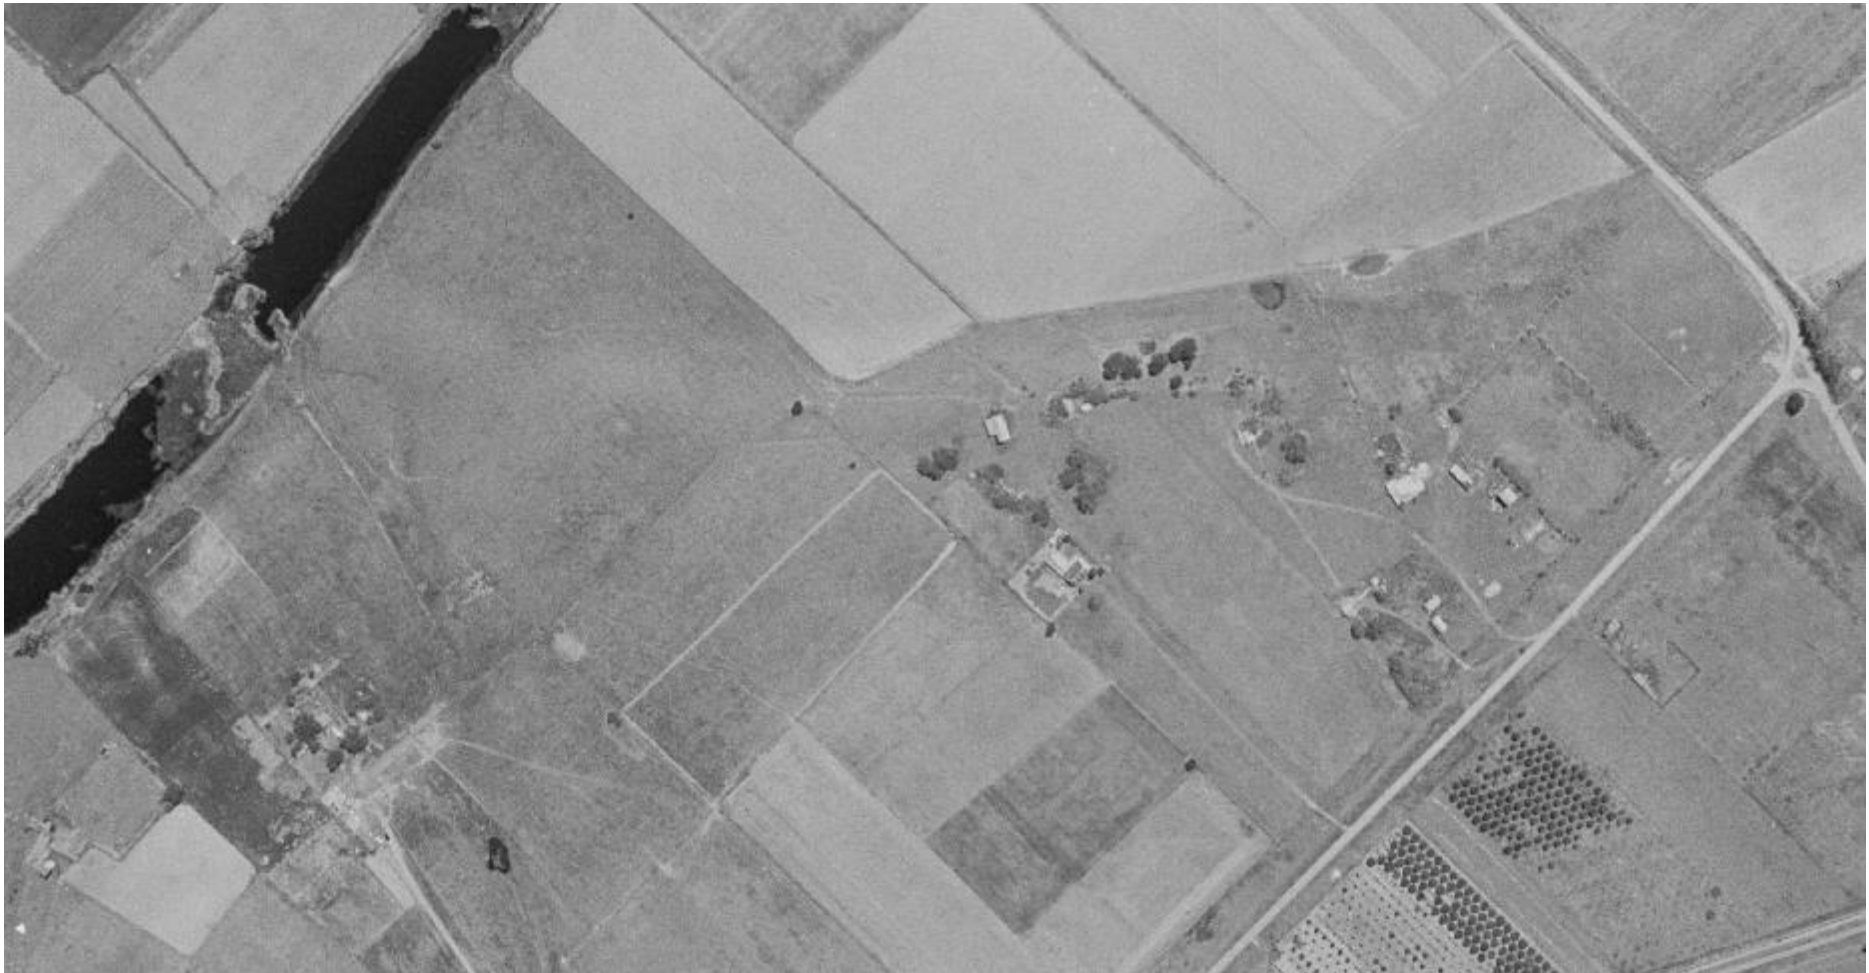
Figure 39: Solutions for IA1SW

Possible solutions are displayed in Figure 39.

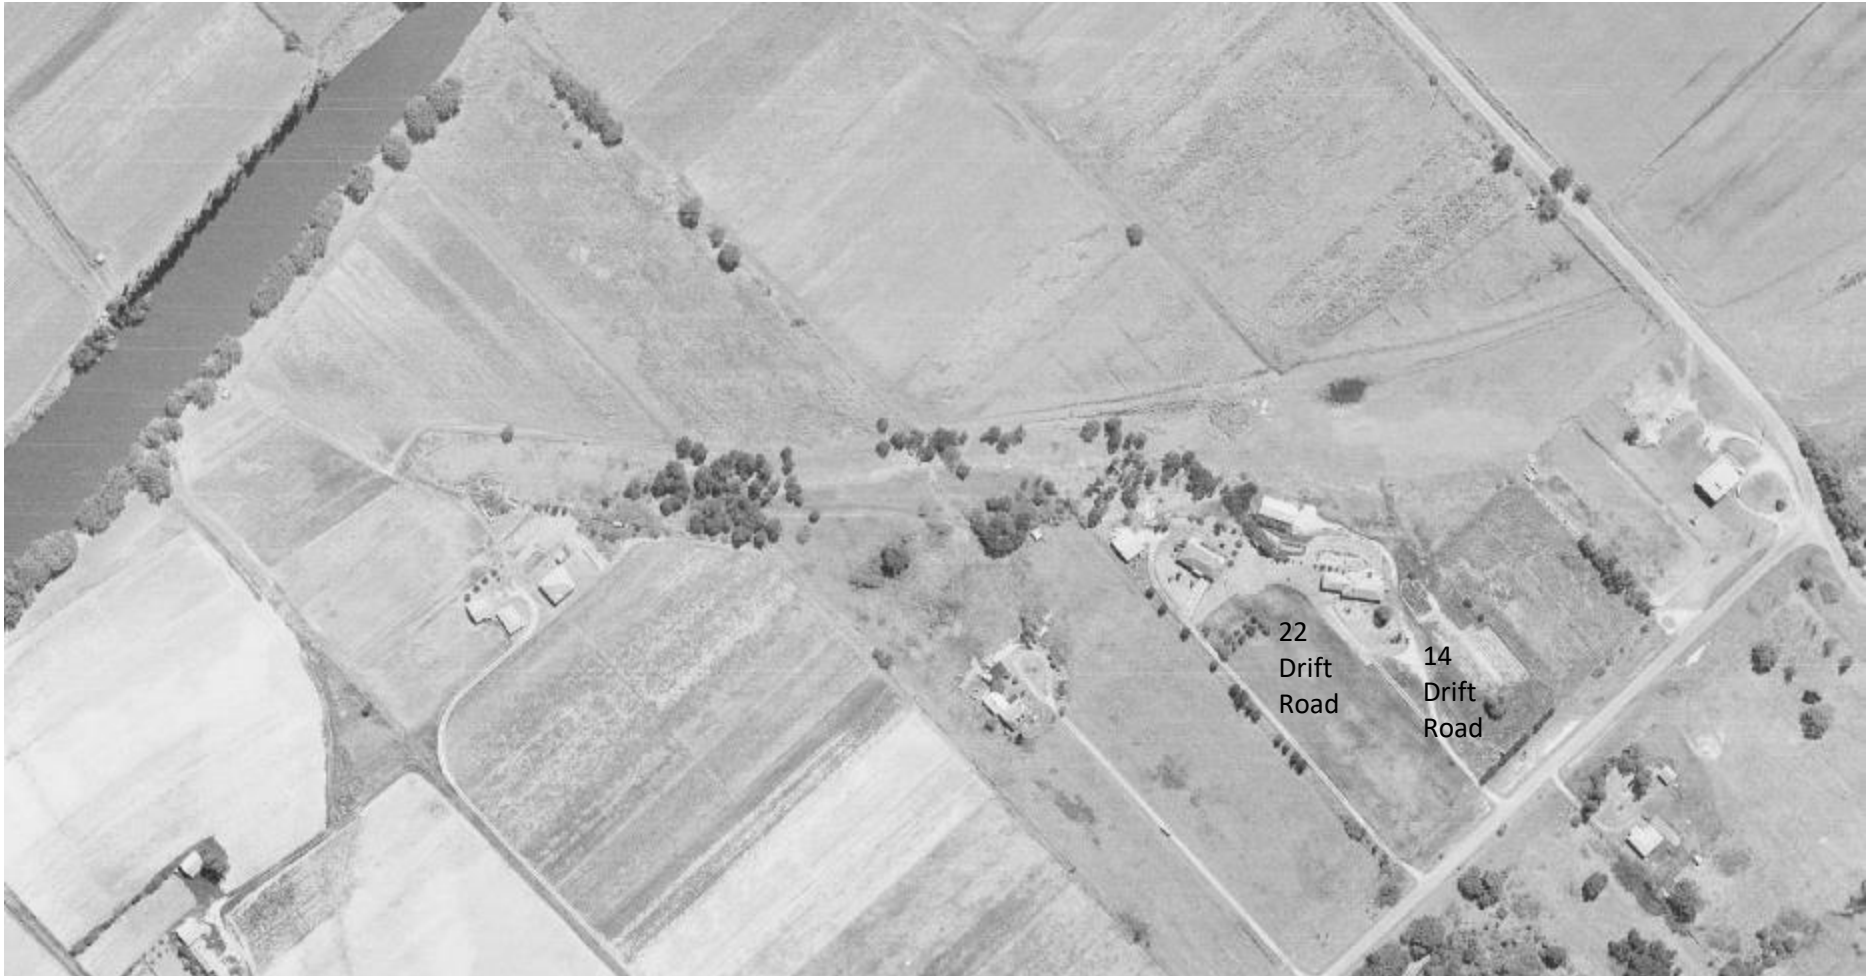
Figure 40: West of Inalls Lane and North of Drift Road 1955

It has been observed that there was no discernible drainage channel through this area yet it was shown as a water course on the topographic maps. One possibility may have been that at some time since 1960, and possibly since 1990, a former drainage line had been filled in. To investigate this, historical airphotos were searched and Figure 40 to Figure 43 show the period from 1955 to 2018. At the scale of the imagery there does not appear to be any discernible changes to any drainage lines or channels.

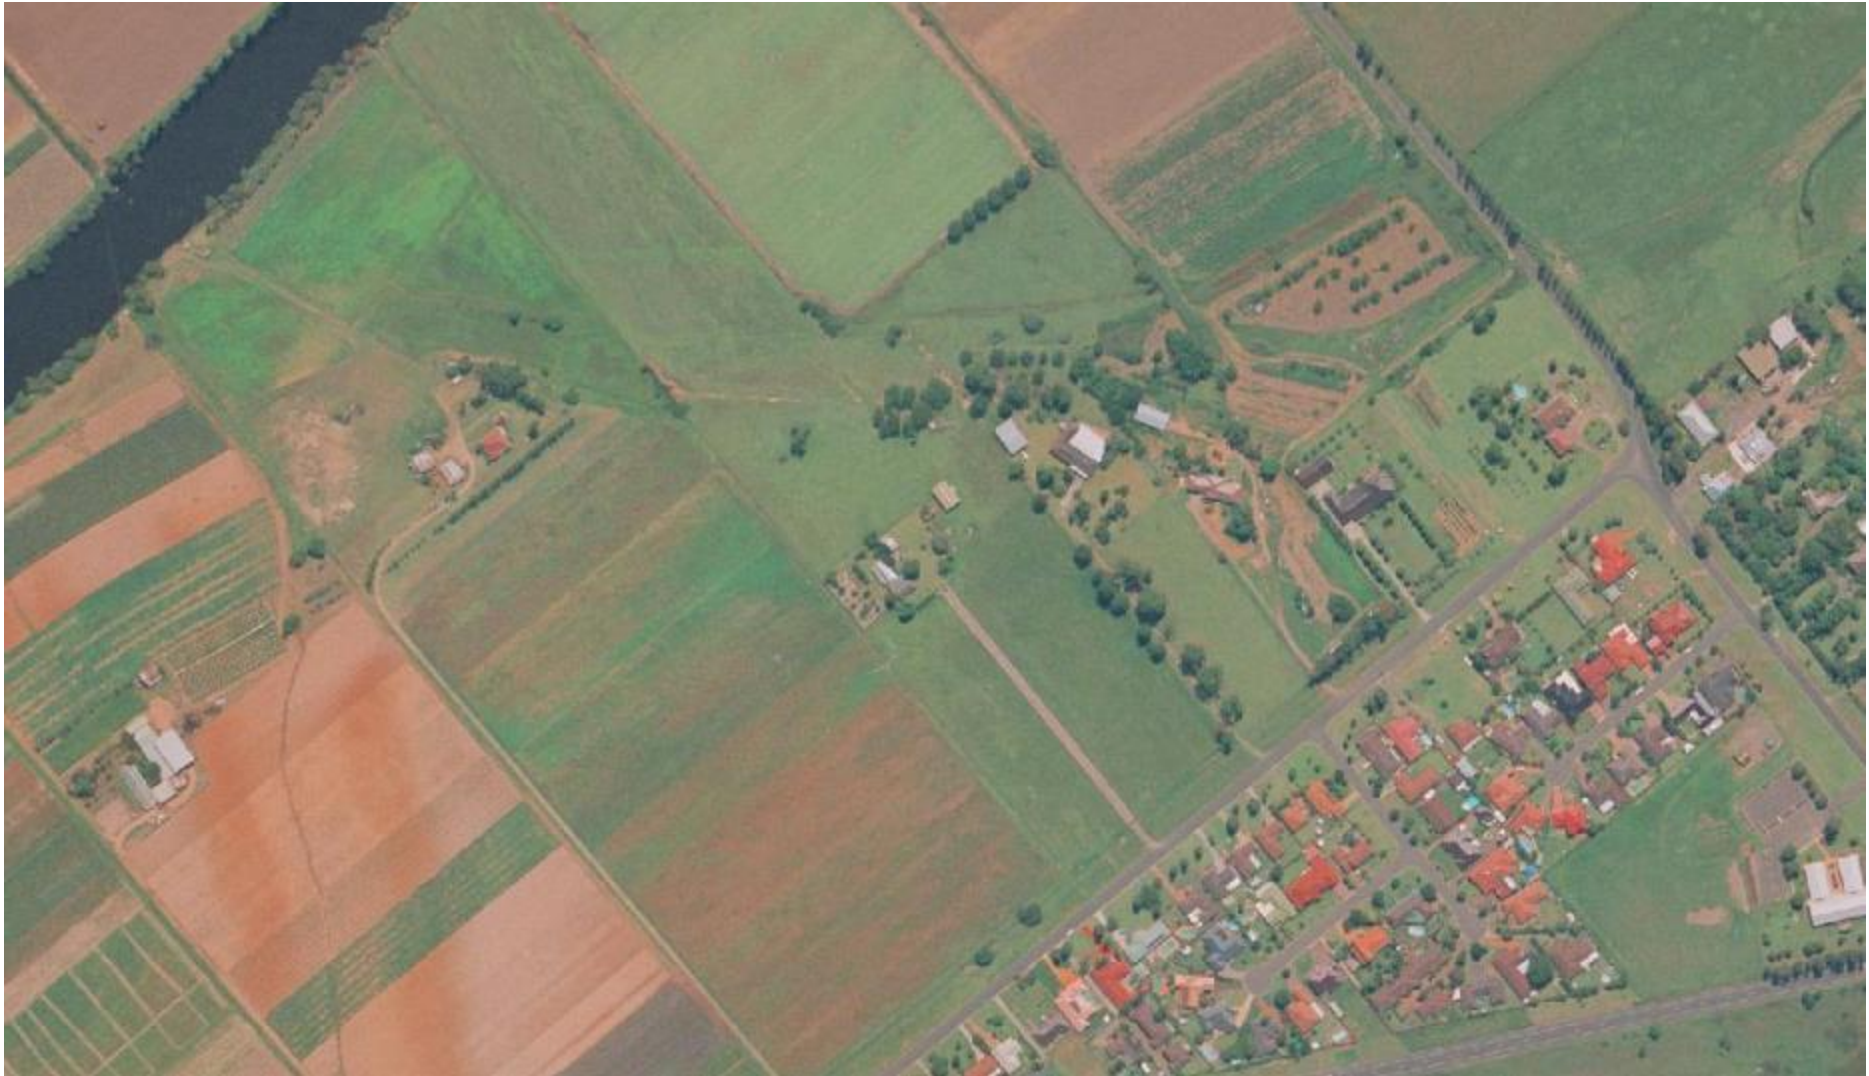
However, in the 1980 image (Figure 41) houses and outbuildings can be seen on the properties at 14 and 22 Drift Road. The buildings have been built on substantial fill platforms which have extended into the floodplain. One possibility is that these are inhibiting drainage from the west but a detailed ground level survey through the area would be needed to determine whether this is the case or not.

Figure 41: West of Inalls Lane and North of Drift Road 1980

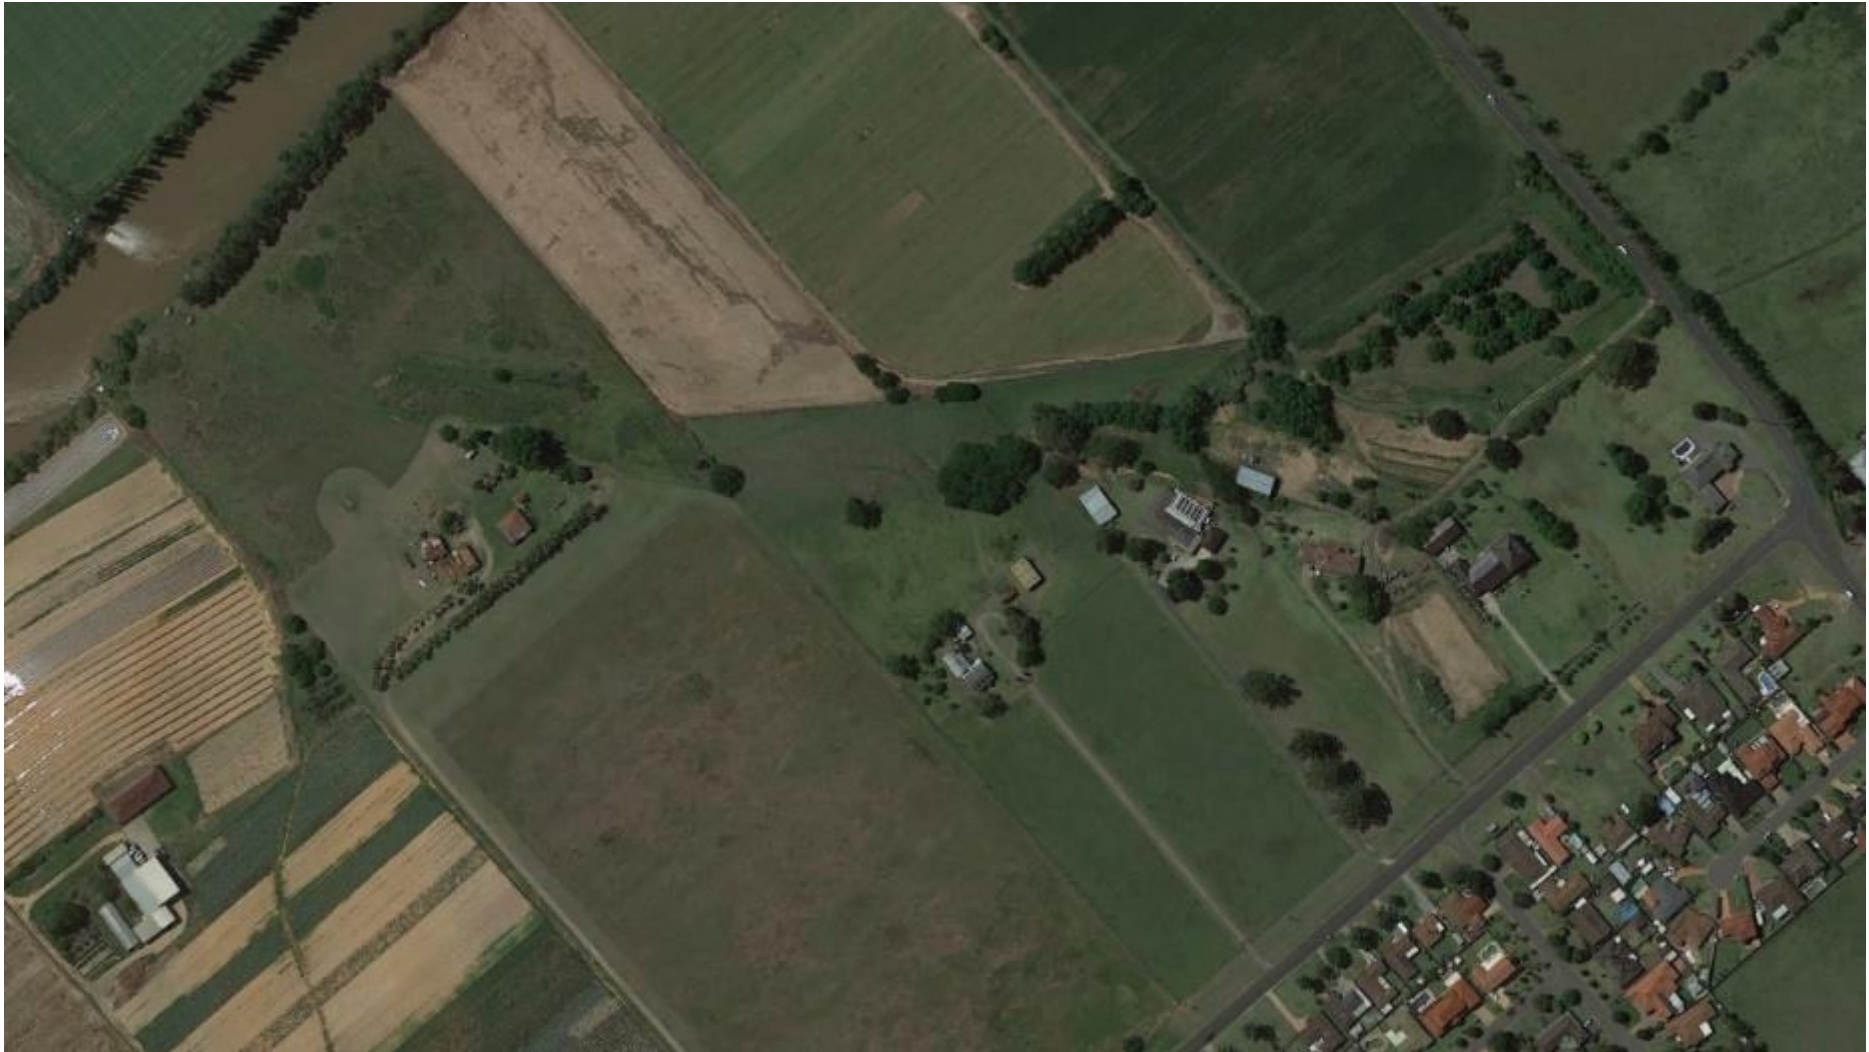
Figure 42: West of Inalls Lane and North of Drift Road 2002
