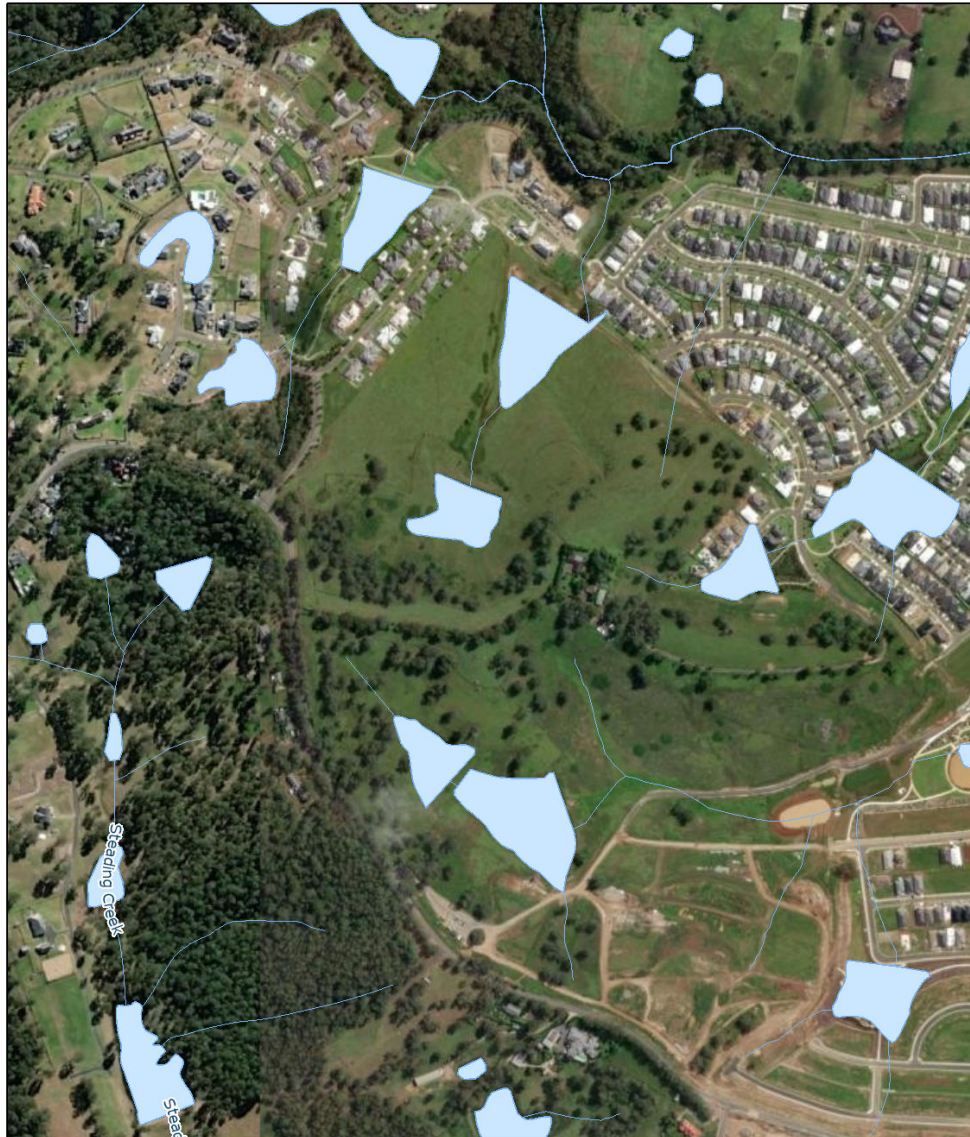
Figure 4-1 Hydro line spatial data

2018 Hydroline spatial data 1.0

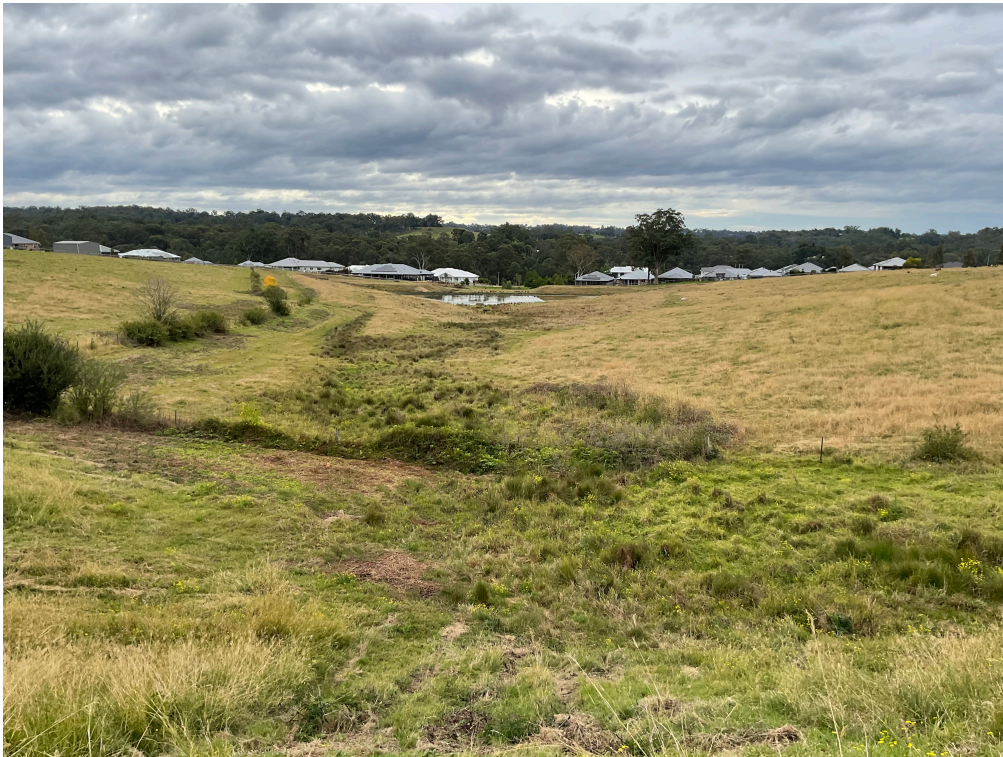
Figure 6-1 Declassified section of Stream O, between Dam 3 and 11

A previously declassified section of Stream O runs distinctly between Dam 3 and Dam 11 (Figure 6-1). Beyond Dam 11, Stream O transitions into a developed urban area which is part of the existing Redbank site, where it passes between Yabby Place and Belmont Grove. Here, previously classified Stream O is confined within a stabilised drainage channel that has been subject to revegetation works. It eventually flows into Redbank Creek. At the time of the survey, the entirety of the riparian channel was dry, except for within Dam 3 & 11, likely due to limited recent rain.

A spillway for overflowing water from Dam 3 was observed. From this point, the vegetation present was characterised by the following species; *Juncus effusus* (Soft Rush), *Plantago lanceolata* (Plantain ribwort), *Paspalum dilatatum* (Dallis Grass), *Persicaria decipiens* (Slender Knotweed), *Solanum sisymbriifolium* (Sticky Nightshade), *Senecio madagascariensis* (Fireweed), *Lantana camara* (Lantana), *Trifolium repens* (White Clover), *Dittrichia graveolens* (Stinkwort), *Erigeron sumatrensis* (Fleabane), *Sida rhombifolia* (Arrow-leaf Sida), *Verbena bonariensis* (Purpletop), *Sporobolus indicus* (Smut Grass), and *Rumex crispus* (Curly Dock). The area is dominated by introduced grasses and weed species. The existing corridor downstream of Dam 3 is thin, being approximately 30 m across at its thinnest point below Dam 3, and 100 m across at its widest extent, just above Dam 11.

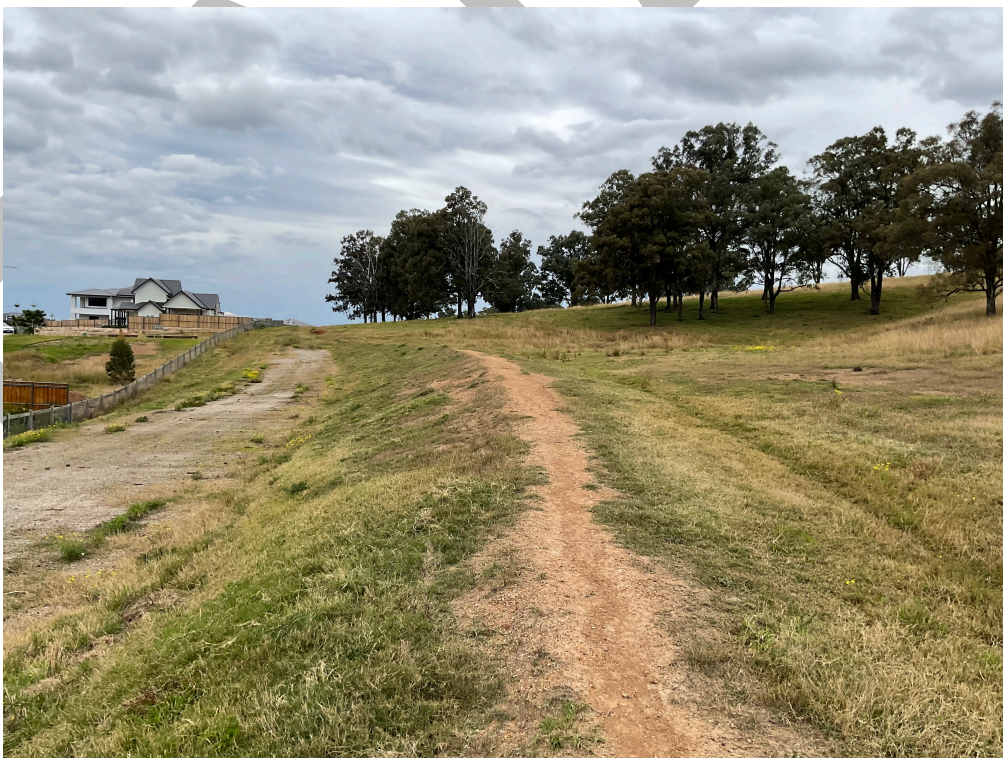
Figure 6-2 Declassified Stream N (running from right to left across the image)

The declassified drainage lines present within the subject site, identified as J, K, M, N and O tend to be characterised by a poorly defined and very thin channel of approximately 2 - 15 m in all instances (Figure 6-2 - Figure 6-5).

Whilst these possess species characteristic of water-logged soils, they do not possess any permanent freshwater/wetland plant species. They also possess a higher abundance of introduced weedy grassland species that have spread down from drier ridgetops and grazing paddock areas. Species present within these drainage lines include *Paspalum dilatatum* (Dallis Grass) and weed species such as *Lantana camara* (Lantana), *Verbena bonariensis* (Purpletop), *Senecio madagascariensis* (Fireweed), *Plantago lanceolata* (Ribwort Plantain), *Conyza bonariensis* (Fleabane) and *Rumex crispus* (Curly Dock).
