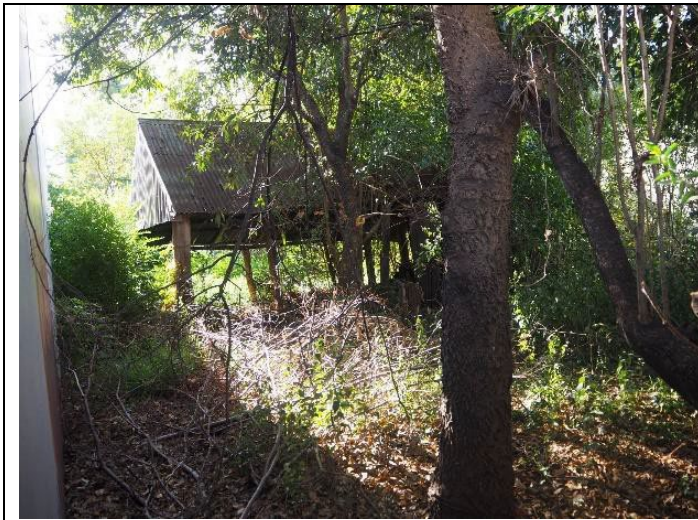
Caption: Barn at 118 Francis Street, Richmond (exterior)
 Photographer: K. Denny
 Copyright Owner: Lucas Stapleton Johnson & Partners Pty Ltd
 Date: June 2023

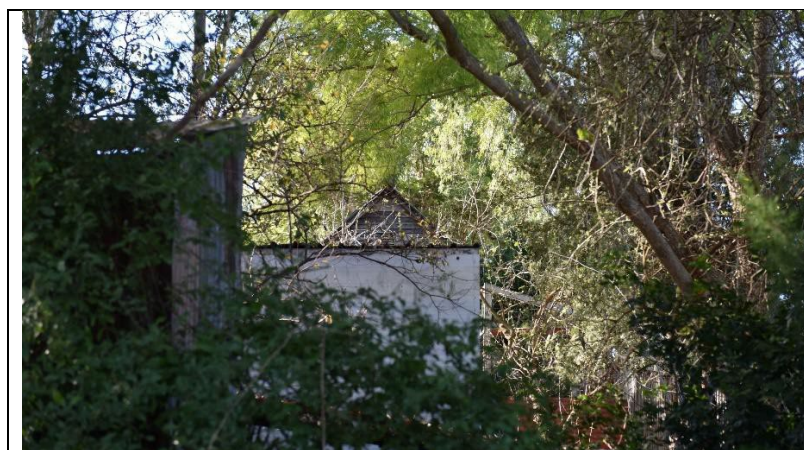
Caption: Barn at 135 Francis Street, Richmond (exterior)
 Photographer: S. Johnson
 Copyright Owner: Lucas Stapleton Johnson & Partners Pty Ltd
 Date: July 2023

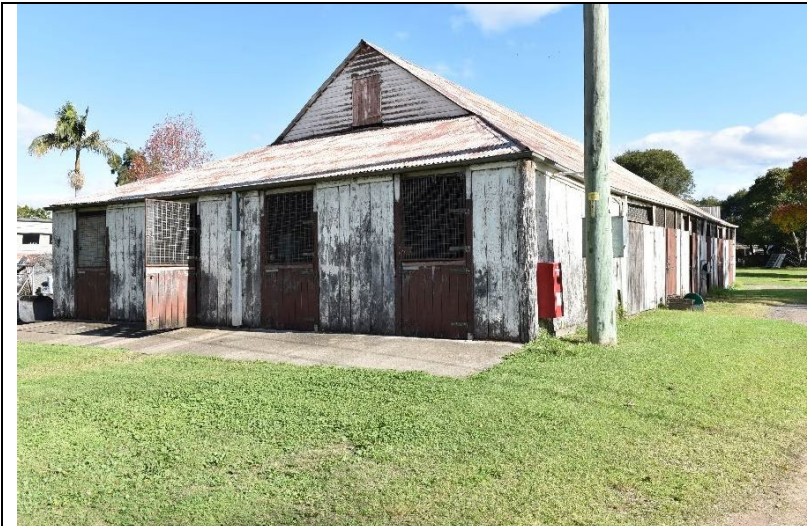
Caption: Barn 1 at 331 Hobartville, 36-40 Inalls Lane, Richmond (exterior)
Photographer: S. Johnson
Copyright Owner: Lucas Stapleton Johnson & Partners Pty Ltd
Date: June 2023

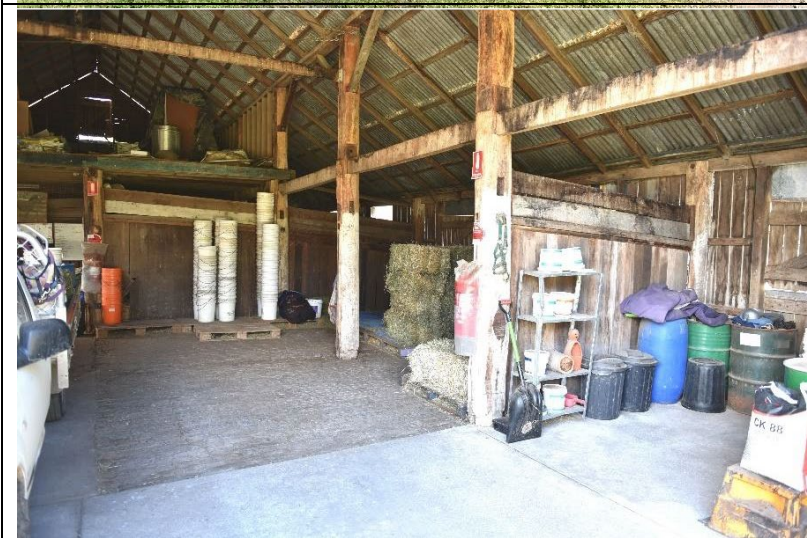
Caption: Barn 1 at 331 Hobartville, 36-40 Inalls Lane, Richmond (interior)
Photographer: S. Johnson
Copyright Owner: Lucas Stapleton Johnson & Partners Pty Ltd
Date: June 2023

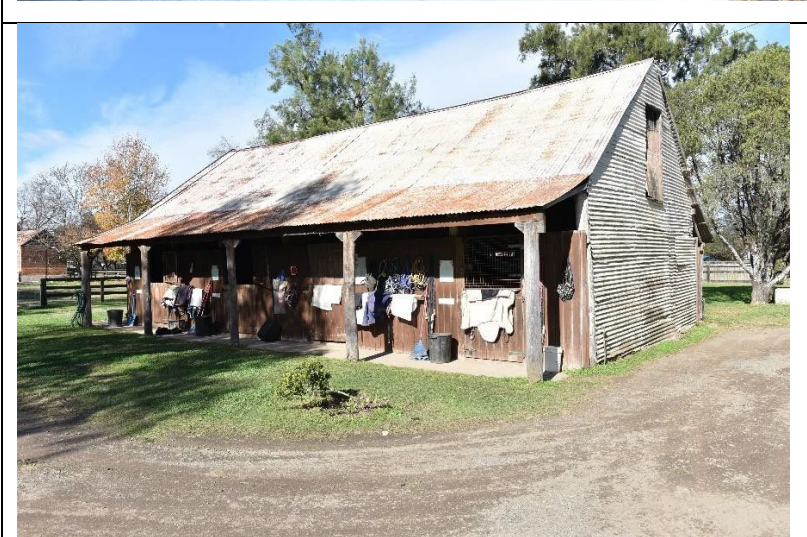
Caption: Barn 2 at 331 Hobartville, 36-40 Inalls Lane, Richmond (exterior)
Photographer: S. Johnson
Copyright Owner: Lucas Stapleton Johnson & Partners Pty Ltd
Date: June 2023

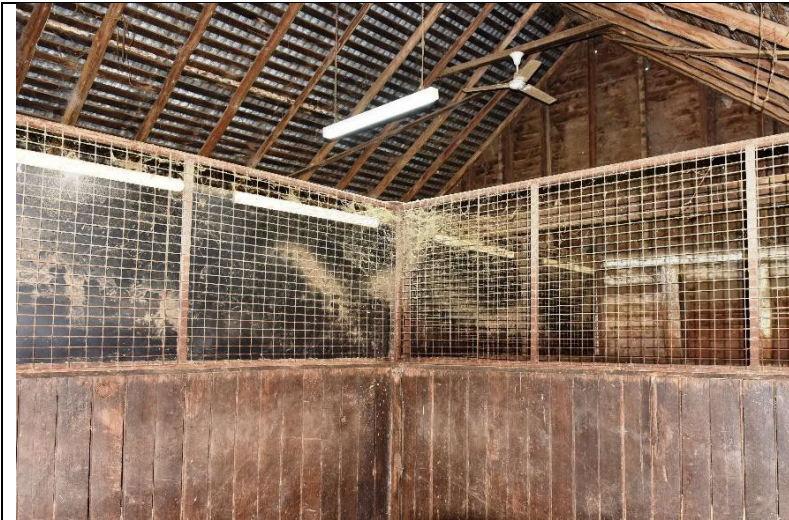
Caption: Barn 2 at 331 Hobartville, 36-40 Inalls Lane, Richmond (interior)
Photographer: S. Johnson
Copyright Owner: Lucas Stapleton Johnson & Partners Pty Ltd
Date: June 2023

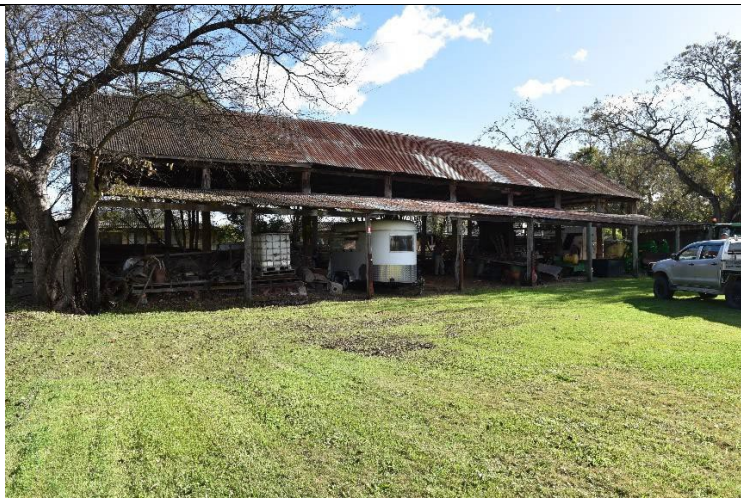
WALL CLADDING	Vertical planks to long sides, horizontal corrugated iron to gable ends. Condition: Moderate Date: Early or mid-20 th century?
OPENINGS	Stable doors both sides.
FLOORING (GROUND)	Concrete slab
CURRENT USE	Stables
CHANGES FROM 2010?	None
DESCRIPTION BARN 3 'OLD BARN'	
MAIN BARN STRUCTURE	Large round posts are trenched at the top to take rectangular longitudinal beams with bolted connections. Large square cross beams have iron tie bars at mid span connected to the top of each rafter. Slabs are stockpiled within the barn but there is no evidence of their use in cladding the walls of this barn. Condition: Moderate – tops of posts have been repaired in places and longitudinal beams spliced or replaced. Date: Late 19 th early 20 th century?
NO. OF BAYS	Eight
ROOF STRUCTURE	Each pair of sawn rafters is triangulated by connection to a large rectangular cross beam and the sag in the latter member is limited by vertical iron tie rods connected to the apex of the roof. Condition: Moderate Date: Late 19 th early 20 th century?

SKILLION 1	Low pitched skillion on east side intersects with the main barn approximately 1m below the eaves. It is constructed of round pole rafters with sawn battens for iron roofing. Condition: Moderate Date: Late 19 th early 20 th century?

ROOF CLADDING:	Corrugated iron in short sheets. Condition: Moderate. Date: Late 19 th early 20 th century?
WALL CLADDING	None
OPENINGS	Sides are open
FLOORING (GROUND)	Earthen
FLOORING (SKILLION)	Earthen
OTHER (Fixings?)	Bolted with some later strengthening
CURRENT USE	Machinery shed and storage
HISTORY	
<p>The Hobartville estate, including the main house and associated outbuildings, the group of three barns and other agricultural outbuildings, is located on a 100 acre grant made to James Blackman in 1802 and 400 acres made to surgeon Edward Luttrell in 1804.</p> <p>In 1816, William Cox Jnr. purchased Luttrell's grant and the property become known as Hobartville and was advertised as having a house, garden and out offices. By 1818, Cox had also purchased Blackman's grant.</p> <p>On the death of William Cox in 1850, the estate was left to his eldest son, yet another William, but with a life interest to his widow, Elizabeth. She moved permanently to England in 1864 and William had another property, so they passed Hobartville to another son, Sloper Cox who lived there until 1877.</p> <p>In 1877 it was bought by Andrew Town, who established his famous horse stud and sales there. In 1900, the property was sold to Percy Reynolds who continued the use of the place as a thoroughbred stud. Reynolds had been born at Tocal Station, Paterson. The Reynolds family built up Australia's most renowned Hereford cattle herd in the 1930s.</p> <p>Although the original estate lands have been subdivided and sold for residential development, the property still retains a large amount of land and continues to operate as a stud facility.</p>

Caption: Barn 3 at 331 Hobartville, 36-40 Inalls Lane, Richmond (exterior)
Photographer: S. Johnson
Copyright Owner: Lucas Stapleton Johnson & Partners Pty Ltd
Date: June 2023

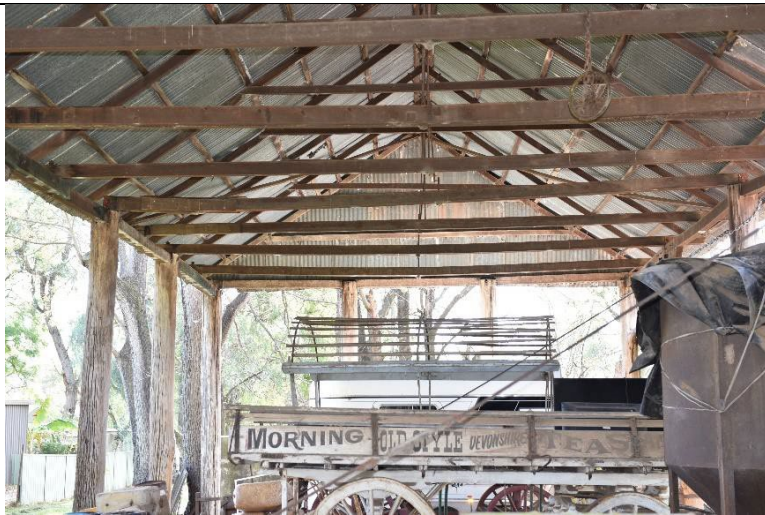
Caption: Barn 3 at 331 Hobartville, 36-40 Inalls Lane, Richmond (interior looking north)
Photographer: S. Johnson
Copyright Owner: Lucas Stapleton Johnson & Partners Pty Ltd
Date: June 2023

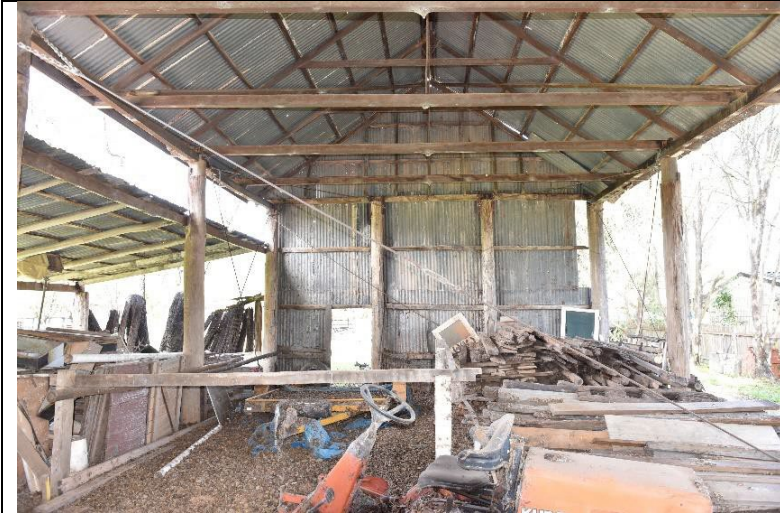
Caption: Barn 3 at 331 Hobartville, 36-40 Inalls Lane, Richmond (interior looking south)
 Photographer: S. Johnson
 Copyright Owner: Lucas Stapleton Johnson & Partners Pty Ltd
 Date: June 2023

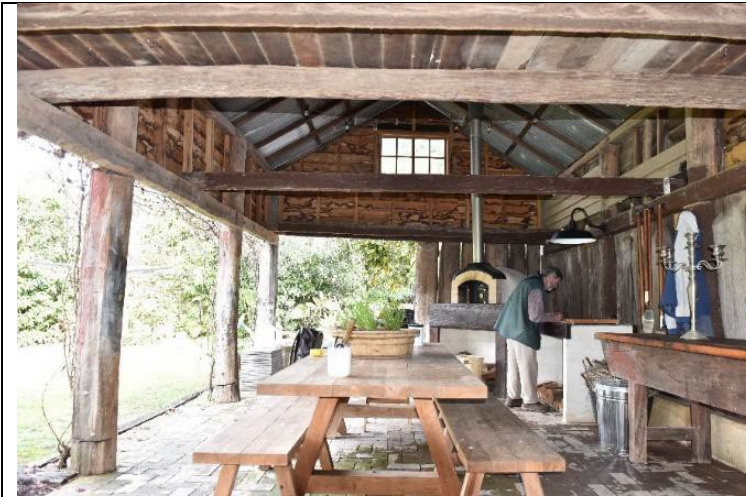
ROOF CLADDING:	Corrugated iron short sheets Condition: Poor Date: Mid-20 th century?
WALL CLADDING	Vertical timber slabs (some 400 wide) up to loft floor level. Weatherboards to loft level and gables, early beaded weatherboards to western side, other weatherboards are more recent. Condition: Moderate Date: Mid 19 th century with late 20 th century repairs
OPENINGS	All bays are open on eastern side and at each end.
FLOORING (GROUND)	Brick paving
FLOORING (LOFT)	Timber boarding
OTHER (Fixings?)	Beams let into and bolted to posts.

Caption: The town barn at No. 102 Lennox Street, Richmond (interior).
Photographer: S. Johnson
Copyright Owner: Lucas Stapleton Johnson & Partners
Date: May 2023

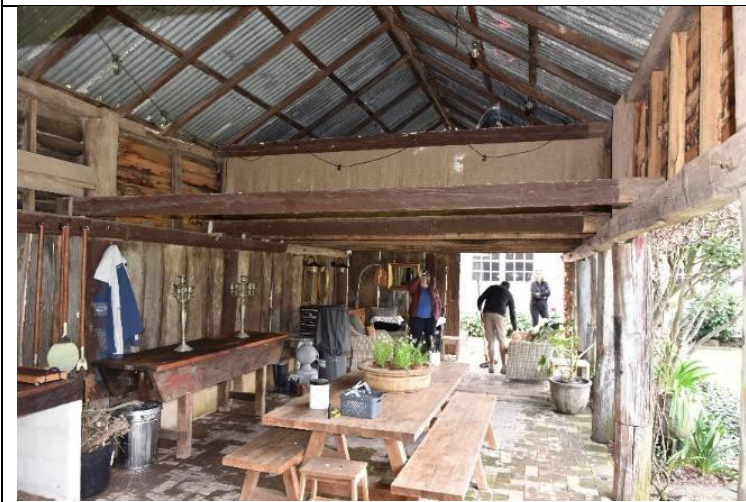
Caption: The town barn at No. 102 Lennox Street, Richmond (interior).
Photographer: S. Johnson
Copyright Owner: Lucas Stapleton Johnson & Partners
Date: May 2023

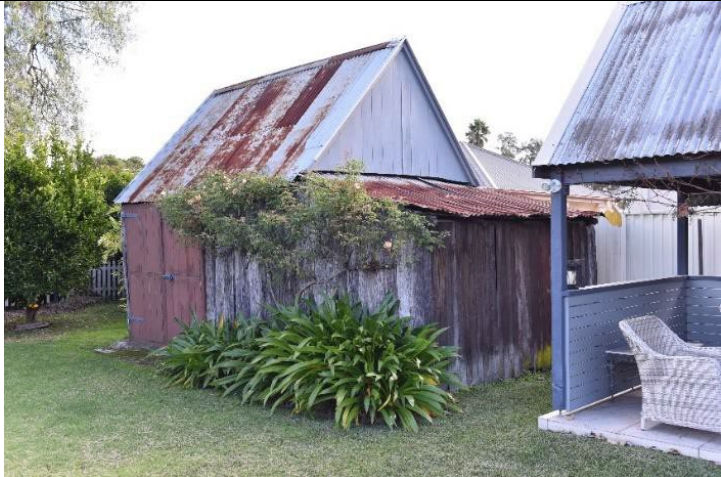
<p>Caption: The town barn at No. 158 March Street, Richmond (exterior). Photographer: S. Johnson Copyright Owner: Lucas Stapleton Johnson & Partners Date: May 2023</p>
---	---

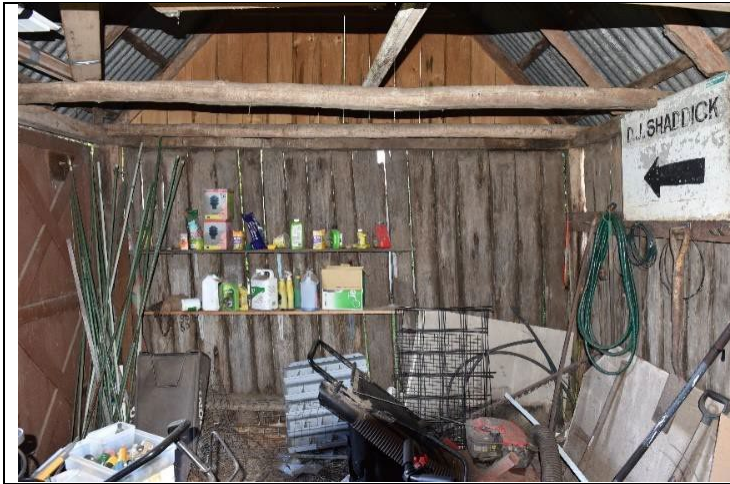
Caption: The town barn at No. 158 March Street, Richmond (interior).
 Photographer: S. Johnson
 Copyright Owner: Lucas Stapleton Johnson & Partners
 Date: May 2023

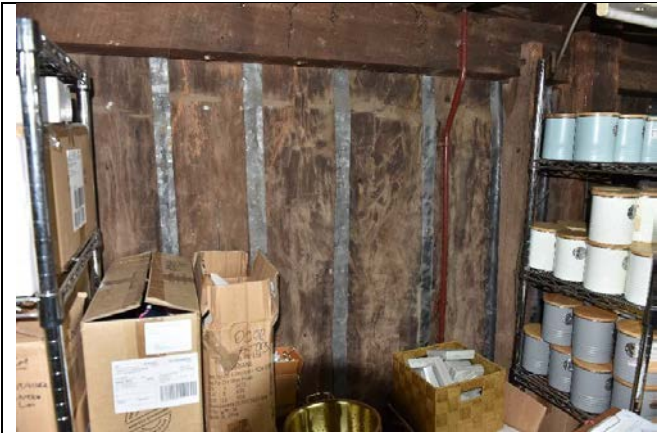
Caption: surviving original slabs at the town barn at No. 239 Windsor, Richmond (interior).
Photographer: S. Johnson
Copyright Owner: Lucas Stapleton Johnson & Partners
Date: May 2023

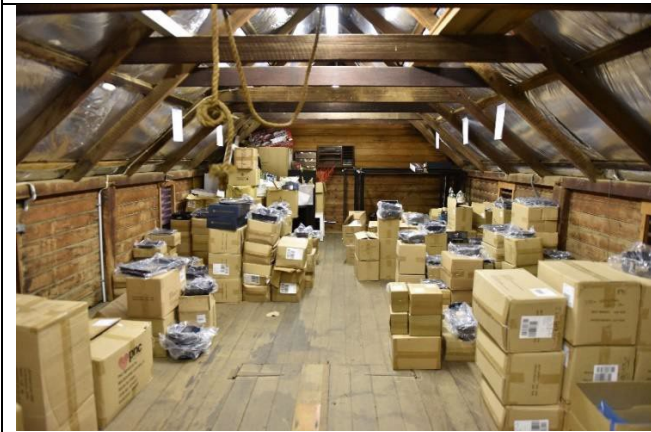
LOFT	Loft is well built (rebuilt?) with deep joists spanning between longitudinal beams, herringbone strutting, tonged and grooved flooring and wall linings of beaded horizontal boards. Date: Mid to late 19 th century (potentially)
SKILLION 1	Skillion addition to half the length of the southern side of the barn. Condition: Good. Date: Mid to late 19 th century (potentially)
ROOF CLADDING:	Corrugated steel long sheets. Condition: Good Date: Mid to late 19 th century (potentially)
WALL CLADDING	Vertical timber slabs with cover strips of galvanized steel. Weatherboard outer cladding added later. Condition: good Date: Mid to late 19 th century (potentially)
OPENINGS	The loft has a door on the street front with a beam over for hoisting in goods. There are a series of louvred ventilation openings in the loft wall.
FLOORING (GROUND)	Concrete slab
FLOORING (LOFT)	Timber boarding
FLOORING (SKILLION)	Not known

Caption: The town barn at No. 239 Windsor, Richmond (loft interior).
Photographer: S. Johnson
Copyright Owner: Lucas Stapleton Johnson & Partners
Date: May 2023

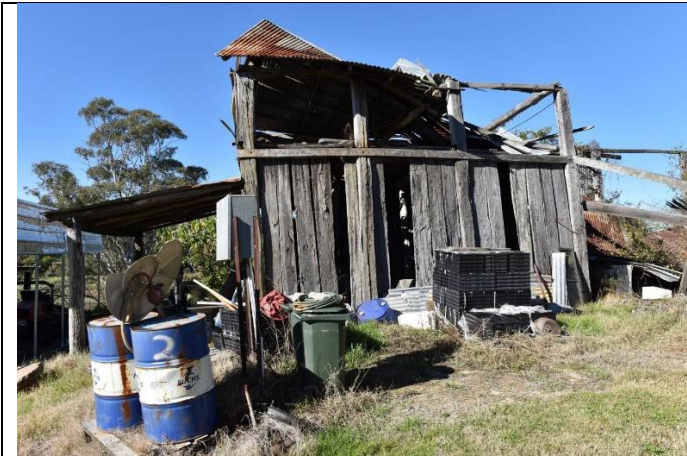
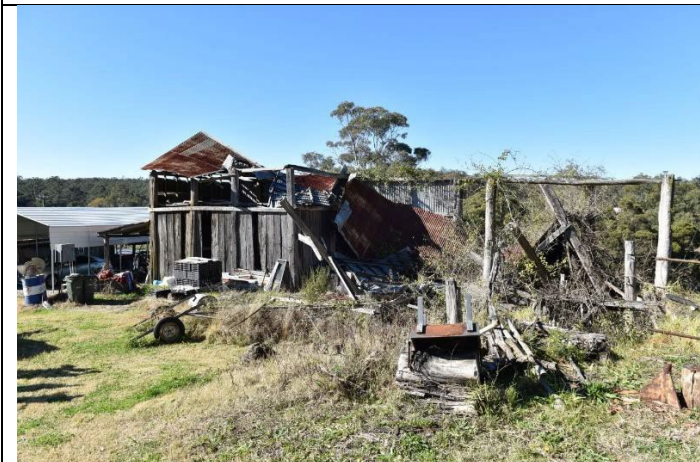
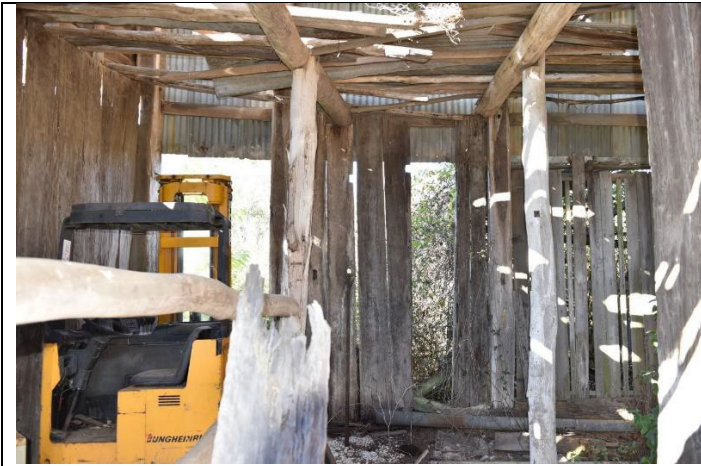
Mostly collapsed- only 3 bays of 8 remain.

Caption: Barn at 888 Sackville Road, Sackville (exterior)
Photographer: LSJ
Copyright Owner: Lucas Stapleton Johnson & Partners Pty Ltd
Date: June 2023

Caption: Barn at 888 Sackville Road, Sackville (interior)
 Photographer: LSJ
 Copyright Owner: Lucas Stapleton Johnson & Partners Pty Ltd
 Date: June 2023

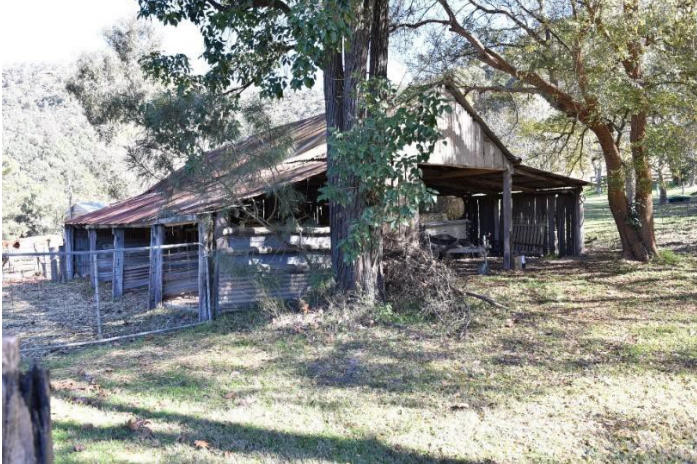
<p>Caption: Milking Shed at No. 239 Upper Macdonald Road, St Albans (exterior) Photographer: S. Johnson Copyright Owner: Lucas Stapleton Johnson & Partners Date: June 2023</p>

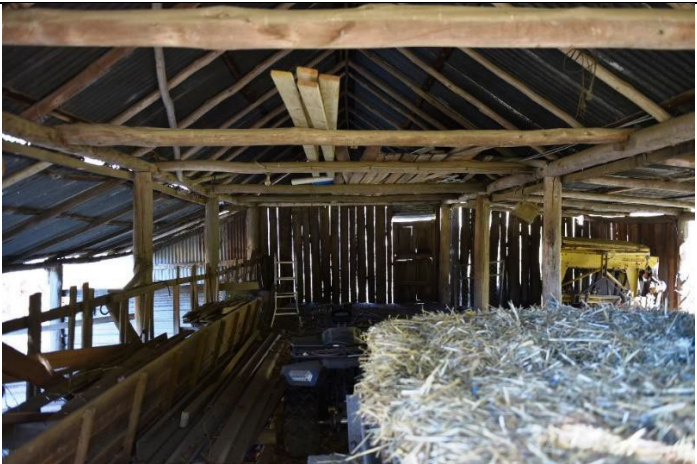
<p>Caption: Milking Shed at No. 239 Upper Macdonald Road, St Albans (interior) Photographer: S. Johnson Copyright Owner: Lucas Stapleton Johnson & Partners Date: June 2023</p>

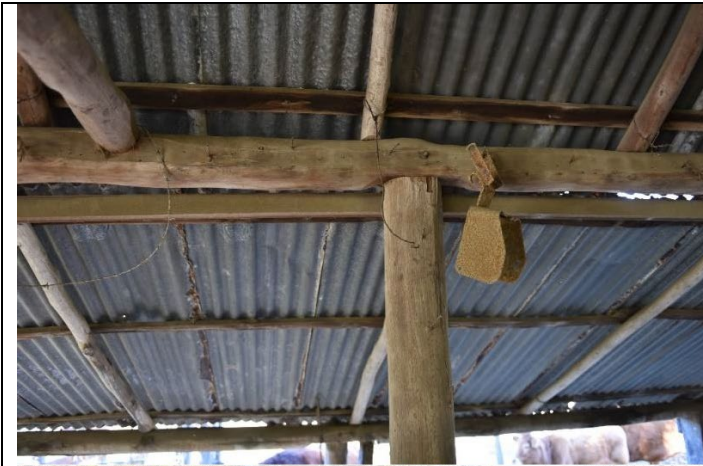
Caption: Detail of Milking Shed at No. 239 Upper Macdonald Road, St Albans (exterior)
Photographer: S. Johnson
Copyright Owner: Lucas Stapleton Johnson & Partners
Date: June 2023

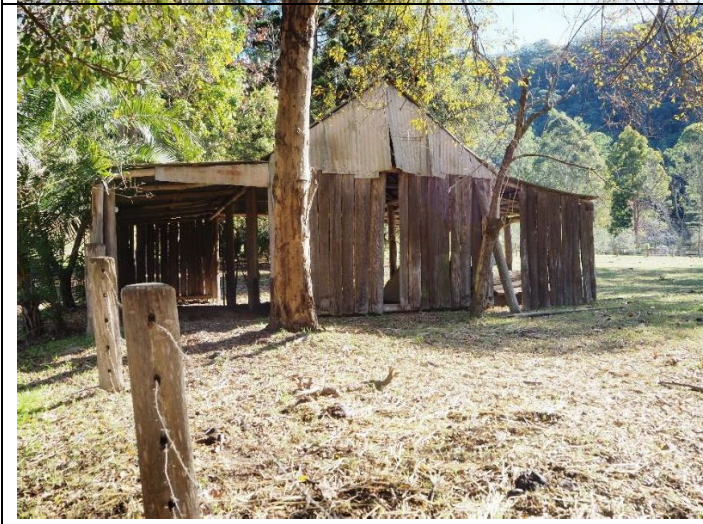
NO. OF BAYS	Four
ROOF STRUCTURE	Slender bush pole rafters meet at the ridge board and support sawn battens for iron. Thin bush poles are fixed diagonally for wind bracing. The roof has a pitch of approx. 30°. Condition: Date: early 20 th century
SKILLION 1	The eastern skillion is divided by rails into four stalls and has access to a continuous feeding trough along the eastern side of the main barn. Condition: Good Date: early 20 th century
SKILLION 2	The western skillion is enclosed with timber slabs apart from one open bay. Roofing is supported on bush poles laid at a very flat angle. Condition: Date: early 20 th century
ROOF CLADDING:	Galvanised corrugated iron. Condition: Moderate Date: early 20 th century
WALL CLADDING	Vertical timber slabs enclose the western skillion and southern end. Slabs are of differing lengths and some have previous cut-outs and possibly have been reused from elsewhere. The gables are clad in corrugated iron. Condition: Moderate.

SKILLIONS	Both skillions are constructed of bush pole rafters on round posts but earlier square posts were identified outside the southern perimeter indicating that reconstruction work has occurred. Condition: Good Date: early 20 th century
ROOF CLADDING:	Galvanised corrugated iron. Condition: Moderate Date: early 20 th century
WALL CLADDING	Vertical timber slabs enclose half the length of the perimeter. Slabs are nailed to a bottom plate and to the eaves beam. Gables are clad in corrugated iron. Condition: Moderate. Date: early 20 th century
OPENINGS	Half the perimeter bays are open and half enclosed with slabs.
FLOORING (GROUND)	Remains of timber boarding was reported at the eastern end.
FLOORING (SKILLIONS)	Earth
OTHER (Fixings?)	Bolted
CURRENT USE	Storage/ shelter
HISTORY	
<p>The barn and milking shed at Jack's Dairy, No. 239 Upper Macdonald Road, St Albans are located on part of a 60 acre grant (Portion 33, Parish Macdonald) made to Sylvester Butler in 1823. Conditions of the grant included that he clear and cultivate 16 acres within five years.</p> <p>The following year, Butler assigned his 60 acres to Mary Fernance for £30. The Fernance family was a notable family in the district, creating a network of land holdings along the river, including Portion 34 immediately to the north.</p> <p>On 30 April 1857, John Fernance, Macdonald River, farmer and his wife Mary conveyed Butler's 60 acre grant to Aaron Walker, Macdonald River, farmer as trustee for the benefit of their son, Charles Fernance. Mary Fernance died on 9 July 1860 and John Fernance died on 10 October 1860. Many of the family left the district and settled at Ulmarra on the Clarence River, selling various parcels of land. Some was sold to Thomas Thompson including Portion 33.</p>

Based on the physical evidence of the barns including low pitched roofs, bolted lapped joints, use of traditional timber slabs and bush poles, some earlier squared posts indicating extensive repair/ reconstruction, the barn appears to have been constructed in the early 20th century and seem likely to have been constructed by Thomas Thompson.

Caption: Barn at No. 239 Upper Macdonald Road, St Albans (exterior)
Photographer: S. Johnson
Copyright Owner: Lucas Stapleton Johnson & Partners
Date: June 2023

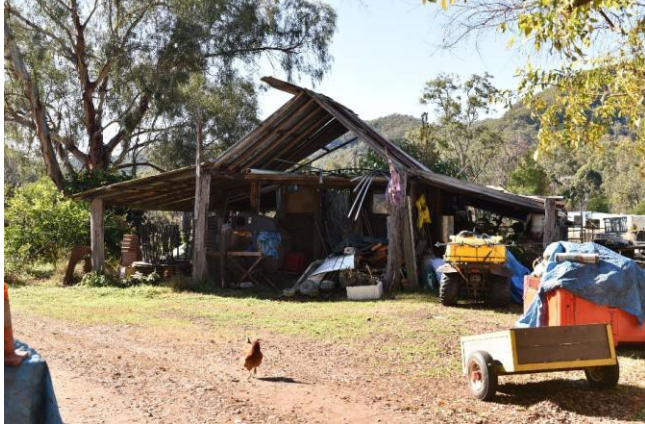
<p>Caption: Barn at No. 476 Upper Macdonald Road, St Albans (exterior) Photographer: S. Johnson Copyright Owner: Lucas Stapleton Johnson & Partners Date: June 2023</p>

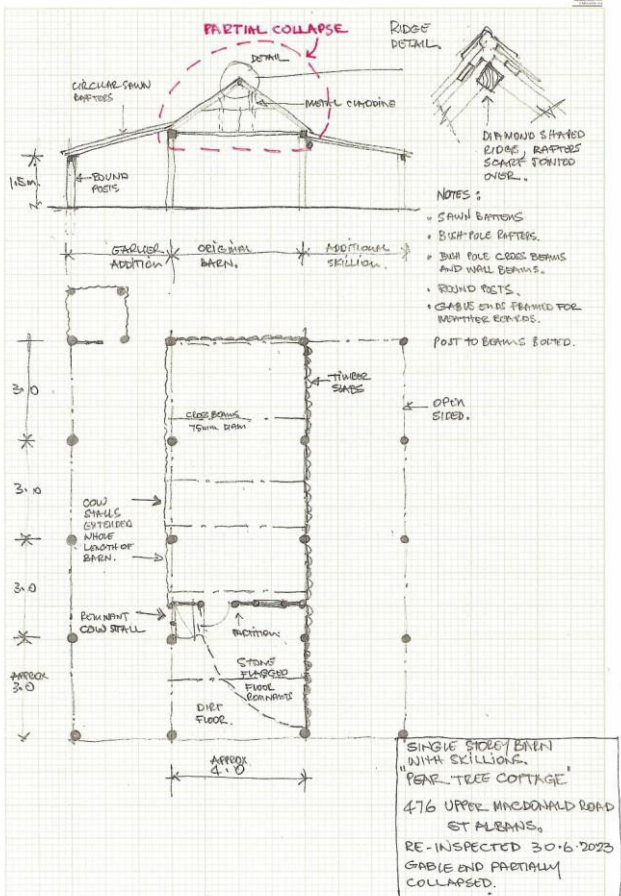
<p>PARTIAL COLLAPSE</p> <p>RIDGE DETAIL</p> <p>CIRCULAR SAWN RAFTERS</p> <p>5-BOUND POSTS</p> <p>METAL CLADDING</p> <p>DIAMOND SHAPED RIDGES, RAFTERS SOME POINTED DOWN.</p> <p>NOTES:</p> <ul style="list-style-type: none"> SAWED BATTENS BUSH-POLE RAFTERS DIAM PILE CROSS BEAMS AND WALL BEAMS ROUND POSTS CABLE ENDS FORMED FOR MOUNTING RACKS POST TO BEAMS BOUND. <p>ENLARGED ADDITION ORIGINAL BARN ADDITIONAL SKILLIONS</p> <p>3.0</p> <p>3.0</p> <p>3.0</p> <p>APPROX 3.0</p> <p>APPROX 4.0</p> <p>TIMBER SLABS</p> <p>OPEN SIDED</p> <p>CLEAR BENCH 75mm DIA</p> <p>COW STALLS EXTENDED WHOLE LENGTH OF BARN.</p> <p>POWERTH COW STALL</p> <p>STAIRS</p> <p>FLOOR CONTAINING</p> <p>DIRT FLOOR</p> <p>SINGLE SIDED BARN WITH SKILLIONS "PEN TREE COTTAGE" 476 UPPER MACDONALD ROAD ST ALBANS. RE-INSPECTED 30.6.2023 GABLE AND PARTIALLY COLLAPSED.</p>	<p>Caption: Measured drawing of milking shed at No. 476 Upper Macdonald Road, St Albans Copyright Owner: Graham Edds & Associates Date: June 2023</p>

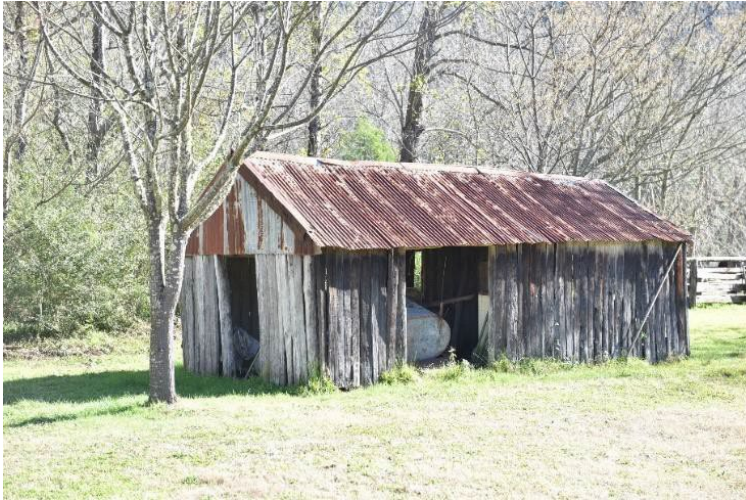
Caption: Barn 6 at 135A & B Wollombi Road (exterior)
Photographer: LSJ
Copyright Owner: Lucas Stapleton Johnson & Partners Pty Ltd
Date: June 2023

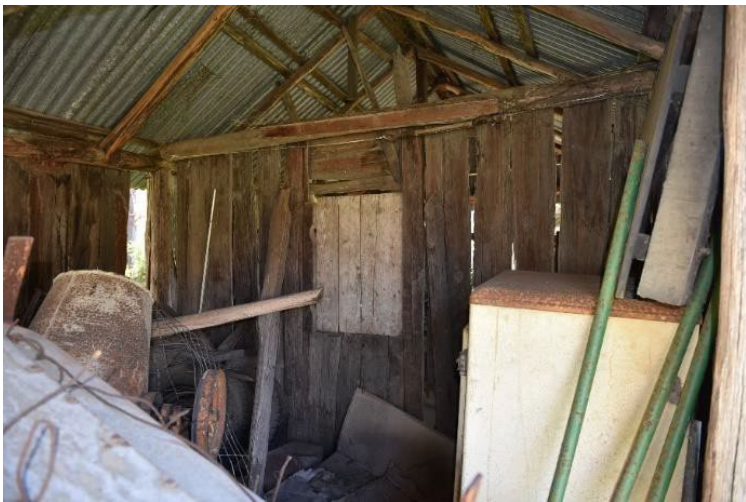
Caption: Barn 6 at 135A & B Wollombi Road (interior)
Photographer: LSJ
Copyright Owner: Lucas Stapleton Johnson & Partners Pty Ltd
Date: June 2023

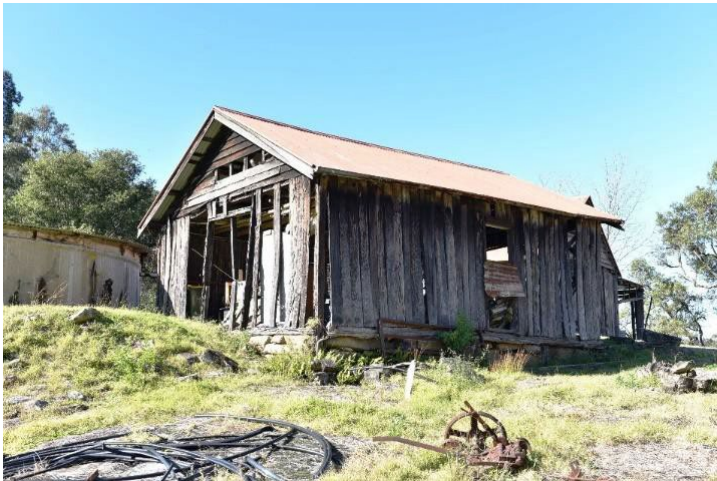
Caption: Barn 7 at 135A & B Wollombi Road (exterior)
Photographer: LSJ
Copyright Owner: Lucas Stapleton Johnson & Partners Pty Ltd
Date: June 2023

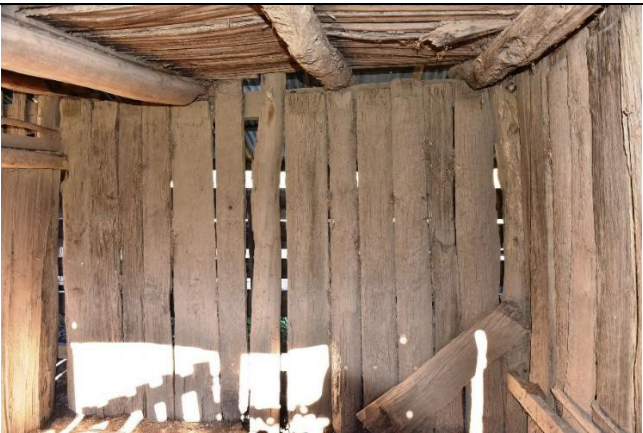
Caption: Interior detail of barn at No. 995 Upper Colo Road, Upper Colo Photographer: S. Johnson Copyright Owner: Lucas Stapleton Johnson & Partners Date: June 2023

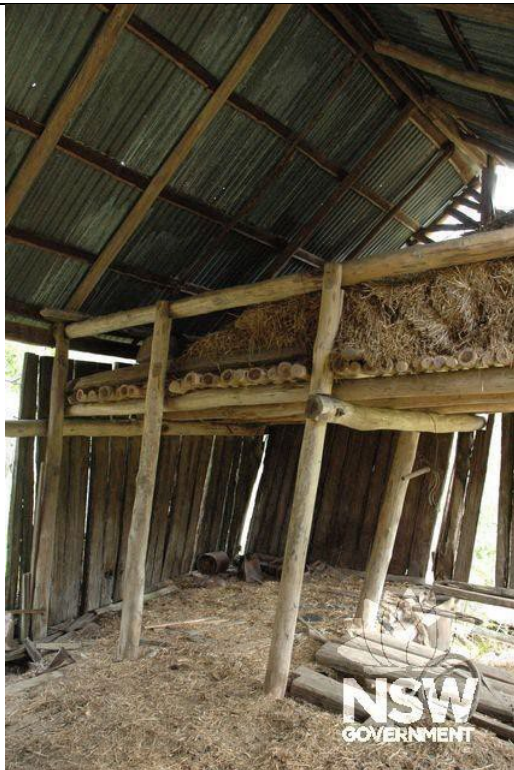
Caption: Slab barn at No. 1665
Upper Colo Road, Upper Colo.
Photographer: C. Edds
Copyright Owner: Graham Edds &
Associates
Date: 2010

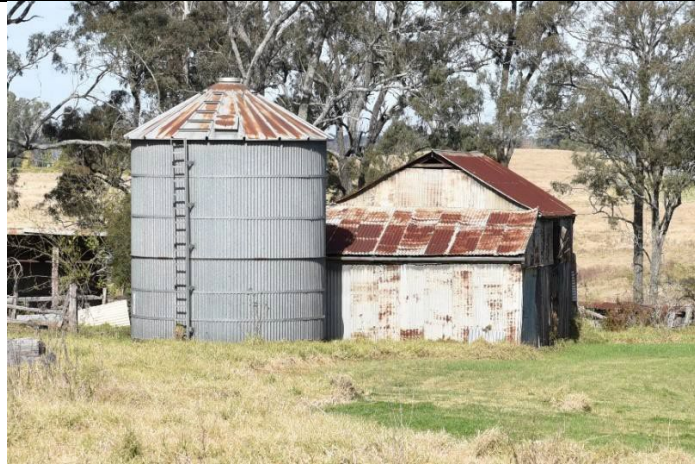
Caption: Barn and silo at 86 King Road, Wilberforce Road, Freemans Reach (exterior)
Photographer: S. Johnson
Copyright Owner: Lucas Stapleton Johnson & Partners Pty Ltd
Date: June 2023

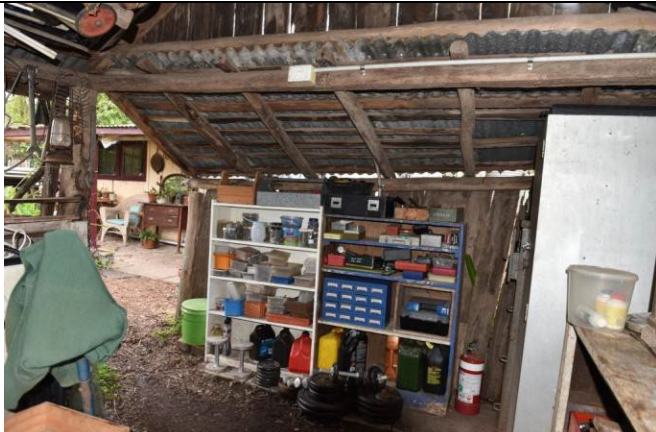
<p>Caption: Barn at No. 87 King Road, Wilberforce (interior) Photographer: S. Johnson Copyright Owner: Lucas Stapleton Johnson & Partners Date: July 2023</p>

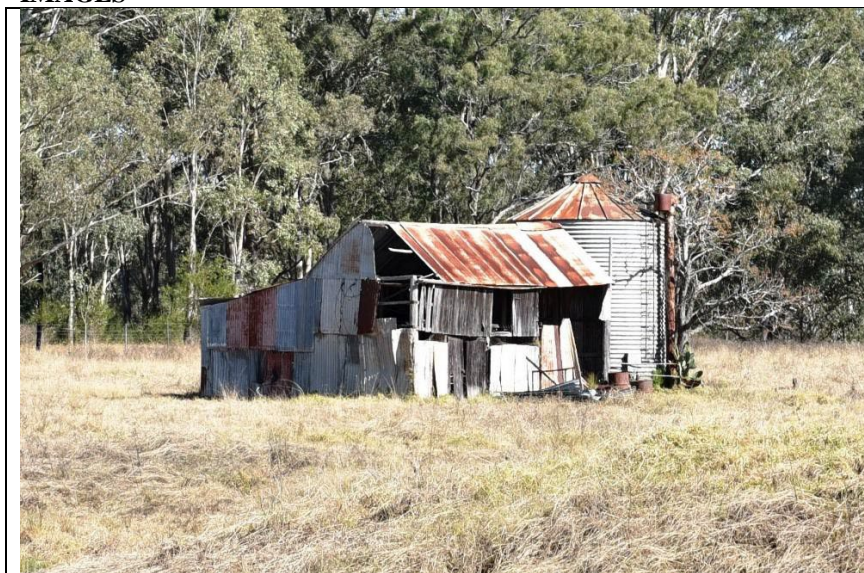
Caption: Barn at No. 55 McKinnons Road, Wilberforce.
 Photographer: S. Johnson
 Copyright Owner: Lucas Stapleton Johnson & Partners
 Date: July 2023

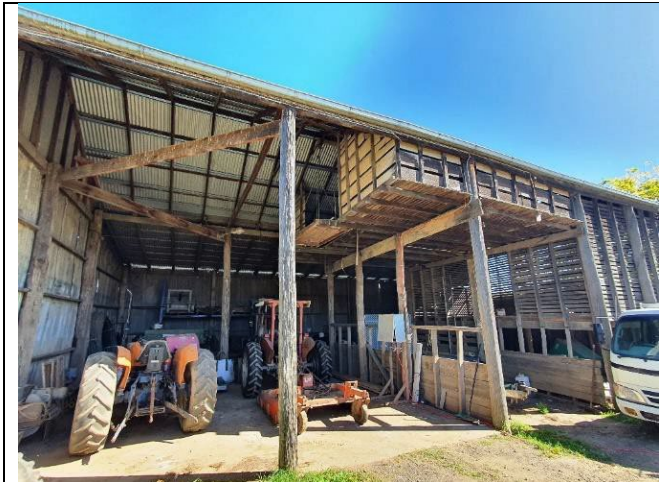
Caption: Barn at 63 Wilberforce Road, Wilberforce (interior)
 Photographer: S. Johnson
 Copyright Owner: Lucas Stapleton Johnson & Partners
 Date: May 2023

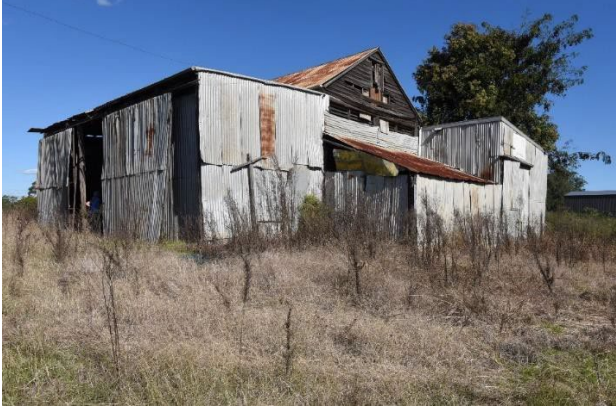
Caption: Barn at 87 Wilberforce Road, Wilberforce (exterior) Photographer: S. Johnson Copyright Owner: Lucas Stapleton Johnson & Partners Pty Ltd Date: May 2023

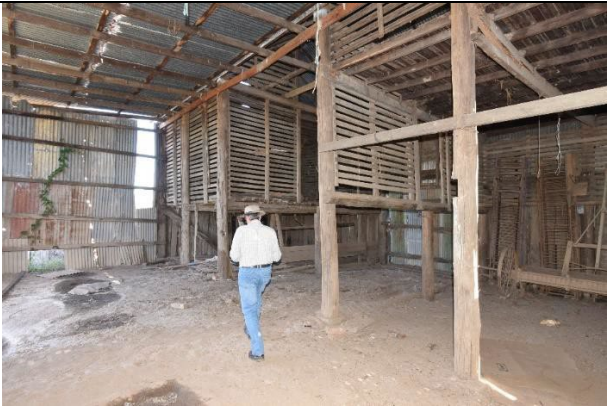
Caption: Barn at 87 Wilberforce Road, Wilberforce (interior) Photographer: S. Johnson Copyright Owner: Lucas Stapleton Johnson & Partners Pty Ltd Date: May 2023

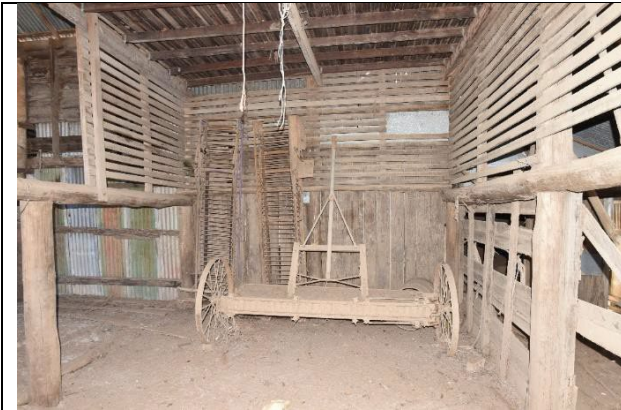
Caption: Barn at 87 Wilberforce Road, Wilberforce (interior)
 Photographer: S. Johnson
 Copyright Owner: Lucas Stapleton Johnson & Partners Pty Ltd
 Date: May 2023

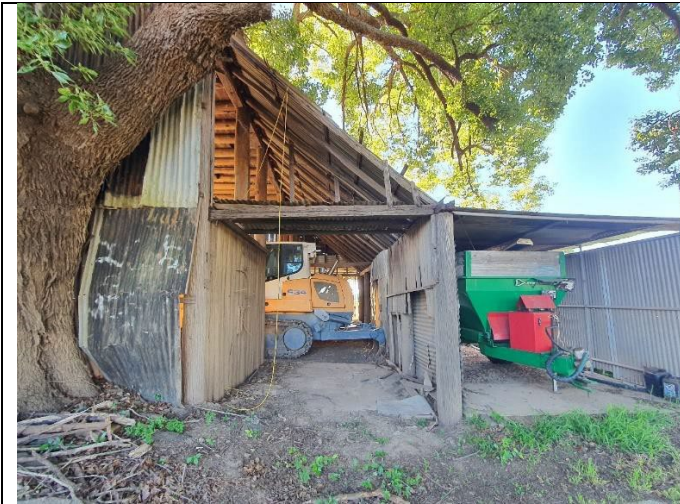
Caption: Barn at 191 Wilberforce Road, Wilberforce (exterior and skillion)
Photographer: K. Denny
Copyright Owner: Lucas Stapleton Johnson & Partners
Date: May 2023

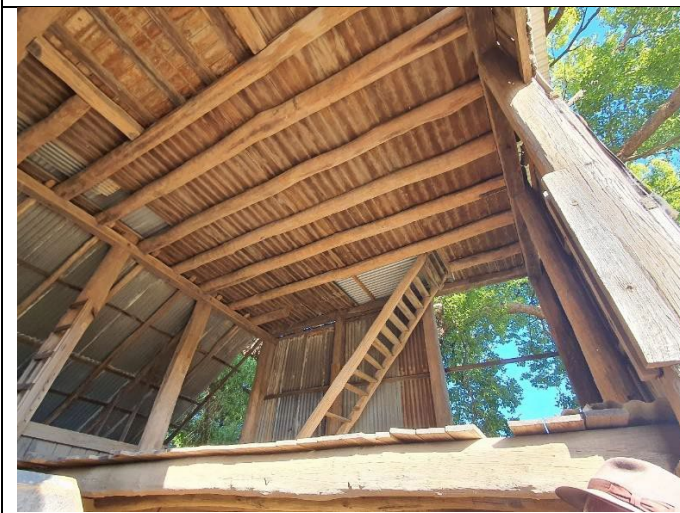
Caption: Barn at 191 Wilberforce Road, Wilberforce (interior)
Photographer: K. Denny
Copyright Owner: Lucas Stapleton Johnson & Partners
Date: May 2023

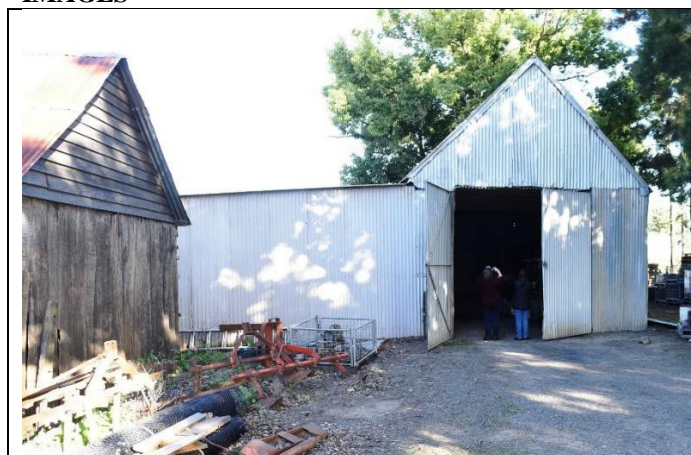
Caption: Barn A at 253 Wilberforce Road, Wilberforce (exterior)
Photographer: S. Johnson
Copyright Owner: Lucas Stapleton Johnson & Partners Pty Ltd
Date: May 2023

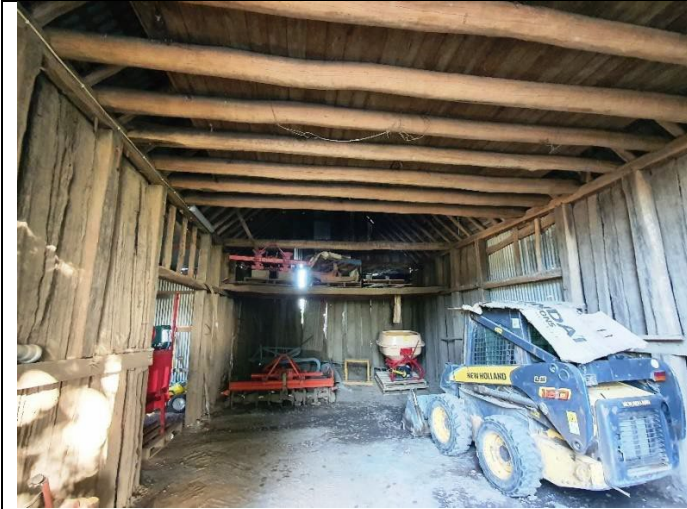
Caption: Barn A at 253 Wilberforce Road, Wilberforce (interior)
Photographer: S. Johnson
Copyright Owner: Lucas Stapleton Johnson & Partners Pty Ltd
Date: May 2023

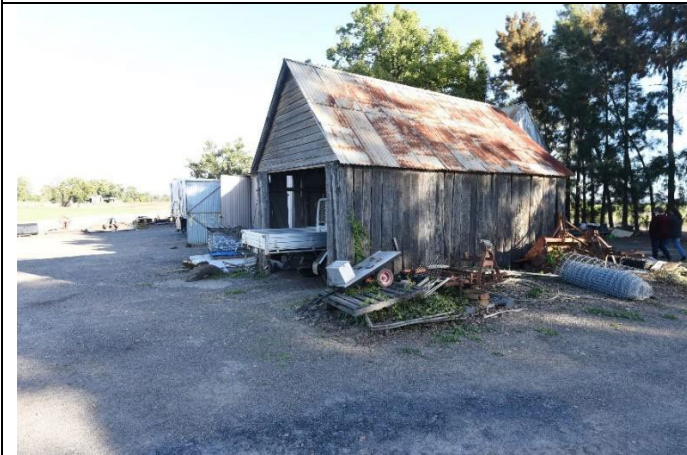
FLOORING (SKILLION)	N/A
INTERNAL STRUCTURE	Large, round, closely spaced beams to mezzanine and loft floors. Condition: Moderate Date: Late 19 th century?
OTHER (Fixings?)	Iron bolts and straps used to join beams to posts. Condition: Moderate Date: Late 19 th century?
HISTORY	
<p>Matthew/Matthias Lock (various Locke) was granted 30 acres (Portion 60, Parish Wilberforce) in the district of Mulgrave Place on the River Hawkesbury on 19 November 1794. Lock had been transported to Australia for 7 years, arriving in 1790.</p> <p>Lock originally concentrated on growing maize but switched to wheat, which had a ready market. Later, Lock acquired his neighbour David Lankey's 30 acre grant (Portion 61, Parish Wilberforce), and he eventually became one of the most successful ex-convict landholders in the district, obtaining various other grants of land including 50 acres on Robinson's (later Bushell's) Lagoon, 30 acres at Mulgrave Place, 60 acres at Kurrajong and a further 100 acres at Kurrajong.</p> <p>In 1805 Lock was made one of the residential trustees of the Phillip (Wilberforce) Common, in 1808 he was made District Constable, and in 1810 he became the Chief Constable of the Hawkesbury.</p> <p>Matthew (Matthias) Lock of Hawkesbury, yeoman, assigned his entire 1794 grant to Thomas Maloney, Hawkesbury, farmer on 3 April 1830. The transfer was for £150 and included a covenant permitting Lock and his wife Alice to reside on the farm for the term of the natural lives, free of rent or any demands. Matthew Lock died in April 1836. Alice was his second wife and she died on 2 December 1834. Maloney was an emancipist, who had arrived in NSW in 1811 with a life sentence and in 1818, he married Matthew Lock's daughter Mary Graham.</p> <p>After this date, the land was in the hands of the Maloney family and appears to have been passed down through their line for many decades. It was not conveyed by any member of the Maloney family. During this time Lock's 30 acres was divided into two halves. In June 1864, a severe flood demolished Thomas Maloney senior's house as well as Thomas Maloney junior's house.</p>

Caption: Barn B at 253 Wilberforce Road, Wilberforce (exterior)
Photographer: S. Johnson
Copyright Owner: Lucas Stapleton Johnson & Partners Pty Ltd
Date: May 2023

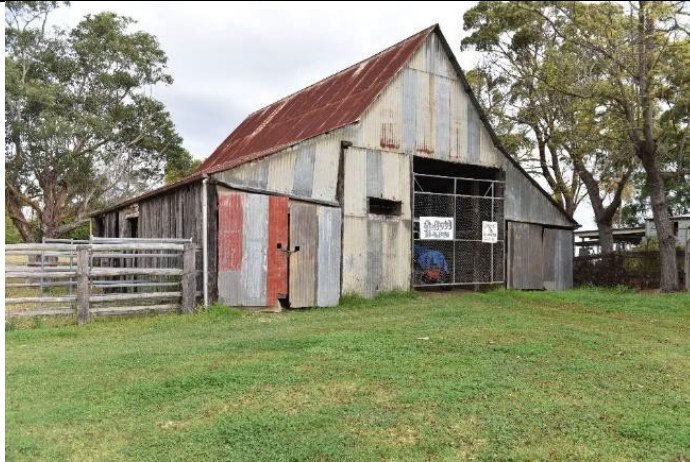
Caption: Barn at Australiana Pioneer Village, No. 496 Wilberforce Road, Wilberforce (exterior)
 Photographer: S. Johnson
 Copyright Owner: Lucas Stapleton Johnson & Partners
 Date: July 2023

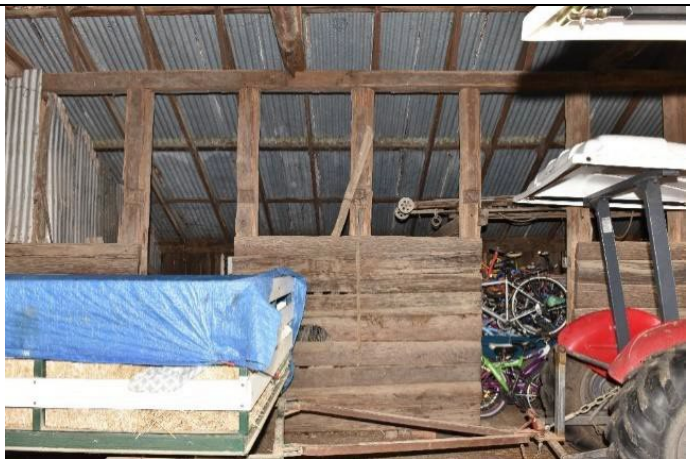
Caption: Detail of posts and beam separating main barn from skillion (note evidence of loft support), No. 496 Wilberforce Road, Wilberforce
 Photographer: S. Johnson
 Copyright Owner: Lucas Stapleton Johnson & Partners
 Date: July 2023

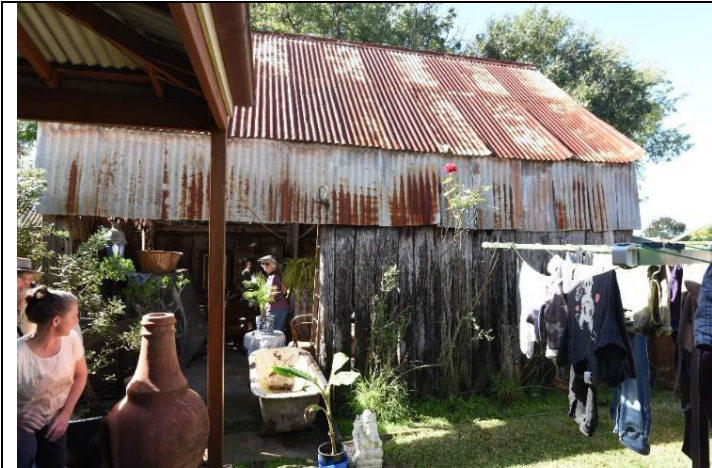
Caption: The town barn at No. 4 Catherine Street, Windsor (exterior).
Photographer: S. Johnson
Copyright Owner: Lucas Stapleton Johnson & Partners
Date: May 2023

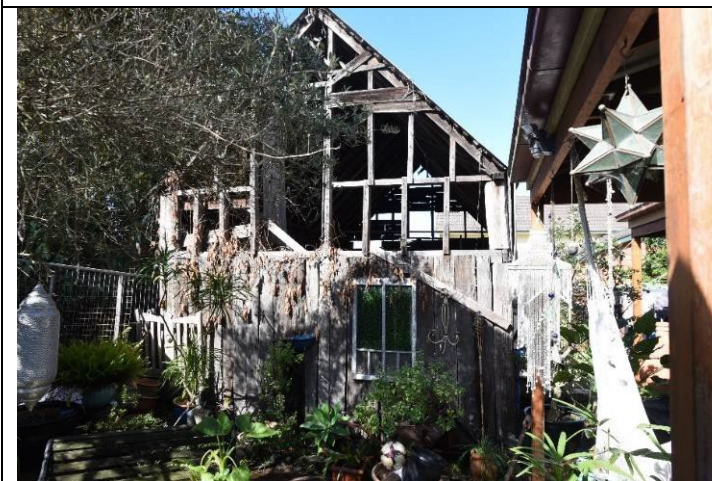
Caption: The town barn at No. 4 Catherine Street, Windsor (exterior).
Photographer: S. Johnson
Copyright Owner: Lucas Stapleton Johnson & Partners
Date: May 2023

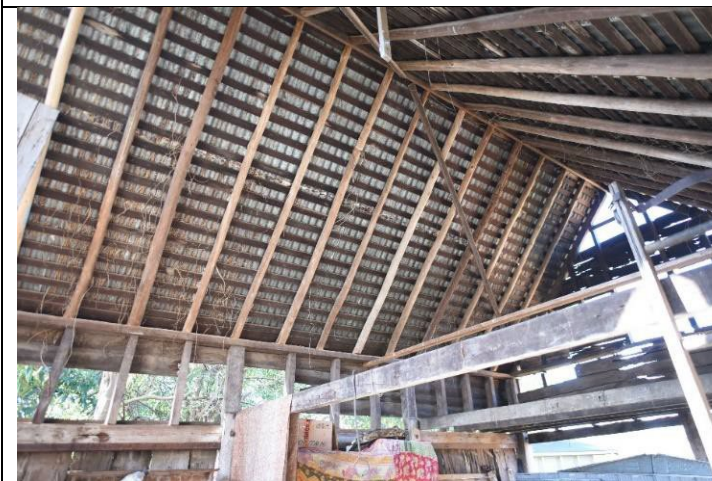
Caption: The town barn at No. 4 Catherine Street, Windsor (interior).
Photographer: S. Johnson
Copyright Owner: Lucas Stapleton Johnson & Partners
Date: May 2023

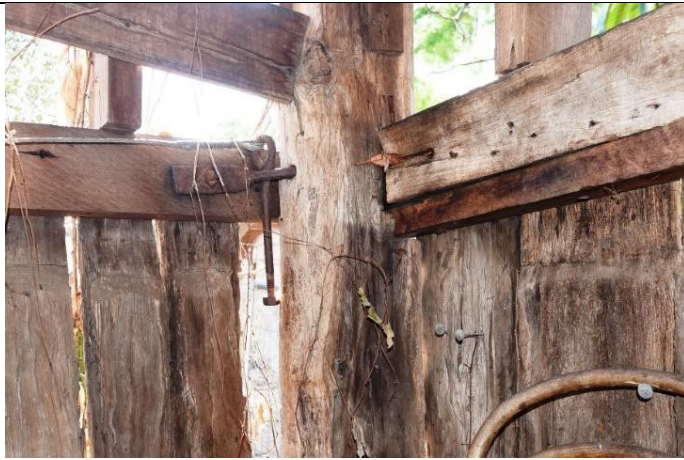
ITEM CLASSIFICATION	
ITEM TYPE	Built
ITEM GROUP	Farming and Grazing
ITEM CATEGORY	Barn
DESCRIPTION	
CIRCA	Y
PERIOD	Mid 19 th century
CURRENT USE	Storage
FORMER USE	Town Barn
LOCATION ON SITE	Town barn located immediately behind single storey attached cottage.
MAIN BARN STRUCTURE	Single storey with loft. Size 8m x 5m. Adzed posts with loft floor beam let into posts. Eaves beam is flat section. Beams are pit sawn. Date: 1860s Condition: Moderate
NO. OF BAYS	Three bays
ROOF STRUCTURE	Pole rafters and shingle battens. Roof pitch approx. 45°. Date: 1860s (using earlier technique) Condition: Good
LOFT	Remains of loft floor joists only.
SKILLION	None
ROOF CLADDING:	Corrugated iron short sheets Condition: Poor
WALL CLADDING	Vertical timber slabs to ground floor, remains of weatherboards to loft walls and gables. Corrugated iron over weatherboards to loft walls Date: 1860s (using earlier technique) Condition: Poor

Caption: The town barn at No. 4 Catherine Street, Windsor (interior detail).
 Photographer: S. Johnson
 Copyright Owner: Lucas Stapleton Johnson & Partners
 Date: May 2023

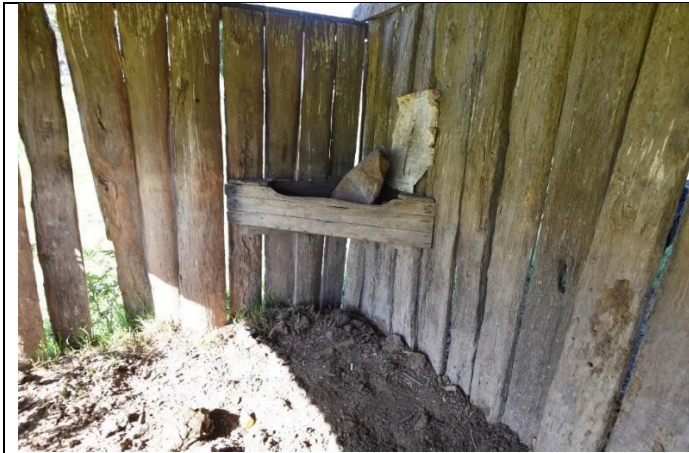
NO. OF BAYS	Six bay central spine
ROOF STRUCTURE	Sawn rafters over stable and bush poles over milking bails indicating that the latter is the older structure.
LOFT	N/A
SKILLION	N/A
ROOF CLADDING:	Corrugated iron
WALL CLADDING	Vertical timber slabs.
OPENINGS	Open sided both sides
FLOORING (GROUND)	Brick paving in part, earthen elsewhere
FLOORING (FIRST)	N/A
FLOORING (LOFT)	N/A
FLOORING (SKILLION)	N/A
INTERNAL STRUCTURE	Timber milking bails and troughs.
CURRENT USE	Animal shelter
CHANGES FROM 2010?	Deterioration
CONDITION	Poor
DESCRIPTION: TIMBER SLAB SHED	
MAIN STRUCTURE	Small 5m square shed or animal shelter with round corner posts and 3 sides clad in vertical timber slabs .

Caption: Timber milk bail in milking shed/stables at No. 10 Day Street, Windsor
 Photographer: S. Johnson
 Copyright Owner: Lucas Stapleton Johnson & Partners Pty Ltd
 Date: May 2023

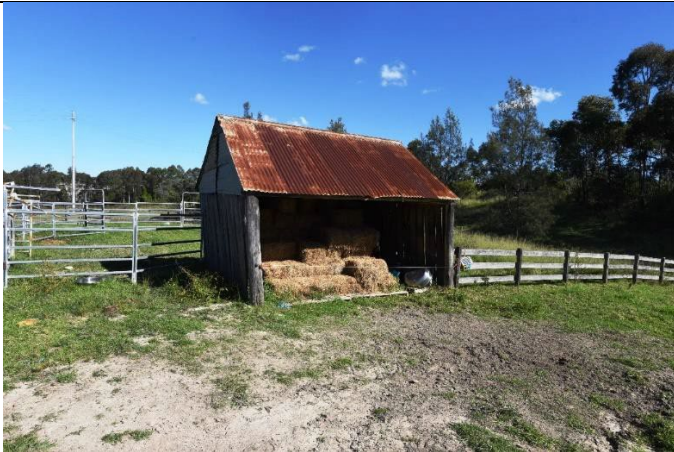
Caption: Timber slab animal shelter/hay shed at No. 10 Day Street, Windsor (exterior)
 Photographer: S. Johnson
 Copyright Owner: Lucas Stapleton Johnson & Partners Pty Ltd
 Date: May 2023
