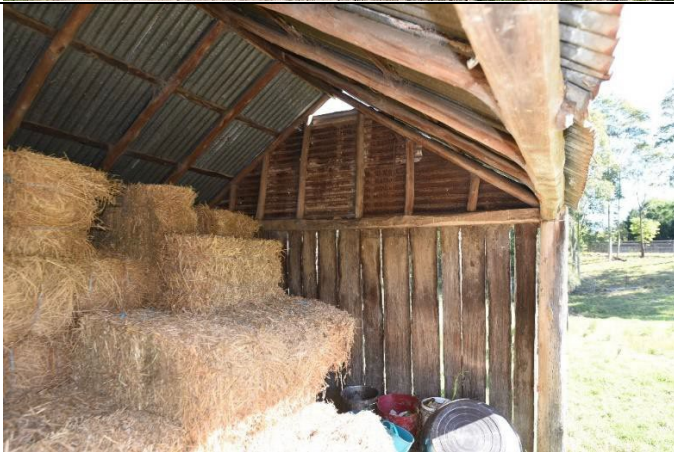
Caption: Timber slab animal shelter/hay shed at No. 10 Day Street, Windsor (interior)
 Photographer: S. Johnson
 Copyright Owner: Lucas Stapleton Johnson & Partners Pty Ltd
 Date: May 2023

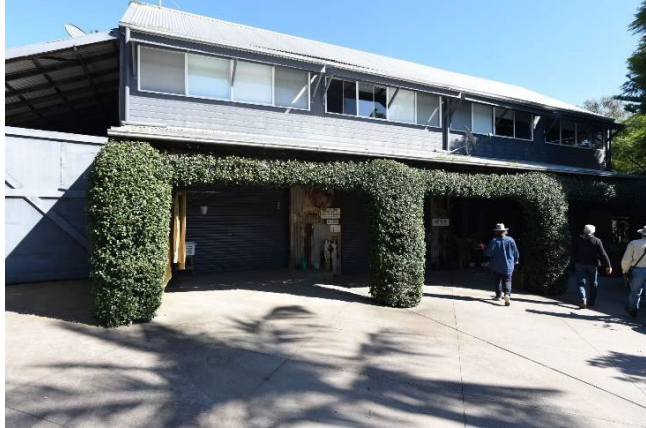
Caption: Barn at 23A George Street, Windsor (exterior)
Photographer: LSJ
Copyright Owner: Lucas Stapleton Johnson & Partners Pty Ltd
Date: May 2023

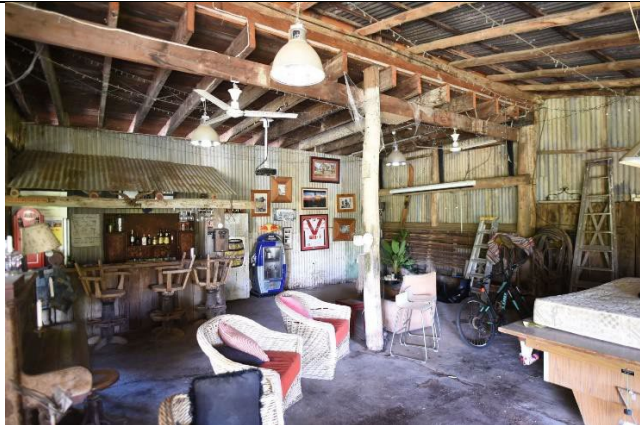
Caption: Barn at 23A George Street, Windsor (interior)
Photographer: LSJ
Copyright Owner: Lucas Stapleton Johnson & Partners Pty Ltd
Date: May 2023

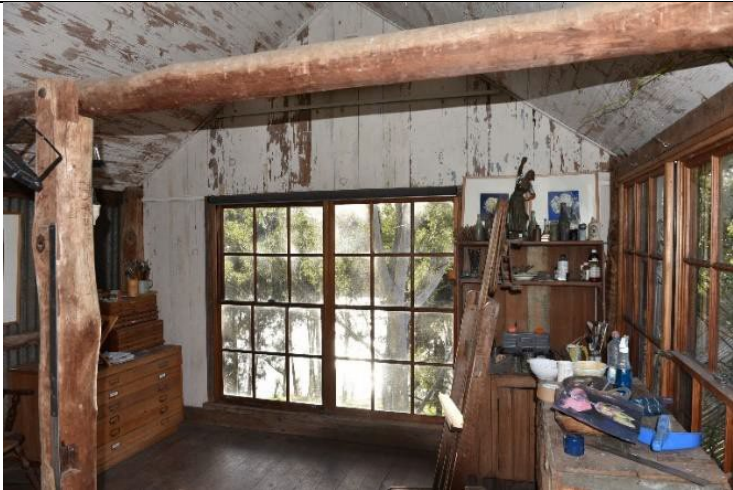
<p>Caption: Studio space within barn at 31 George Street, Windsor (interior) Photographer: S. Johnson Copyright Owner: Lucas Stapleton Johnson & Partners Pty Ltd Date: June 2023</p>

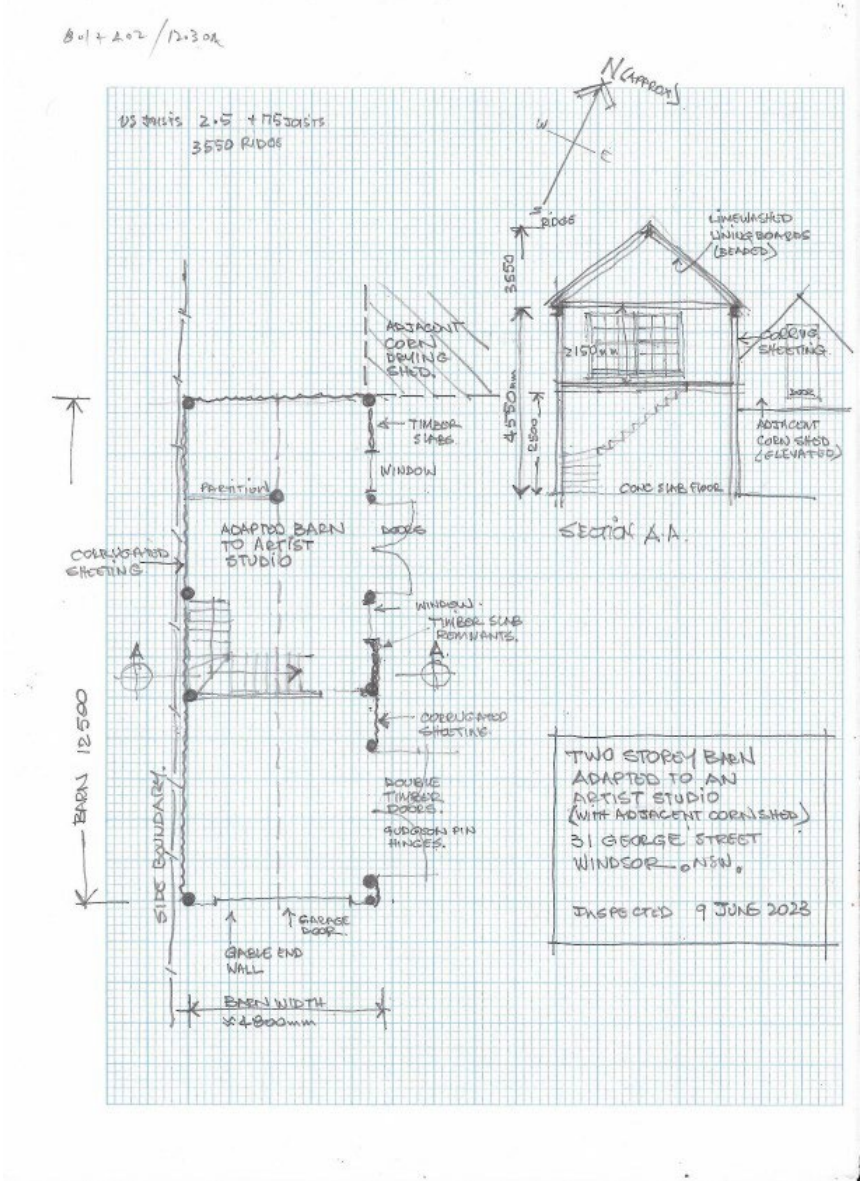
<p>Caption: Measured drawing of barn at No. 31 George Street, Windsor Copyright Owner: Graham Edds & Associates Date: June 2023</p>

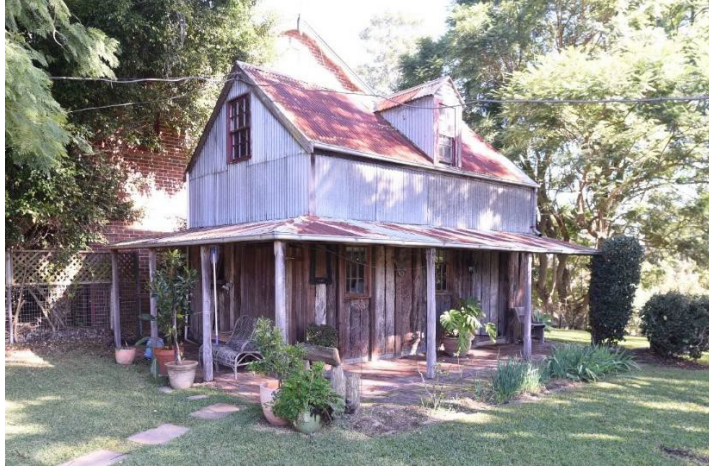
Caption: Slab outbuilding at 35 George Street, Windsor
 Photographer: S. Johnson
 Copyright Owner: Lucas Stapleton Johnson & Partners Pty Ltd
 Date: May 2023

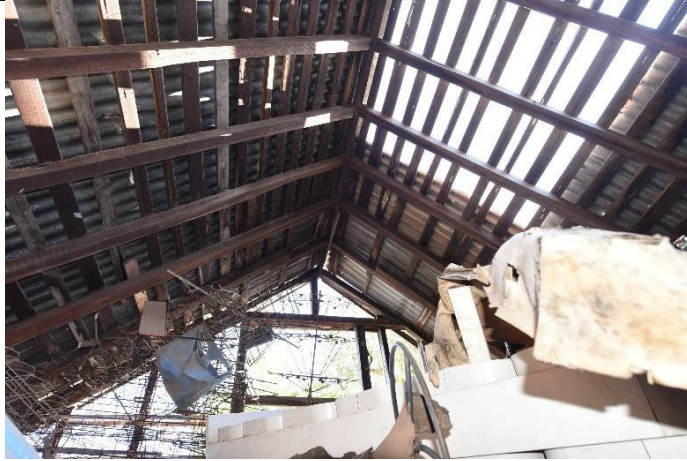
Caption: Town barn at 117 George Street, Windsor (detail)
 Photographer: S. Johnson
 Copyright Owner: Lucas Stapleton Johnson & Partners Pty Ltd
 Date: May 2023

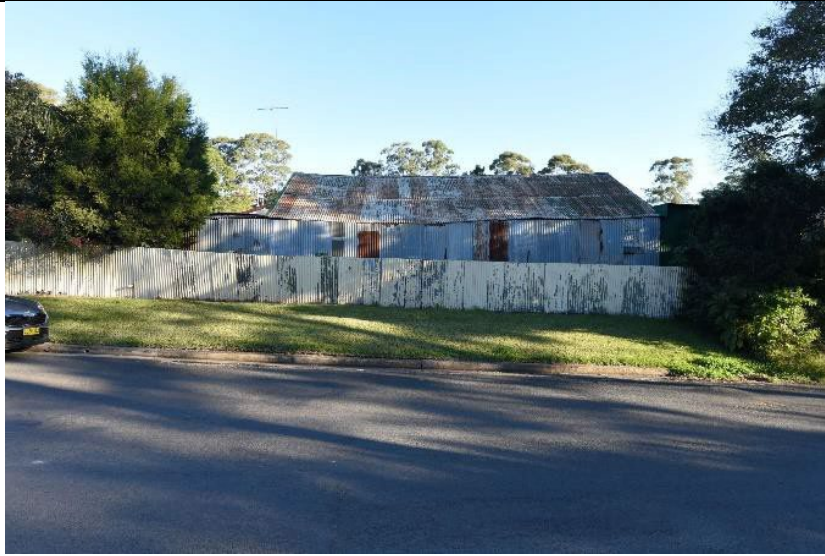
Caption: Barn at No. 24
Greenway Crescent,
Windsor (exterior)
Photographer: S. Johnson
Copyright Owner: Lucas
Stapleton Johnson & Partners
Date: May 2023

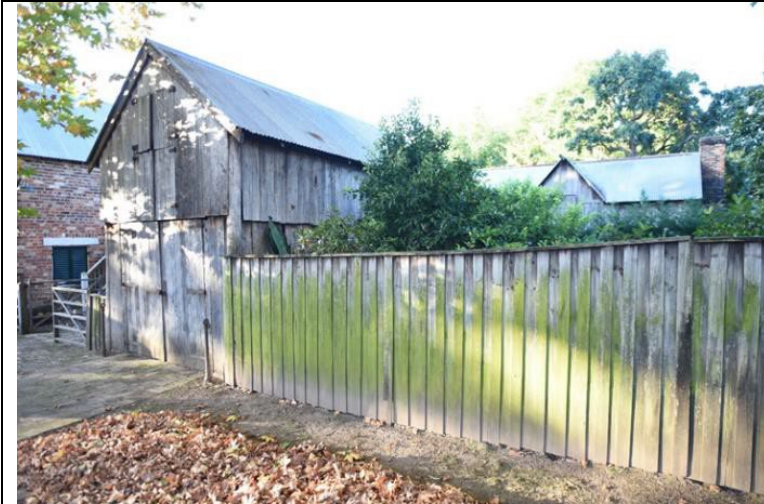
Caption: Barn at 37 -39 North Street, Windsor (exterior)
Photographer: S. Johnson
Copyright Owner: Lucas Stapleton Johnson & Partners Pty Ltd
Date: May 2023

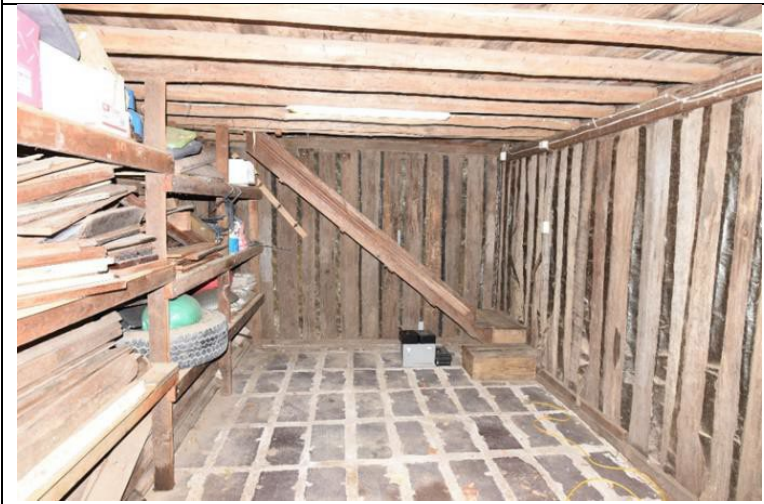
Caption: Barn at 37 -39 North Street, Windsor (interior)
Photographer: S. Johnson
Copyright Owner: Lucas Stapleton Johnson & Partners Pty Ltd
Date: May 2023

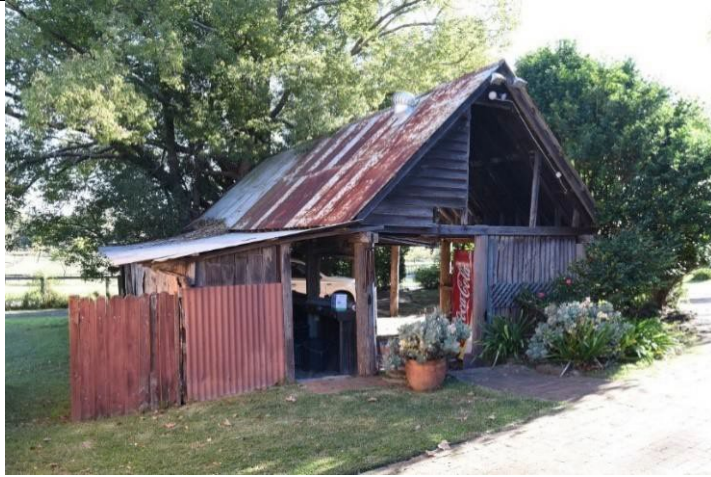
Caption: The corn shed at No. 50 Palmer Street, Windsor (exterior)
Photographer: S. Johnson
Copyright Owner: Lucas Stapleton Johnson & Partners
Date: May 2023

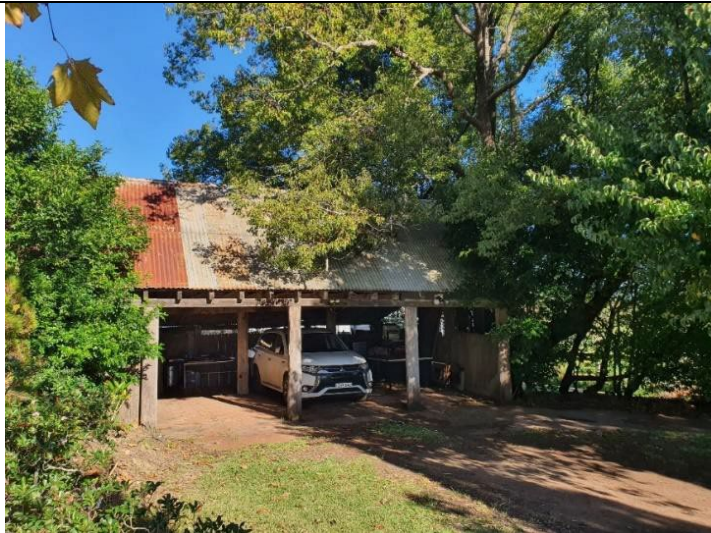
Caption: The corn shed at No. 50 Palmer Street, Windsor (exterior)
Photographer: S. Johnson
Copyright Owner: Lucas Stapleton Johnson & Partners
Date: May 2023

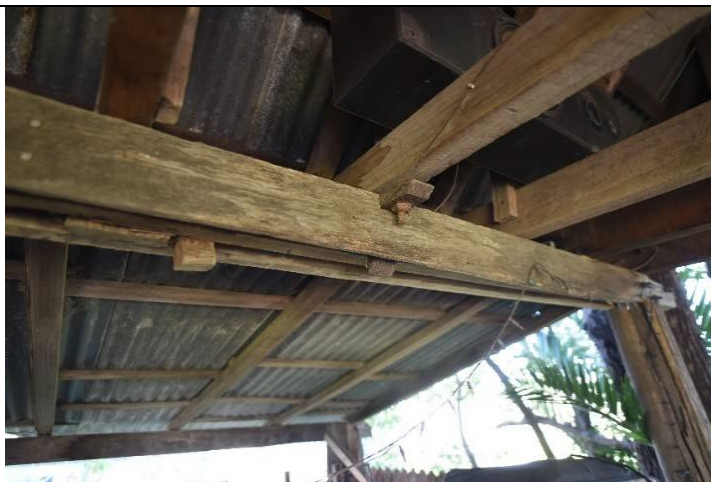
Caption: The corn shed at No. 50 Palmer Street, Windsor (interior detail)
Photographer: S. Johnson
Copyright Owner: Lucas Stapleton Johnson & Partners
Date: May 2023

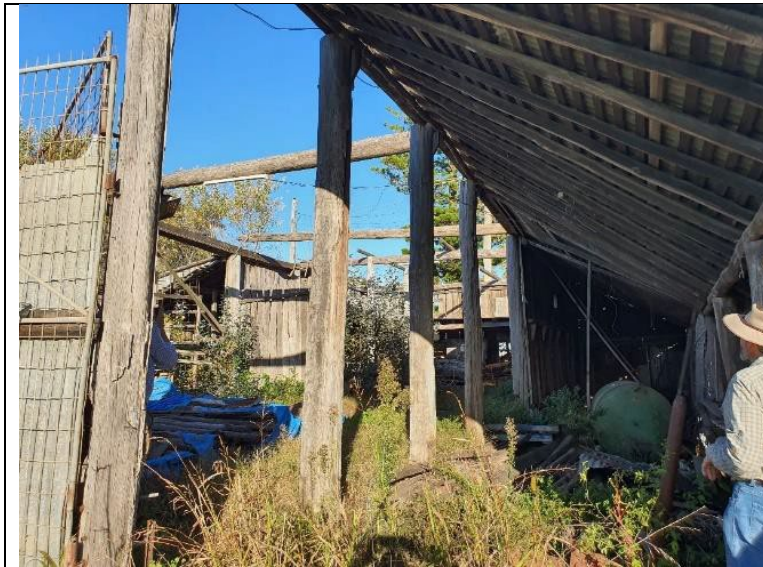
Caption: The derelict barn at No. 40 Pitt Street, Windsor.
Photographer: K. Denny
Copyright Owner: Lucas Stapleton Johnson & Partners
Date: May 2023
