Draft Hawkesbury Timber Barns & Outbuildings Study

Timber Slab Barns & Outbuildings Update Study

Date: March 2024

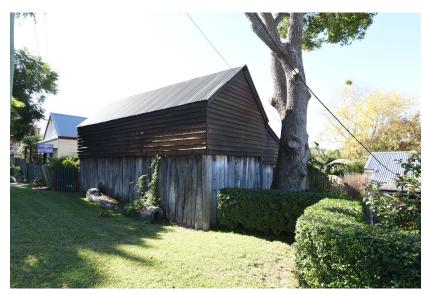
Figure 3. 1: The slab barn at No. 4-8 Chatham Street, Pitt Town in 2023. It was this barn that started the long investigation into the history of timber slab barns throughout the Hawkesbury region

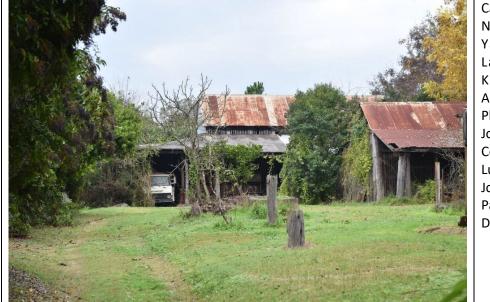
Caption: Barn at No. 2 Yarramundi Lane / 2 Old Kurrajong Road, Agnes Banks Photographer: S. Johnson Copyright Owner: Lucas Stapleton Johnson & Partners Date: June 2023
