Draft Hawkesbury Timber Barns & Outbuildings Update Study

# **Timber Slab Barns & Outbuildings Update Study**

**Lucas Stapleton Johnson &** Partners Pty. Ltd.

Final Issue: November 2024

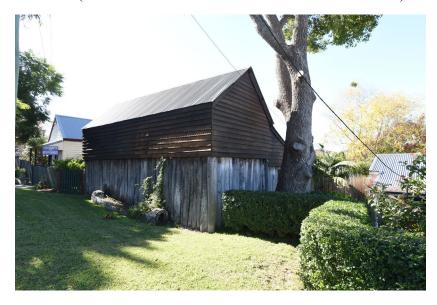
Figure 3. 1: The slab barn at No. 4-8 Chatham Street, Pitt Town in 2023. It was this barn that started the long investigation into the history of timber slab barns throughout the Hawkesbury region
