Hawkesbury Timber Slab Barns & Outbuildings Update Study

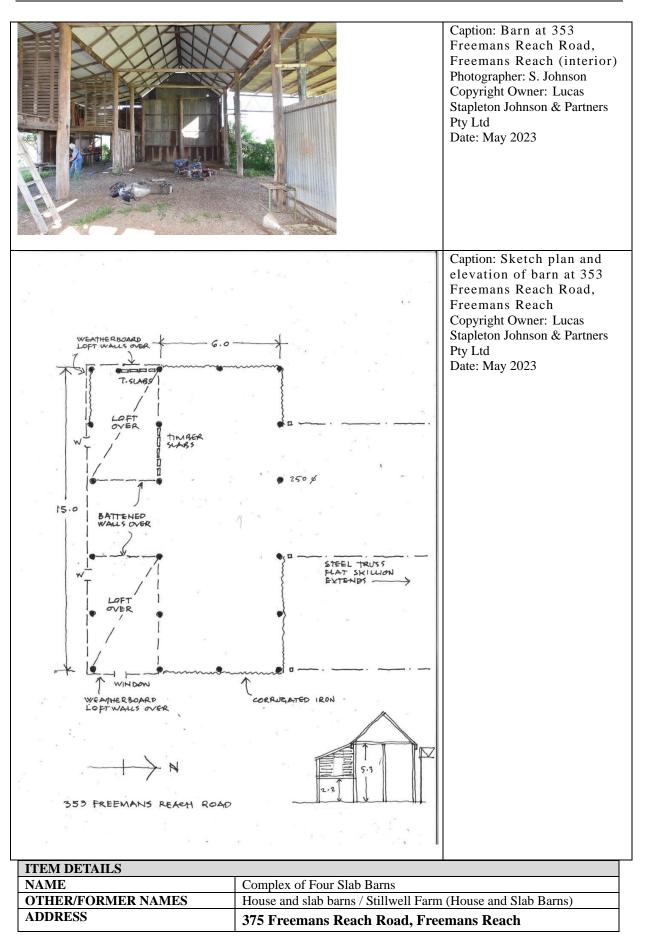
Caption: Barn at 353 Freemans Reach Road, Freemans Reach (exterior) Photographer: S. Johnson Copyright Owner: Lucas Stapleton Johnson & Partners Pty Ltd Date: May 2023

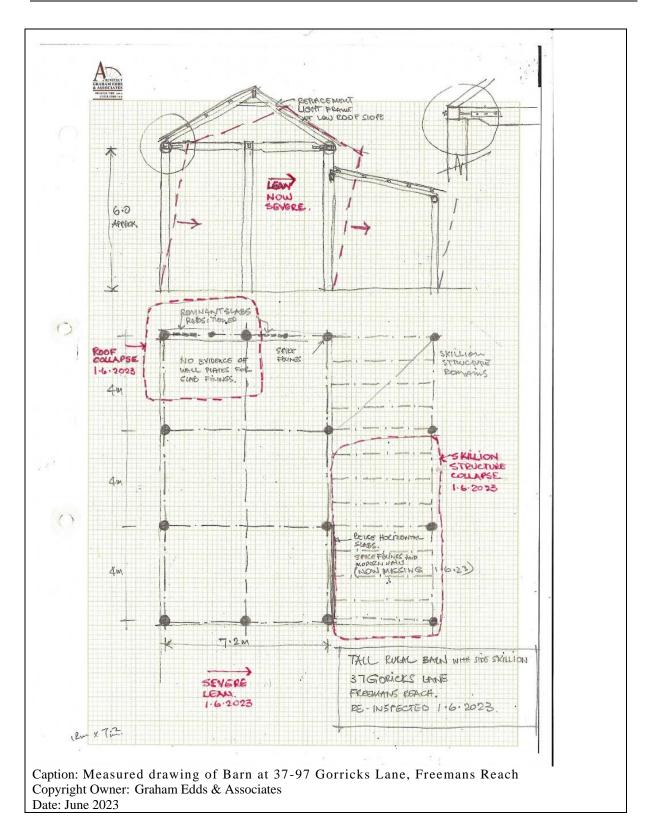
This tall gabled barn is typical of the barns of the Hawkesbury district but unable to determine whether the barn was originally clad with timber slabs. This barn, emanating from the late 19th century or early 20th century, has been considerably altered and is in poor condition, but a visual icon within the rural landscape.

Caption: Barn at 37-97 Gorricks Lane, Freemans Reach (exterior) Photographer: S. Johnson Copyright Owner: Lucas Stapleton Johnson & Partners Pty Ltd Date: June 2023
Caption: Barn at 37-97 Gorricks Lane, Freemans Reach (exterior) Photographer: S. Johnson Copyright Owner: Lucas Stapleton Johnson & Partners Pty Ltd Date: June 2023
Caption: Barn at 37-97 Gorricks Lane, Freemans Reach (exterior) Photographer: S. Johnson Copyright Owner: Lucas Stapleton Johnson & Partners Pty Ltd Date: June 2023

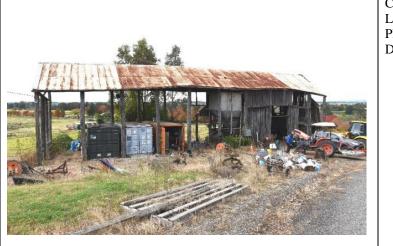
Caption: Barn at 176B Hibberts Lane, Freemans Reach Photographer: S. Johnson Date: June 2023

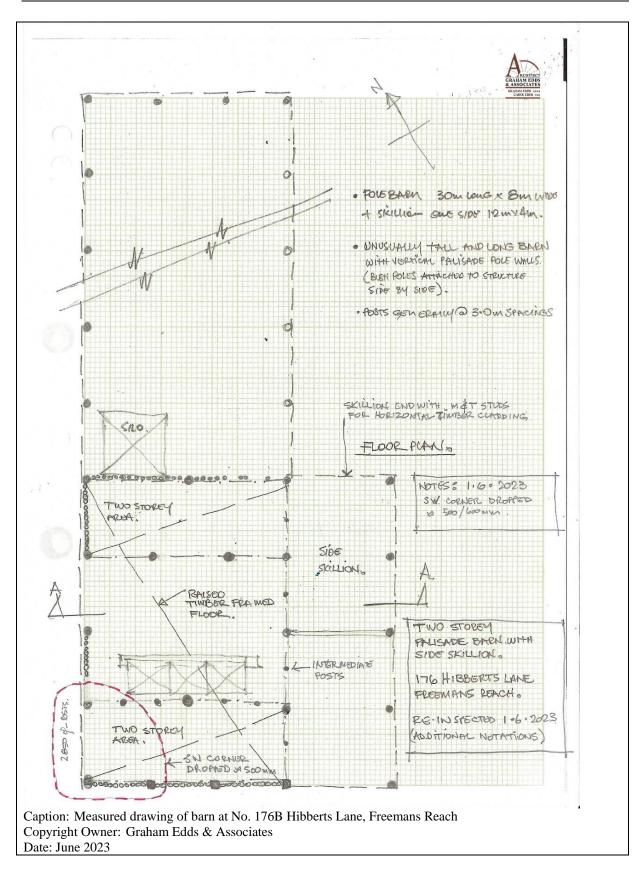
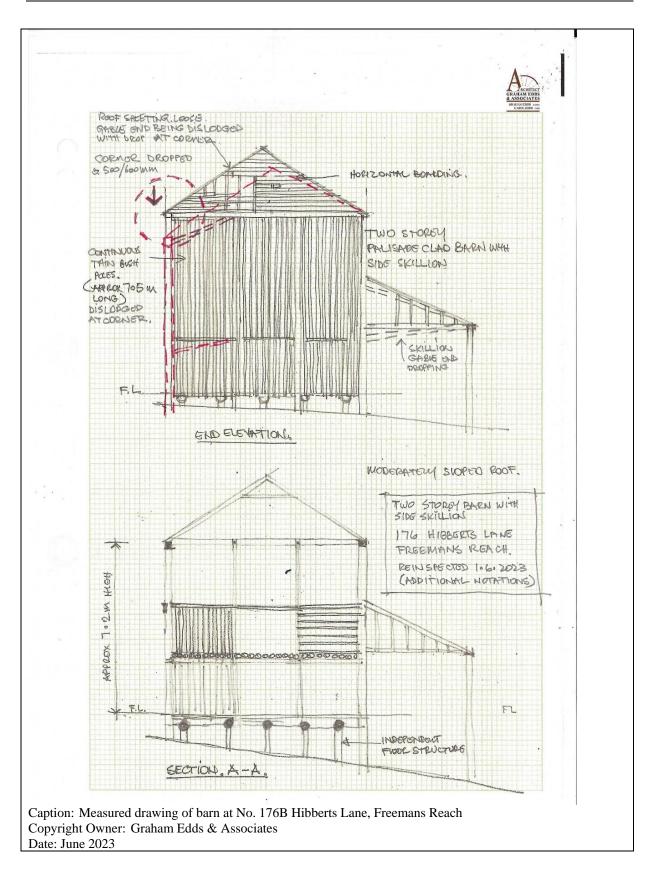
battens spaced for iron. Large square section cross beams at each bay. Roof
	probably rebuilt at time of extension from 4 to 10 bays. Gable ends framed for
	weatherboards of which few remain.
	Condition: Moderate – subject to distortion due to subsidence of posts.
	Date: Late 19 th or early 20 th century
FIRST FLOOR	Upper floors occupy the two end bays of the original 4-bay barn. They are
	enclosed with vertical palisade cladding (slender bush poles spaced apart for
	ventilation) and have a floor of similar pole construction.
	Condition: Good
	Date: Early 19 th century.
SKILLION 1	Original four bay barn has a side skillion of similar construction to the main
	barn but with mortise & tenon post/ beam joints and round rafters birds-
	mouthed over eaves beam. Gable ends framed for weatherboards.
	Condition: Moderate
	Date: Early 19 th century
ROOF CLADDING:	Corrugated iron short sheets.
	Condition: Moderate

Caption: Underside of upper floor of barn at 176B Hibberts Lane, Freemans Reach Photographer: S. Johnson Date: June 2023
Caption: Ground floor structure of barn at 176B Hibberts Lane, Freemans Reach Photographer: S. Johnson Date: June 2023

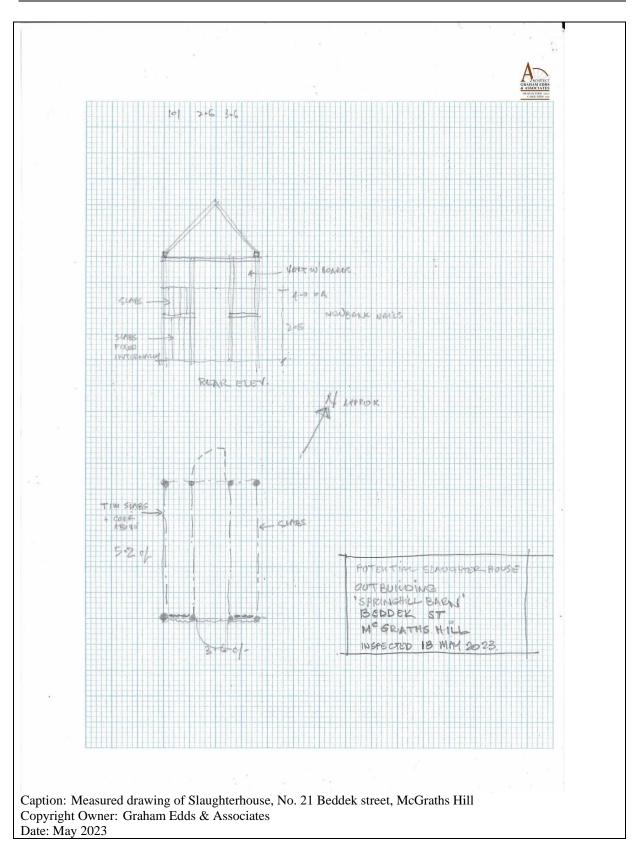
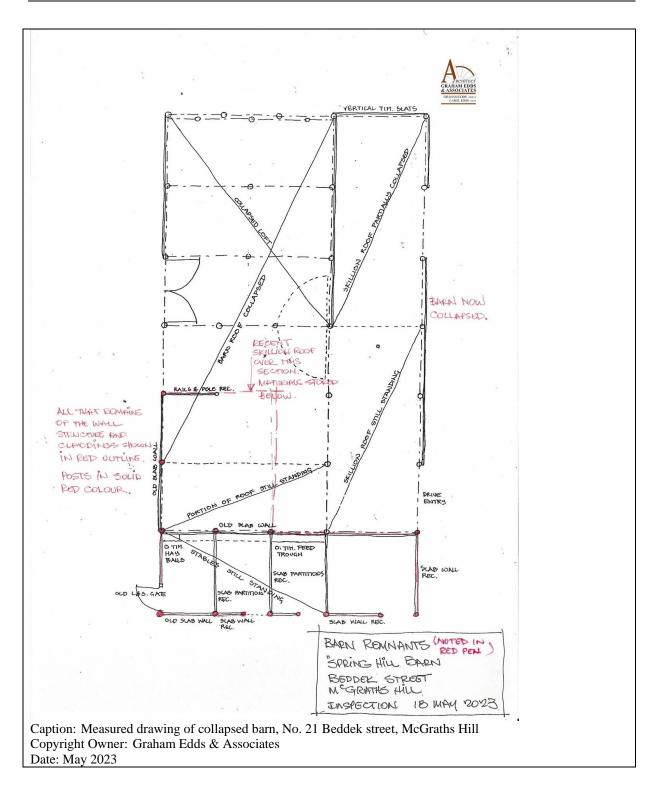
Caption: Slaughterhouse at No. 21 Beddek Street, McGraths Hill (exterior) Photographer: S. Johnson Copyright Owner: Lucas Stapleton Johnson & Partners Pty Ltd Date: May 2023
Caption: Collapsed barn at No. 21 Beddek Street, McGraths Hill (exterior) Photographer: S. Johnson Copyright Owner: Lucas Stapleton Johnson & Partners Pty Ltd Date: May 2023

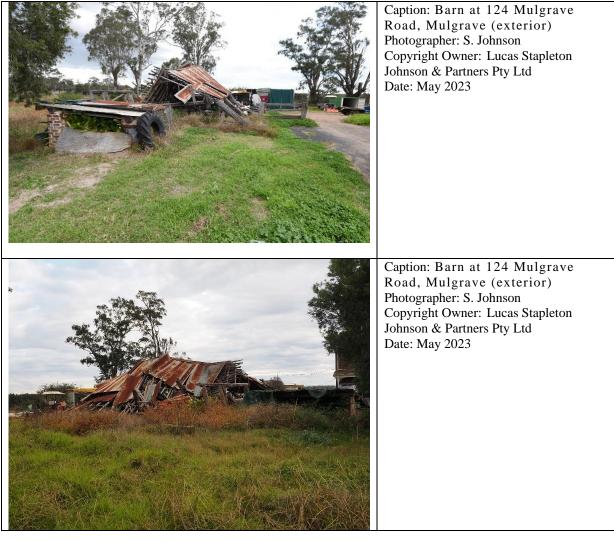
The principal barn with post and beam wall structure, the beam is continuously grooved and each post junctions with two tenons at the post top. A wrought iron strap and pins into the beam T junction also attach to the post. An unusual timber joint detail. (refer to sketch). The roof frame is timber bush poles at close spacings and rectangular timber battens spaced for shingle roof cladding. The early skillion is structured with post and beam walls with roof structure of bush poles aligning with the principal barn and attaching approx. 1/3rd within the barn roof plane. The timber slabs are fixed to the outside of the wall squared beam. The gable ends and upper skillion wall are clad with timber boarding, both horizontally and vertically INTEGRITY/INTACTNESS Completely collapsed

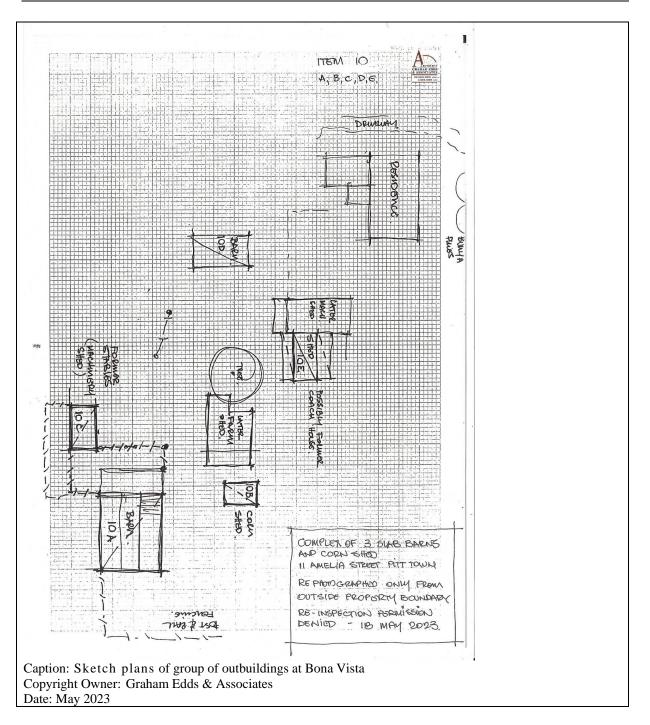
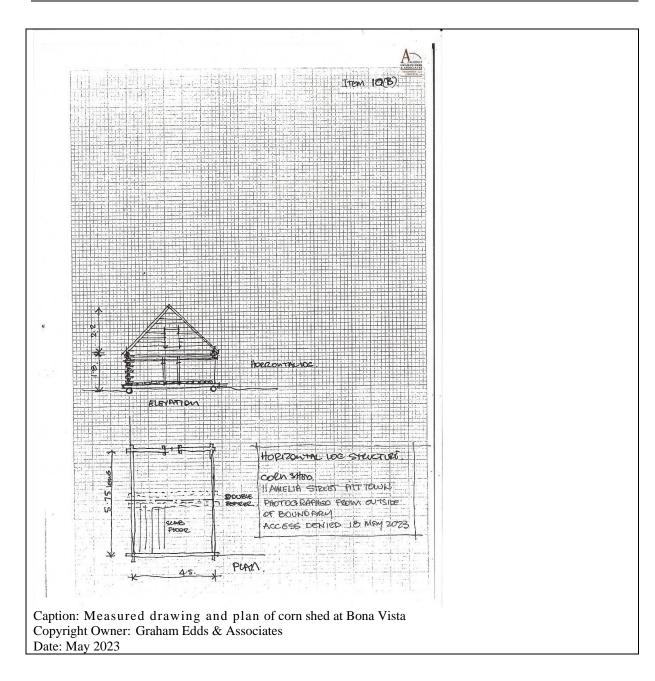
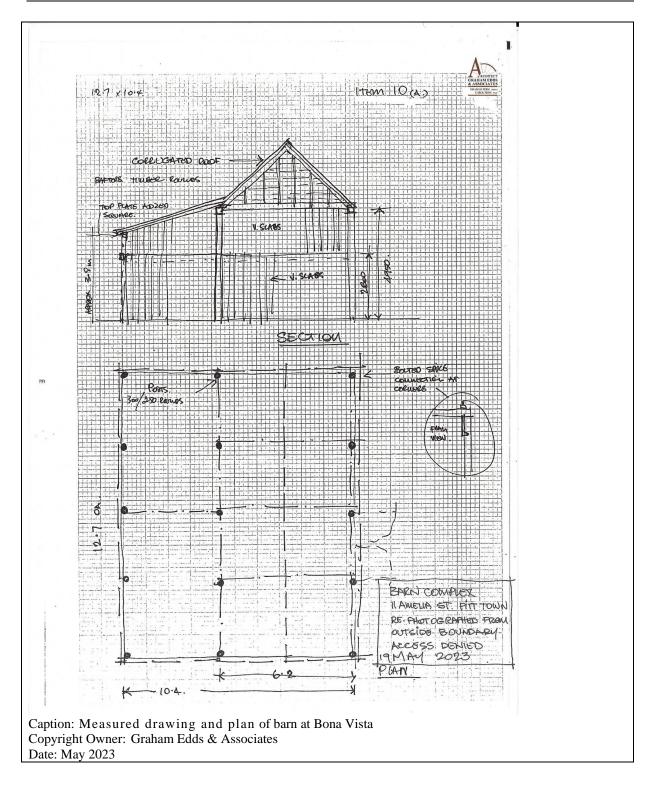
Caption: Barn C at Bona Vista complex Photographer: S. Johnson Copyright Owner: Lucas Stapleton Johnson & Partners Date: May 2023
Caption: Barn D at Bona Vista complex Photographer: S. Johnson Copyright Owner: Lucas Stapleton Johnson & Partners Date: May 2023
Caption: Barn E at Bona Vista complex Photographer: S. Johnson Copyright Owner: Lucas Stapleton Johnson & Partners Date: May 2023

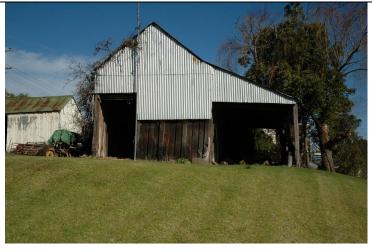
Caption: Barn at No. 134 Bathurst Street, Pitt Town (exterior) Photographer: G. Edds Copyright Owner: Graham Edds & Associates Date: 2009

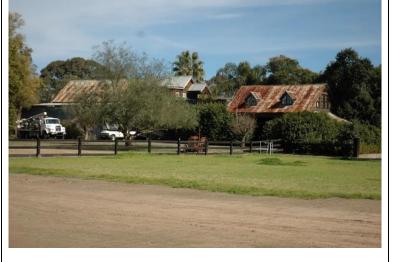
Caption: Barns at No. 265 Pitt Town Bottoms Road, Pitt Town Bottoms Photographer: C. Edds Copyright Owner: Grahams Edds & Associates Date: 2009

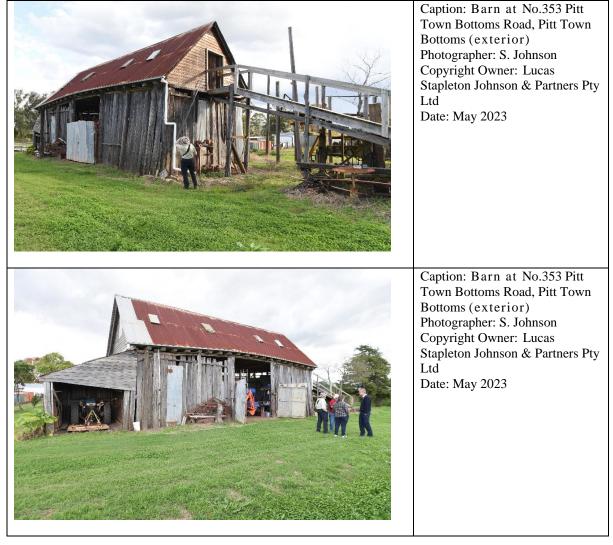
Caption: Barn at No.353 Pitt Town Bottoms Road, Pitt Town Bottoms (interior of skillion) Photographer: S. Johnson Copyright Owner: Lucas Stapleton Johnson & Partners Pty Ltd Date: May 2023
Caption: Barn at No.353 Pitt Town Bottoms Road, Pitt Town Bottoms (interior of loft) Photographer: S. Johnson Copyright Owner: Lucas Stapleton Johnson & Partners Pty Ltd Date: May 2023

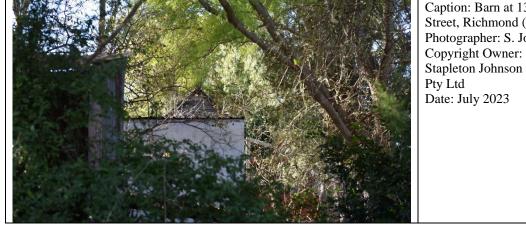
Caption: Barn at 135 Francis Street, Richmond (exterior) Photographer: S. Johnson Copyright Owner: Lucas Stapleton Johnson & Partners

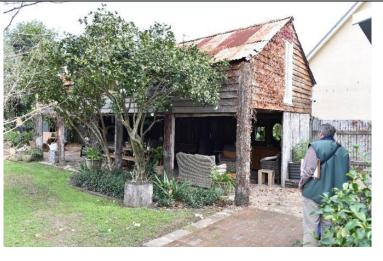
Caption: The town barn at No. 102 Lennox Street, Richmond (exterior). Photographer: S. Johnson Copyright Owner: Lucas Stapleton Johnson & Partners Date: May 2023

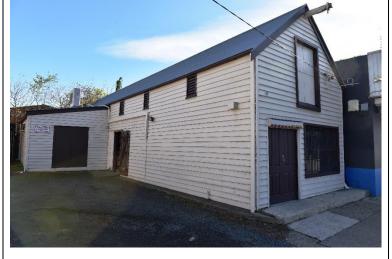
Caption: The town barn at No. 239 Windsor, Richmond (exterior). Photographer: S. Johnson Copyright Owner: Lucas Stapleton Johnson & Partners Date: May 2023

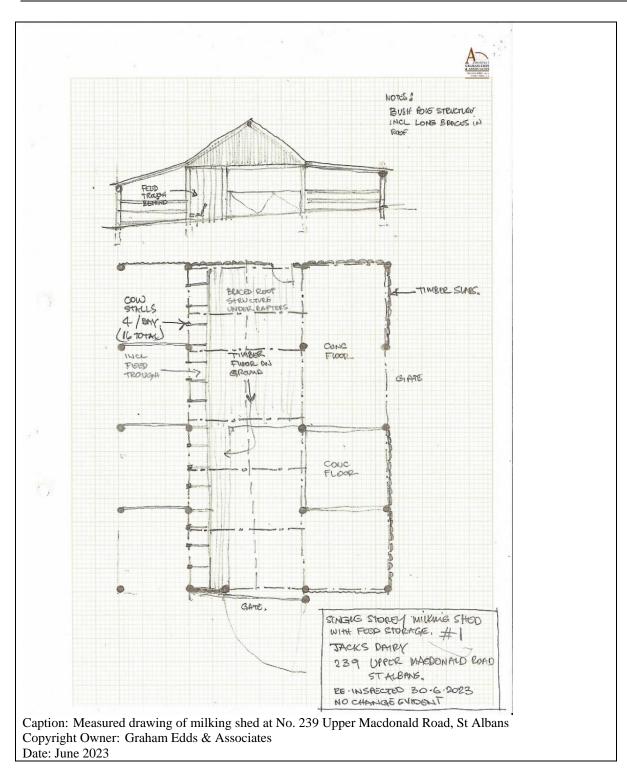
Caption: Detail of Milking Shed at No. 239 Upper Macdonald Road, St Albans (exterior) Photographer: S. Johnson Copyright Owner: Lucas Stapleton Johnson & Partners Date: June 2023
Caption: Barn at No. 239 Upper Macdonald Road, St Albans (exterior) Photographer: S. Johnson Copyright Owner: Lucas Stapleton Johnson & Partners Date: June 2023
