Report MHL3008

Redbank Creek Flood Study

**Manly
Hydraulics
Laboratory**

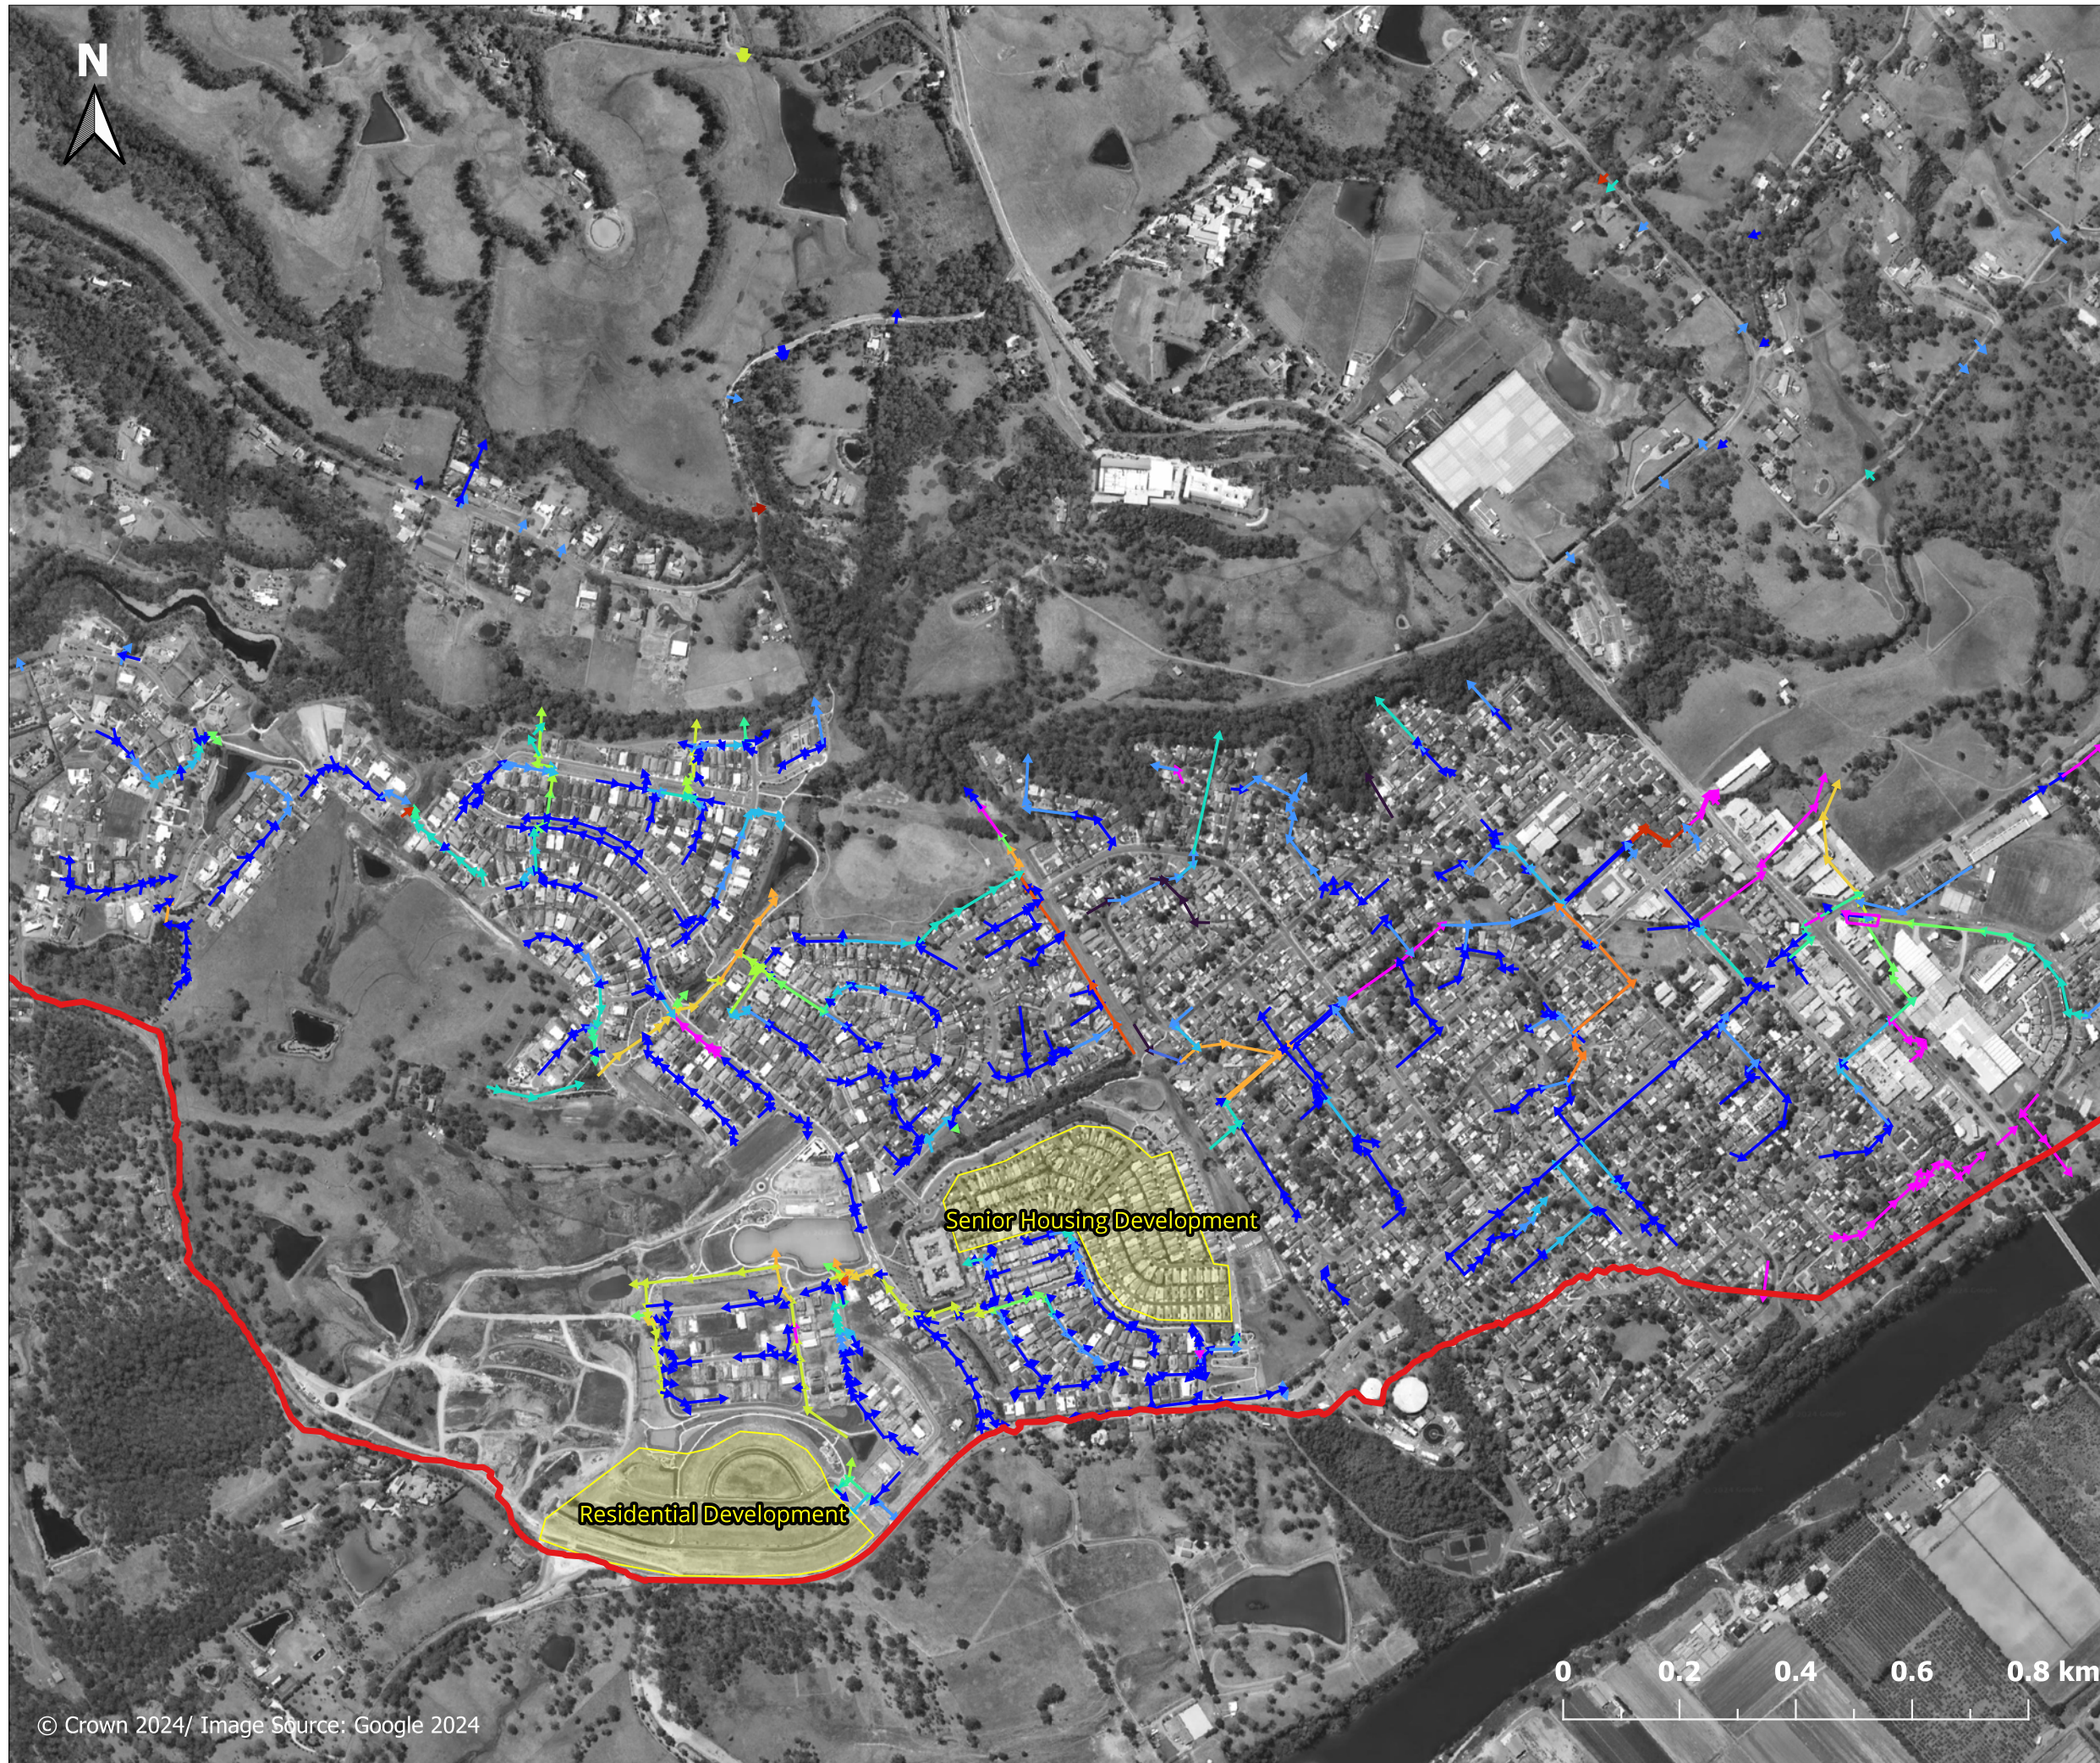
Figure 4.6
Drainage network

Council's drainage network GIS layers were reviewed to determine the adequacy of the data for flood modelling purposes. A map of the drainage network within the study area is shown in **Figure 4.6**. The review identified some missing data required for modelling the stormwater network and the main observations are summarised as follows:

- Pipe / culvert data including approximate locations and sizing were available for the majority of the catchment, but no invert level was provided.
- Information for several pipes was unknown along Shortland Close, Bells Line of Road, Yobarnie Avenue and between Elizabeth Street and Pecks Road. Most of the missing pipes with unknown diameter were inspected to obtain basic dimensions during the site visit (except for the area nearest to the Hawkesbury River where no flooding was observed in our preliminary model).

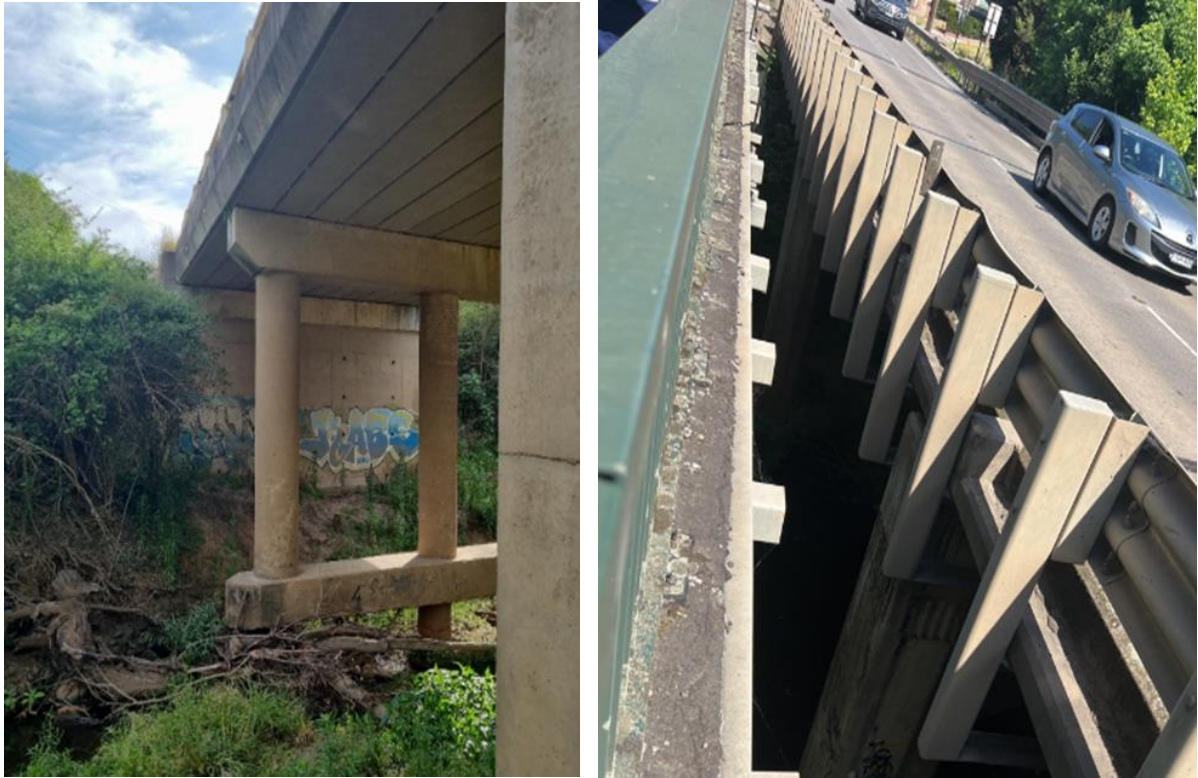
Figure 5.3 Example of photographs of inspected bridges within the study area

- Seven bridges were inspected including two along Terrace Road (items 1 and 2), one along Crooked Lane (item 3), a footbridge in the open area at the back of Monti Place (item 33), a footbridge in the open area near Tyne Crescent (item 37), a small timber bridge along a bush track near Redbank Road (item 41), and a large bridge along Bells Line of Road (item 39). The data collected during the inspection for bridges was length, width, railing height, and location and informed the flood modelling. Example of bridges photographs are shown in **Figure 5.3**.

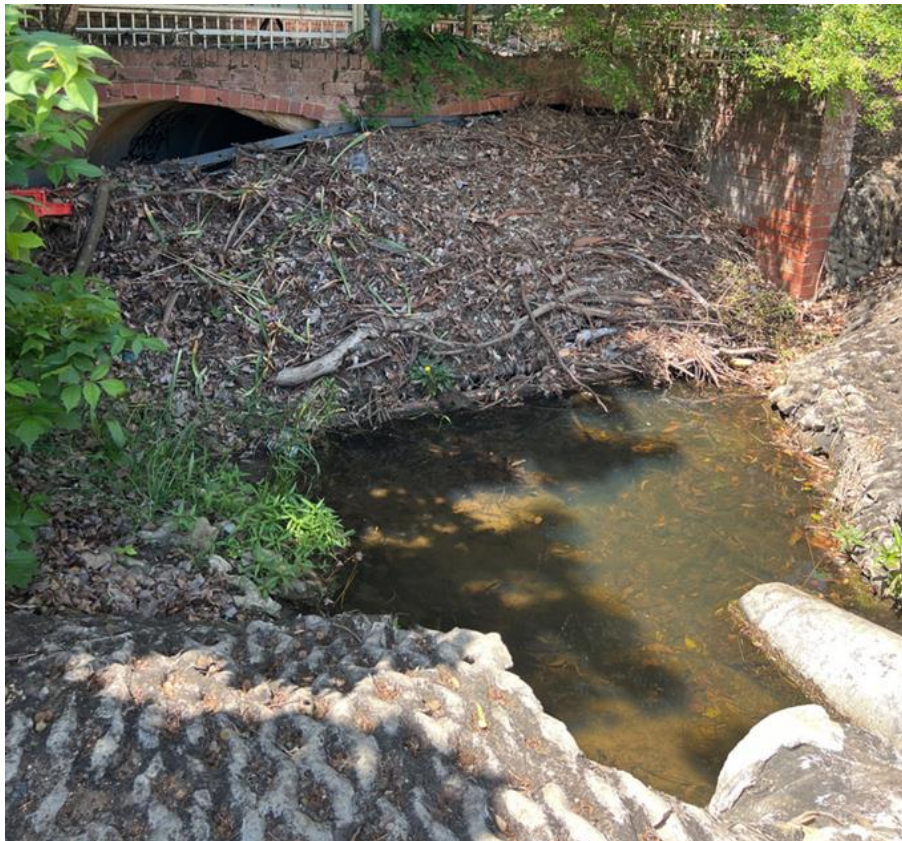
Figure 5.4 Photograph of inspected blocked culvert in the urbanised area (North Richmond)

- Seventeen culverts were inspected within the study area. The data collected during the inspection included the number of barrels, diameter or width / height, and location of each culvert. One of the culverts was found heavily blocked between Pecks Road and Elizabeth Street, as shown in **Figure 5.4**.

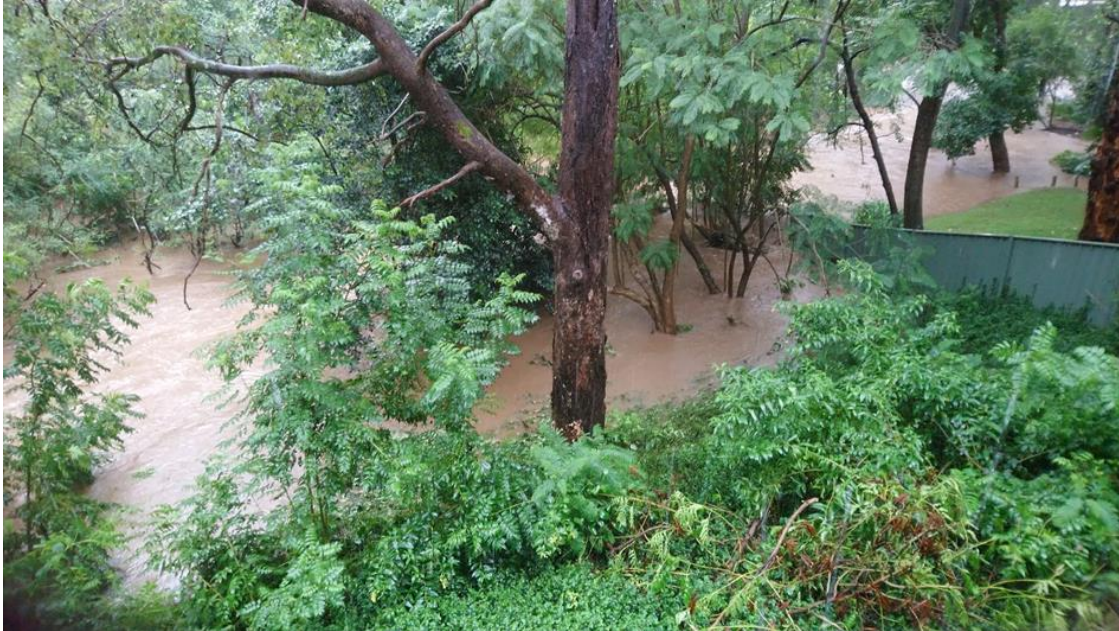
Figure 6.1 Flooding at the back of Susella Crescent on March 2022 (Courtesy of a community member)

- Two of the respondents reported that there are flood marks near the property.
- One of the respondents provided photographs as well as videos. Example of photographs are provided in **Figure 6.1** and **Figure 6.2**.
