Geotechnical and Salinity Assessment Report

**REDBANK EXPANSION AREA (KEMSLEY PARK)
GROSE VALE ROAD, NORTH RICHMOND
PRELIMINARY GEOTECHNICAL ASSESSMENT**

**REPORT 12261/44-AA-R1
16 JULY 2024**

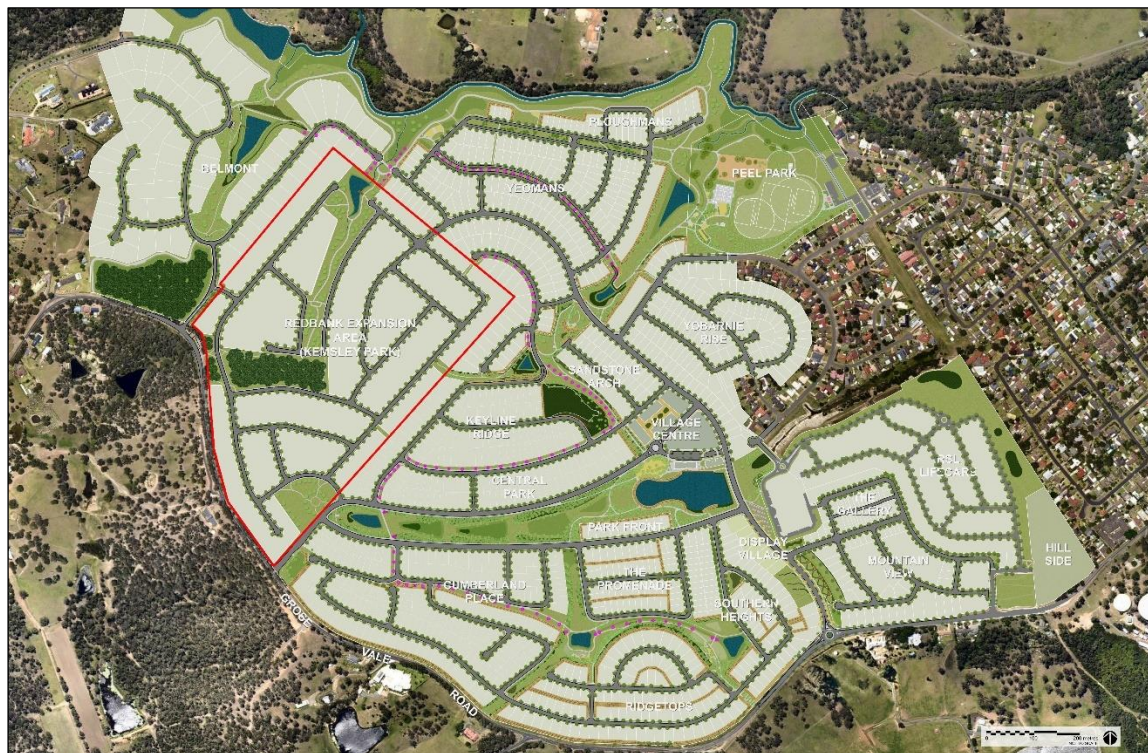
Figure 1: Redbank Expansion Area (Kemsley Park) within Greater Redbank Development

We understand that the site forms part of the overall Redbank master plan. Figure 1 shows the locality of the proposed site within the greater Redbank Development area. The site requires rezoning, and as a precursor a Gateway Planning Proposal is required to be prepared and lodged by Redbank to Hawkesbury City Council. In this regard, a preliminary geotechnical assessment is required for rezoning purposes of the site.

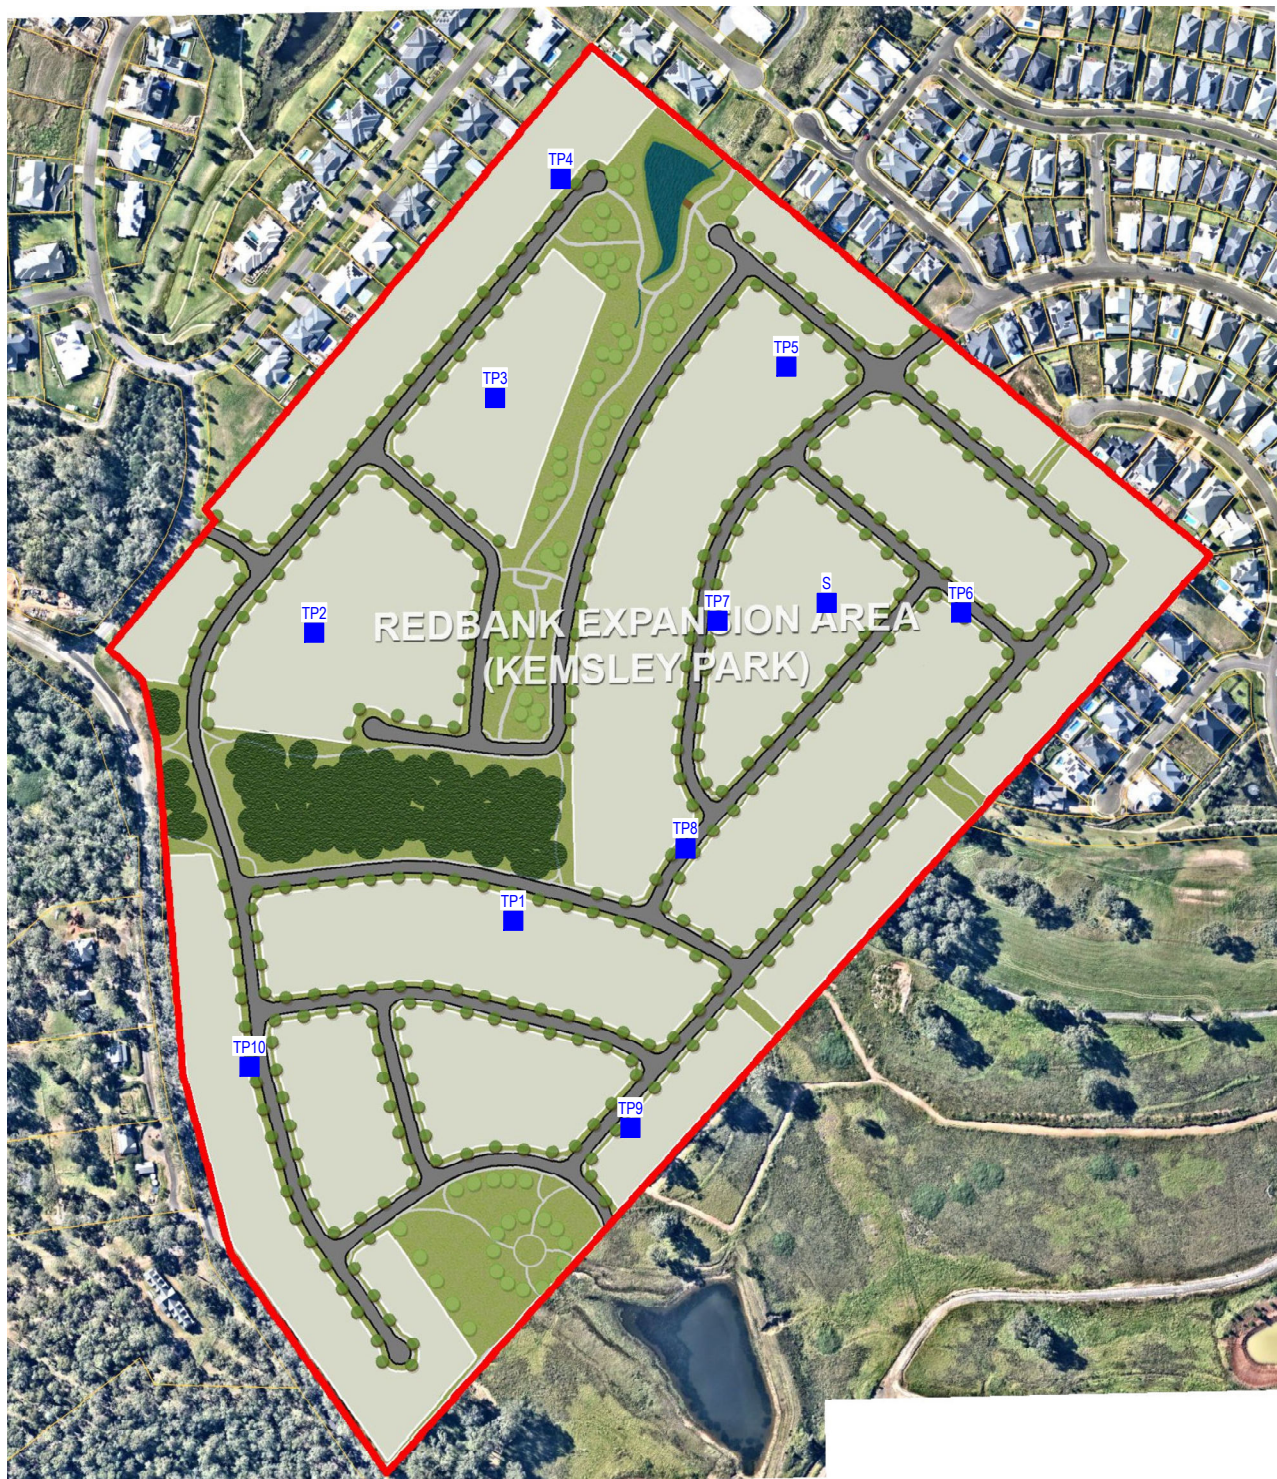
**DRAWING NO 12261/44-AA1
(Test Pit Location Plan)**

■ Test Pit
