Caption: Measured drawing of barn at No. 239 Upper Macdonald Road, St Albans
 Copyright Owner: Graham Edds & Associates
 Date: June 2023

| ITEM DETAILS | |
|--|---|
| NAME | Single storey slab barn with side skillions |
| ADDRESS | 476 Upper Macdonald Road, St Albans |

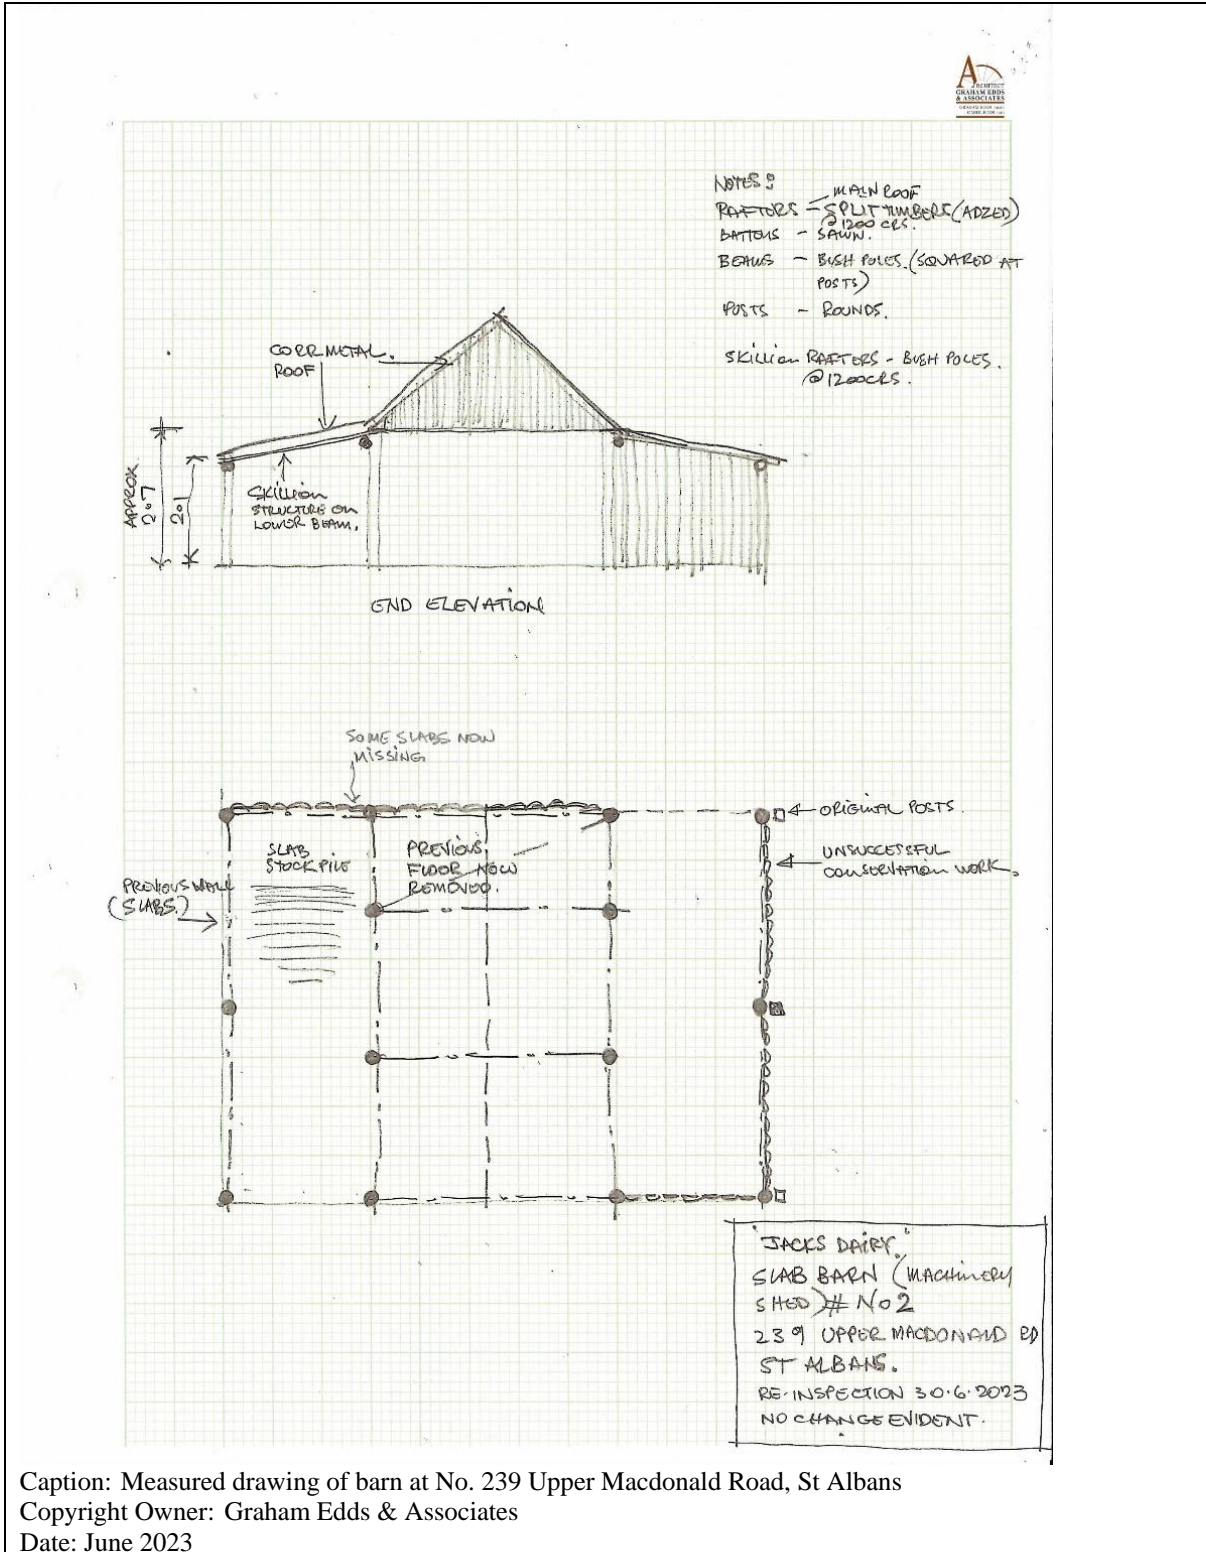
| ITEM DETAILS | |
|--|---|
| MAIN BARN STRUCTURE | Barn is severely dilapidated, roof has partially collapsed and several bays have been removed. Round poles support adzed rectangular longitudinal beams and round cross beams. Condition: Poor Date: late 19 th century |
| ROOF STRUCTURE | Round pole rafters at approx. 30° support square ridge board set at 45°. Gable ends were framed for weatherboard cladding. Condition: Poor – partially collapsed Date: late 19 th century |
| SKILLIONS | Skillion roofs have sawn rectangular rafters. North-western skillion was added to house milking bails, the south-eastern skillion was added in late 20 th century. Condition: Moderate but partially removed. Date: late 19 th century to late 20 th century |

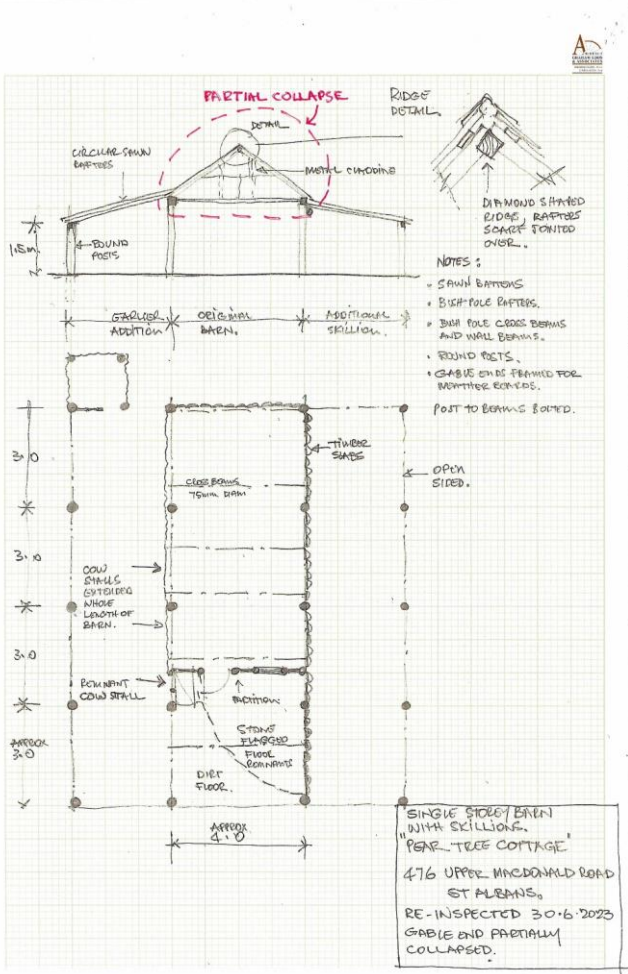
| <p>Notes:</p> <ul style="list-style-type: none"> • SAWN BATTENS • BUSH POLE BATTENS • BUSH POLE CROSS BEAMS AND WALL BEAMS • ROUND PICTS • GABLE ENDS FRAMED FOR BATTERED ROOFED. • POST TO BEAMS BOLTED. <p>Single Storey Barn with Skilions, Pen Tree Cottage 476 UPPER MACDONALD ROAD ST ALBANS RE-INSPECTED 30.6.2023 GABLE END PARTIALLY COLLAPSED.</p> | <p>Caption: Measured drawing of milking shed at No. 476 Upper Macdonald Road, St Albans Copyright Owner: Graham Edds & Associates Date: June 2023</p> |

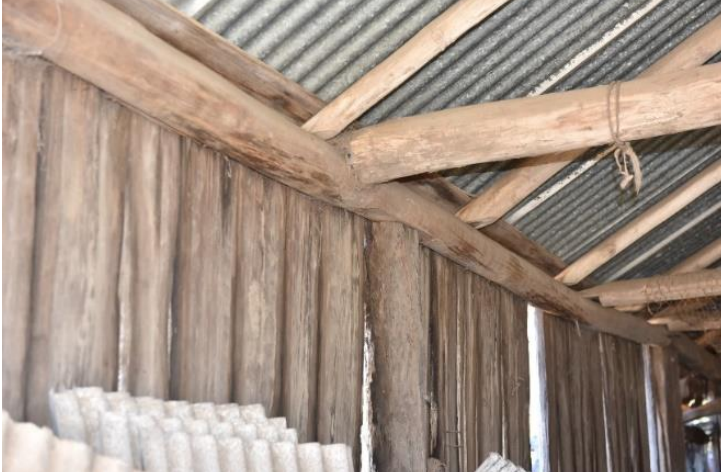
| | <p>Caption: Detail of post/beam junction in barn at 1764 Upper Macdonald Road, Higher Macdonald Photographer: S. Johnson Copyright Owner: Lucas Stapleton Johnson & Partners Pty Ltd Date: June 2023</p> |

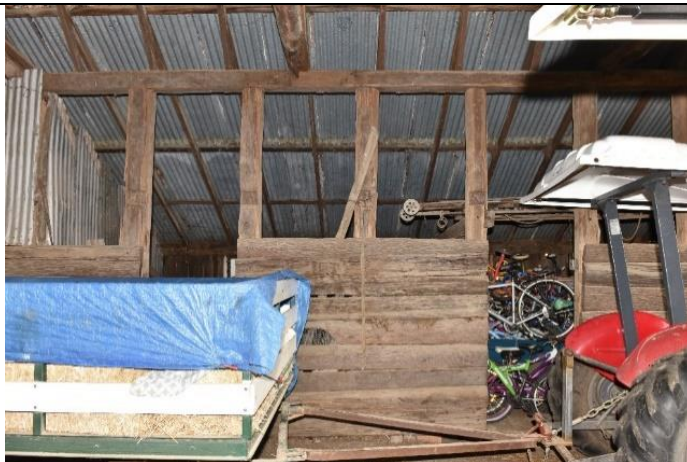
Caption: Detail of posts and beam separating main barn from skillion (note evidence of loft support), No. 496 Wilberforce Road, Wilberforce
 Photographer: S. Johnson
 Copyright Owner: Lucas Stapleton Johnson & Partners
 Date: July 2023

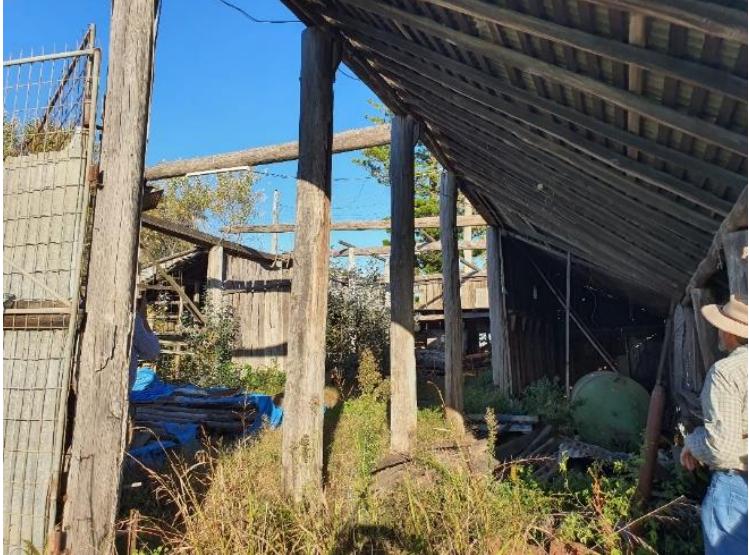
| | <p>Caption: The derelict barn at No. 40 Pitt Street, Windsor. Photographer: K. Denny Copyright Owner: Lucas Stapleton Johnson & Partners Date: May 2023</p> |
