Nominations for State Heritage Listings

Draft State Heritage Nomination Forms – Timber Barns and Outbuildings Study

Name*	Single Storey Town Barn with Skillion and Mezzanine
Other or former names

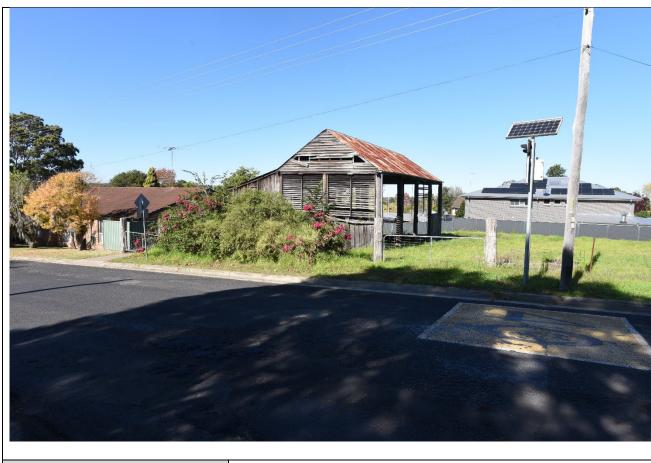
Description*	PERIOD	Late 19 th century
•	CURRENT USE	Vacant
	FORMER USE	Barn
	LOCATION ON SITE:	Close to street frontage on otherwise vacant site
		on north-western fringe of Pitt Town.
	DESCRIPTION	
	MAIN BARN	Large single-storey barn 12 x 6.5m on plan with
	STRUCTURE	round posts up to eaves level (4.8m high)
		mortised and tenoned to square longitudinal
		beams, with round cross beams.
		Condition: Moderate
		Date: late 19 th century
	NO. OF BAYS	Four

Caption*	The barn at No. 26A Buckingham Street, Pitt Town as seen from Buckingham Street.
Date of photograph*	May 2023
Name of photographer*	Kate Denny
Copyright holder, if known	Lucas Stapleton Johnson & Partners

Original or former use/s	Hay barn/drying barn
Any additional comments	It is recommended that the following Site Specific Exemptions be included in the gazettal listing to allow for the continued use of the structure and to support the continuity of the historical practice of undertaking ongoing repairs and maintenance:
	The re-sheeting of roofs with corrugated galvanised steel (not zincalume or Colorbond), and the replacement of or introduction of guttering and down pipes, where this does not involve the removal of or damage to the timber structure (roof framing, beams, joists, posts, slabs or weatherboard cladding).

• All repairs (such as re-fixing and patching) or the replacement of missing, damaged or deteriorated fabric that is beyond further maintenance, which matches the existing fabric in appearance, material and method of affixing, where this does not involve damage to or the removal of adjacent fabric in good condition. The replacement of damaged or deteriorated fabric with new fabric should not result in more than 50% of the original building being replaced.

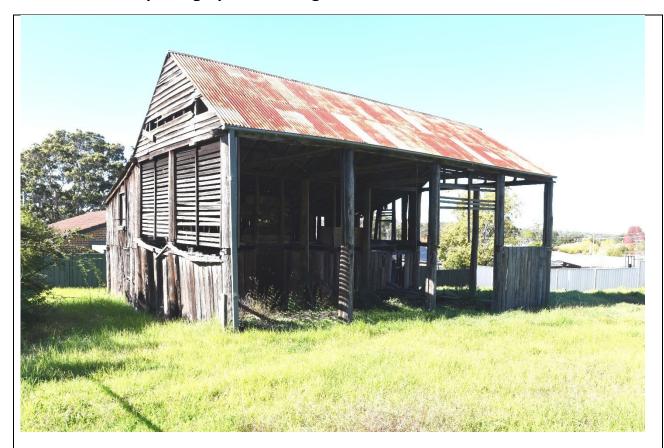
Caption*	West elevation of the town barn at No. 26A Buckingham Street, Pitt Town
Date of photograph*	May 2023
Name of photographer*	Kate Denny
Copyright holder, if known	Lucas Stapleton Johnson & Partners

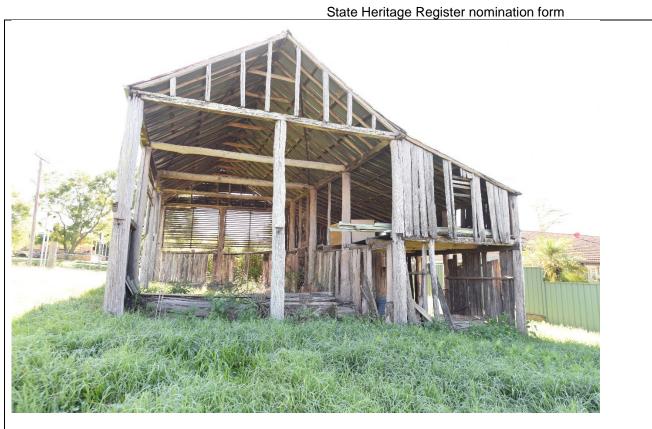
Caption*	South elevation of town barn at No. 26A Buckingham Street, Pitt Town
Date of photograph*	May 2023
Name of photographer*	Kate Denny
Copyright holder, if known	Lucas Stapleton Johnson & Partners

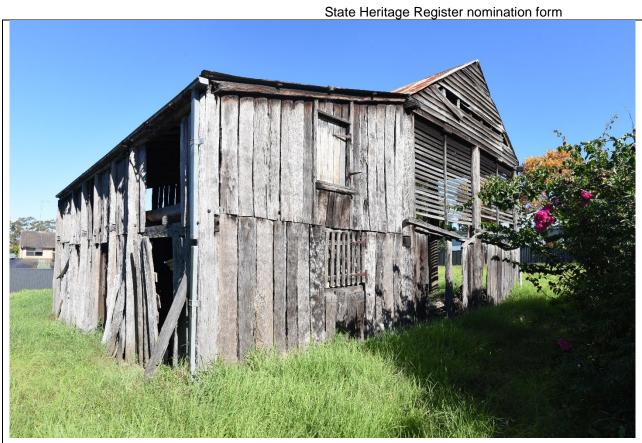
Caption*	North and east elevations of town barn at No. 26A Buckingham Street, Pitt Town.
Date of photograph*	May 2023
Name of photographer*	Kate Denny
Copyright holder, if known	Lucas Stapleton Johnson & Partners

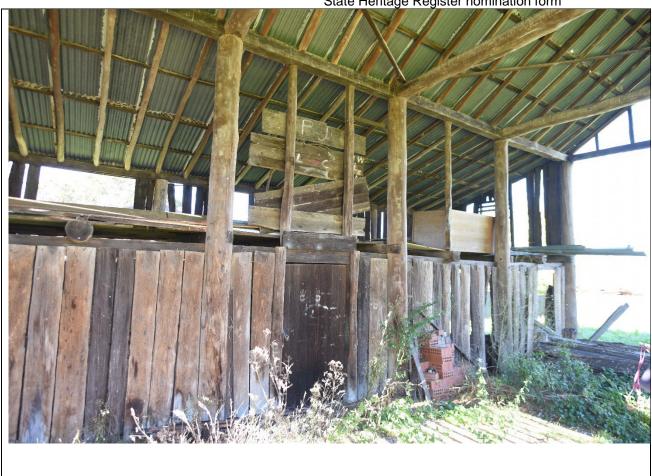
Caption*	Interior view of town barn with mezzanine at No. 26A Buckingham Street, Pitt Town.
Date of photograph*	May 2023
Name of photographer*	Kate Denny
Copyright holder, if known	Lucas Stapleton Johnson & Partners

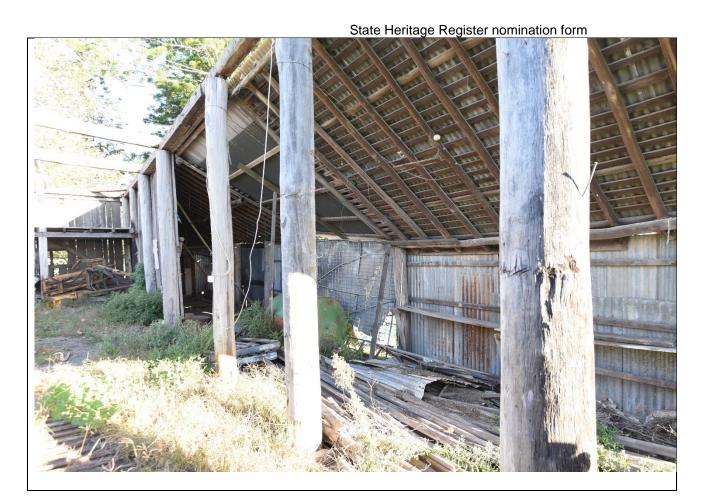
Caption*	Skillion of barn at No. 40 Pitt Street, Windsor.
Date of photograph*	May 2023
Name of photographer*	Kate Denny
Copyright holder, if known	Lucas Stapleton Johnson & Partners Pty ltd

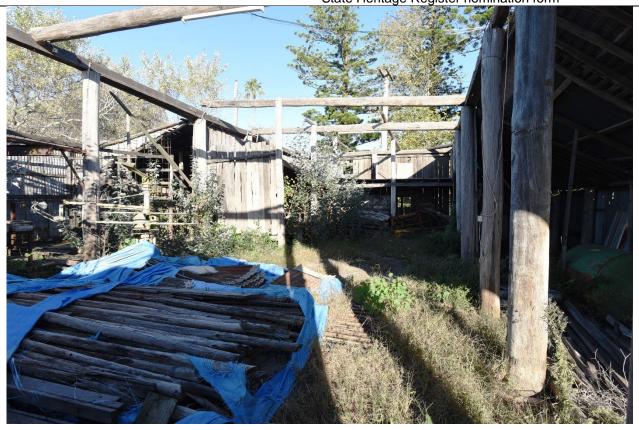
Caption*	Timber framing and corrugated metal sheets stored in barn at No. 40 Pitt Street, Windsor.
Date of photograph*	May 2023
Name of photographer*	Kate Denny
Copyright holder, if known	Lucas Stapleton Johnson & Partners Pty ltd

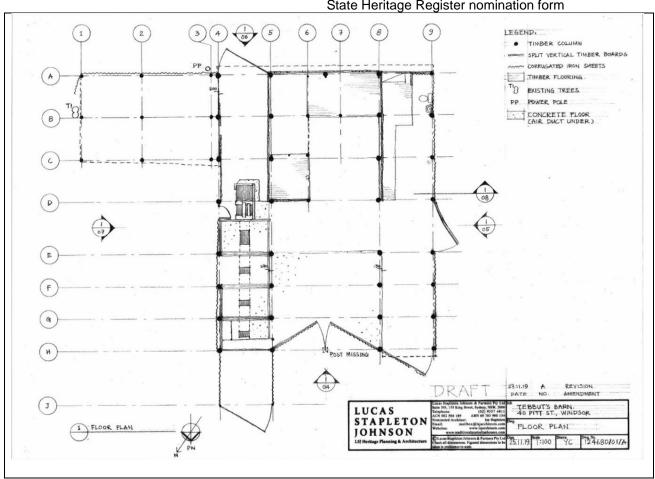
Caption*	Measured drawing of floor plan of barn at No. 40 Pitt Street, Windsor (prior to storm damage)
Date of photograph*	November 2019
Name of photographer*	
Copyright holder, if known	Lucas Stapleton Johnson & Partners

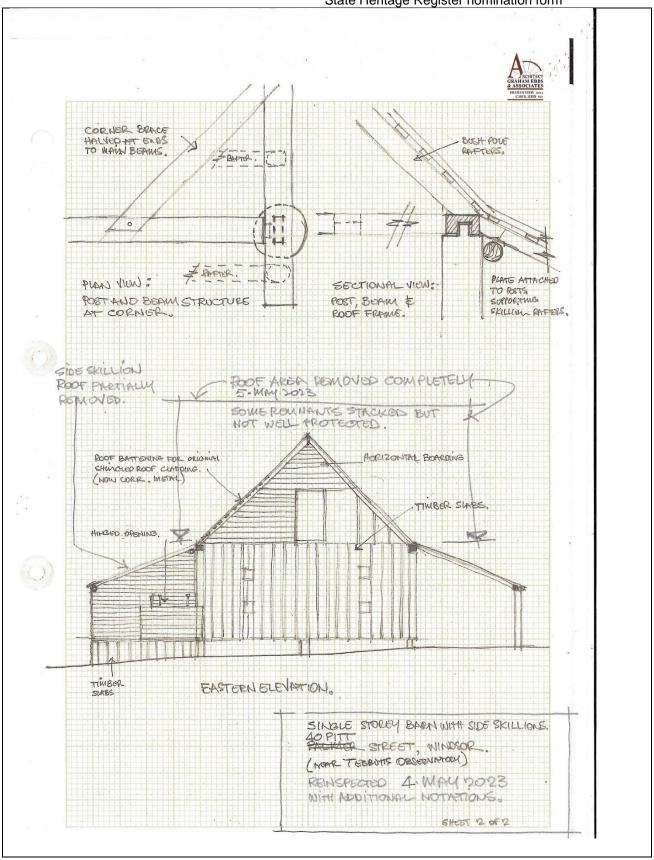
Caption*	Elevation and details of 40 Pitt Street Windsor (prior to storm damage)
Date of photograph*	2010 updated May 2023
Name of photographer*	
Copyright holder, if known	Graham Edds & Associates

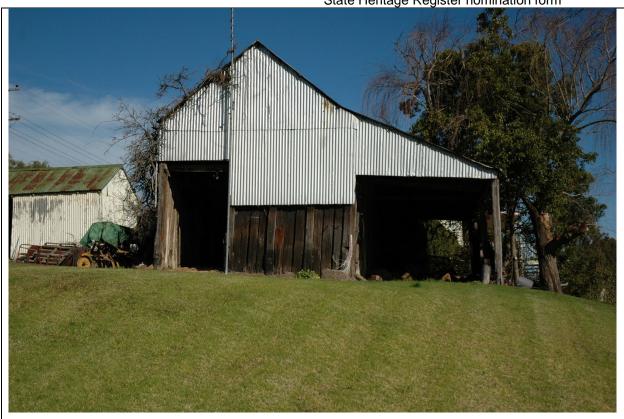
Description*	LOCATION ON SITE:	Close to the road on the north-western fringe of Pitt Town. Access not granted. Barn described based on previous 2010 study and as seen from public road.
	MAIN BARN STRUCTURE	A long single storey barn 12.3 x 5.3m on plan with partial loft and side skillion. Supported on closely spaced squared posts mortised and tenoned to flat longitudinal beams. Condition: Poor – posts rotted through at 2.4m height on south side, top plate is rotten and split, roof is leaking. Barn can still be saved if repairs done soon. Date: Early-19 th century
	NO. OF BAYS	Ten
	ROOF STRUCTURE	Sawn rafters and battens spaced for iron pitched at approximately 30°. Appears to be an early replacement. Condition: Poor Date: mid-19 th century

State Heritage Register nomination form	
	LOFT	Supported on sawn rectangular joists connected to sides of each	
		post. Condition: Poor	
		Date: early-19 th century	
	SKILLION 1	Supported on closely spaced squared posts like the main barn. Longitudinal beam is trenched to accept post tenons and	
		shaped ends of vertical slabs. Constructed together with main body of the barn.	
		Condition: Poor	
		Date: early-19 th century	
	ROOF CLADDING:	Corrugated iron	
		Condition: Poor	
	WALL CLADDING	Date: Unknown Vertical timber slabs between posts, corrugated iron to gable.	
	WALL CLADDING	Condition: Poor	
		Date: early 19 th century?	
	OPENINGS	Central opening between main barn and skillion	
	FLOORING (GROUND)	Earth	
	FLOORING (LOFT)	Timber boarding	
	FLOORING (SKILLION)	Earth	
	INTERNAL STRUCTURE	N/A	
	OTHER (Fixings?)	Mortise and tenon joints, slabs nailed to beams with large spikes.	
Condition of fabric and/or archaeological potential*	Poor condition

Caption*	Barn at No. 134 Bathurst Street, Pitt Town (exterior)
Date of photograph*	2009
Name of photographer*	G. Edds
Copyright holder, if known	Graham Edds & Associates

Integrity / intactness*	Moderate integrity		
Modification dates	Unknown		
When was the last time you inspected the item?	May 2023- external only		
Current use	Hay barn		
Original or former use/s	Hay barn		
Any additional comments	It is recommended that the following Site Specific Exemptions be included in the gazettal listing to allow for the continued use of the structure and to support the continuity of the historical practice of undertaking ongoing repairs and maintenance: • The re-sheeting of roofs with corrugated galvanised steel (not zincalume or Colorbond), and the replacement of or introduction of guttering and down pipes, where this does not involve the removal of or damage to the timber structure (roof framing, beams, joists, posts, slabs or weatherboard cladding). • All repairs (such as re-fixing and patching) or the replacement of missing, damaged or		
	deteriorated fabric that fabric in appearance, ma	is beyond further maintenance, which matches the existing atterial and method of affixing, where this does not involve val of adjacent fabric in good condition. The replacement of

damaged or deteriorated fabric with new fabric should not result in more than 50% of the original building being replaced.

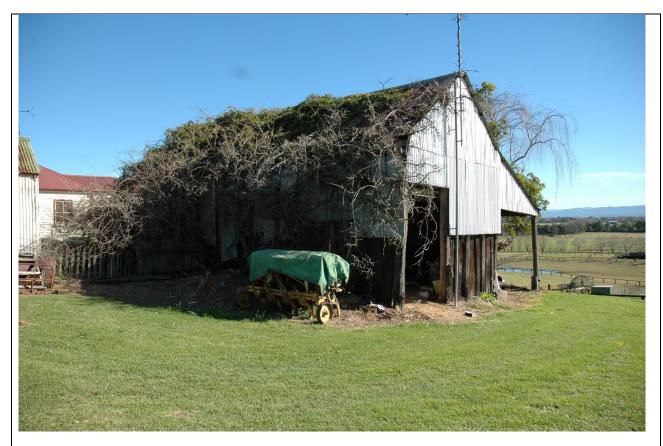
Caption*	Barn at No. 134 Bathurst Street, Pitt Town (interior)
Date of photograph*	2009
Name of photographer*	G. Edds
Copyright holder, if known	Graham Edds & Associates

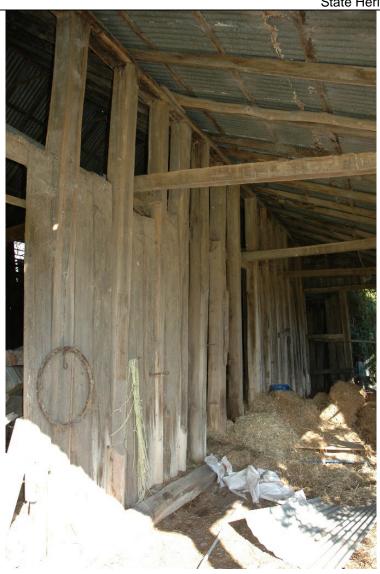
Caption*	Barn at No. 134 Bathurst Street, Pitt Town (interior)
Date of photograph*	2009
Name of photographer*	G. Edds
Copyright holder, if known	Graham Edds & Associates

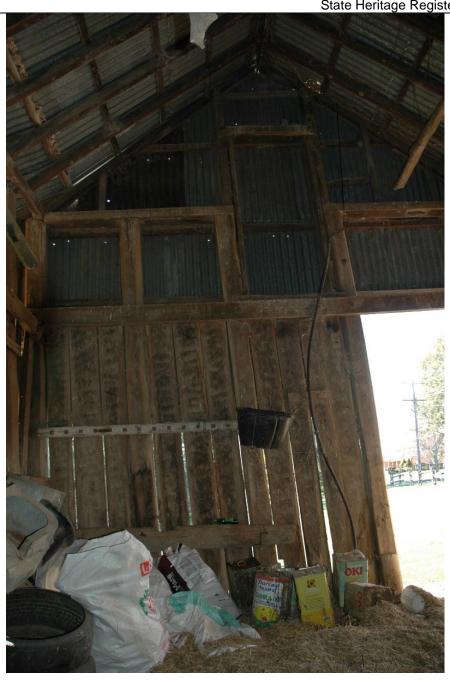
Caption*	Barn at No. 134 Bathurst Street, Pitt Town (interior)
Date of photograph*	2009
Name of photographer*	G. Edds
Copyright holder, if known	Graham Edds & Associates

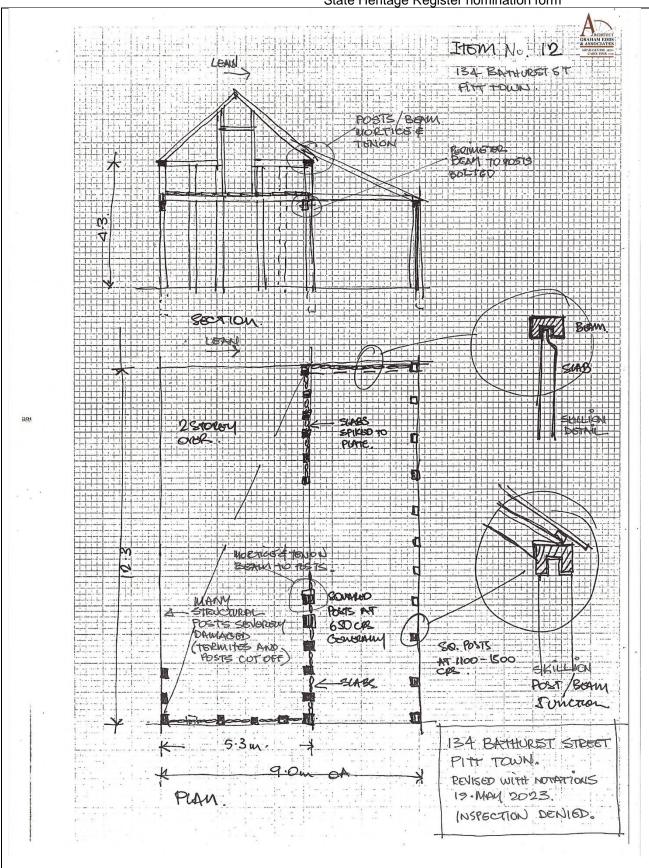
Caption*	Measured drawing of barn at No. 134 Bathurst Street, Pitt Town
Date of photograph*	May 2023
Name of photographer*	G. Edds
Copyright holder, if known	Graham Edds & Associates

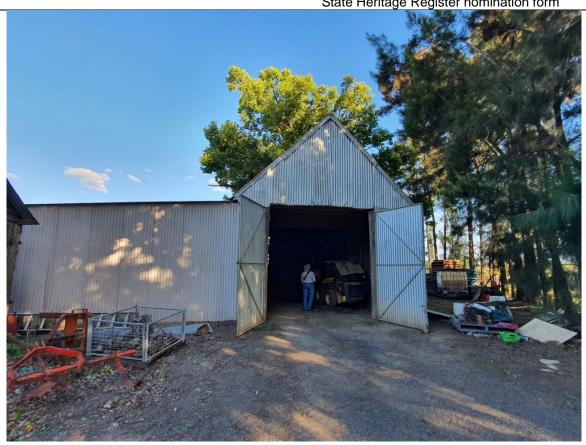
Wooden pegs used to join cross beams to longitudinal				
		beams.				
	LOST	Condition: Good				
	LOFT	Small loft structure supported on pole beams at southern				
		end approximately 1.0m below eaves level. Larger loft at eaves level consisting of closely spaced				
		round beams and loose flooring in centre only.				
		Condition: Good				
	SKILLION 1	Shallow pitched skillion on eastern side				
	SKILLION I	Condition: Good				
		Date: Late 20 th century?				
	ROOF CLADDING:	Corrugated iron short sheets.				
		Condition: Moderate				
	WALL CLADDING	Vertical timber slabs except in central doorways which				
		have timber ventilation grilles over. Exterior now clad in				
		corrugated steel.				
		Condition: Good				
		Date: Early 19 th century?				
	OPENINGS	Central doorways in both sides of barn with ventilated				
		panels over.				
	FLOORING	Earthen				
	(GROUND)					
	FLOORING (LOFT)	Timber boarding				
	FLOORING	Concrete.

(SKILLION)					
	INTERNAL	Large, round, closely spaced beams to loft floors.				
	STRUCTURE					
	OTHER (Fixings?)	Camphor laurel tree at southern end causing damage.				
		Post/ beam pegged mortice and tenon joints				
		Wooden pegs used to join cross beams to longitudinal				
		beams.

Caption*	North elevation of large barn at No. 235 Wilberforce Road, Wilberforce
Date of photograph*	May 2023
Name of photographer*	Kate Denny
Copyright holder, if known	Lucas Stapleton Johnson & Partners

State Heritage Register nomination form
Condition of fabric and/or archaeological potential*	Good condition
Integrity / intactness*	High integrity and intactness
Modification	Addition of large skillion in late 20 th century (?)
dates	Clad in corrugated steel sheets- unknown date
When was the last time you inspected the item?	May 2023
Current use	Machinery store
Original or former use/s	Barn
Any additional comments	 It is recommended that the following Site Specific Exemptions be included in the gazettal listing to allow for the continued use of the structure and to support the continuity of the historical practice of undertaking ongoing repairs and maintenance: The re-sheeting of roofs with corrugated galvanised steel (not zincalume or Colorbond), and the replacement of or introduction of guttering and down pipes, where this does not involve the removal of or damage to the timber structure (roof framing, beams, joists, posts, slabs or weatherboard cladding). All repairs (such as re-fixing and patching) or the replacement of missing, damaged or deteriorated fabric that is beyond further maintenance, which matches the existing fabric in appearance, material and method of affixing, where this does not involve damage to or the removal of adjacent fabric in good condition. The replacement of damaged or deteriorated fabric with new fabric should not result in more than 50% of the original building being replaced.

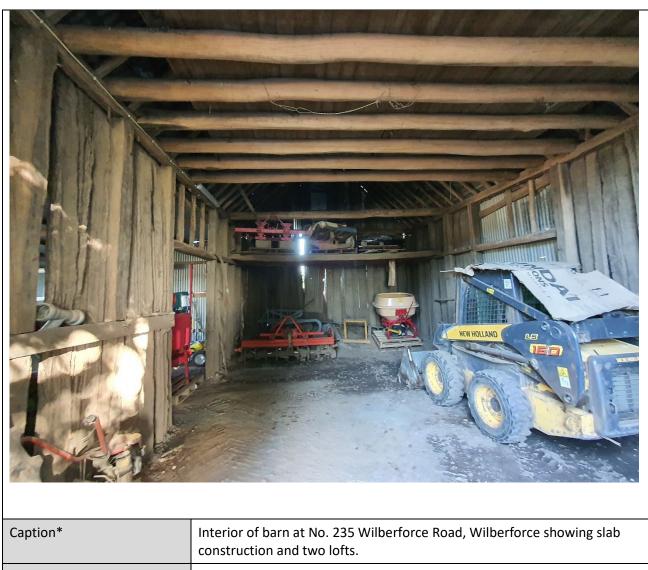
Caption*	Interior of barn at No. 235 Wilberforce Road, Wilberforce showing slab construction and two lofts.
Date of photograph*	May 2023
Name of photographer*	Kate Denny
Copyright holder, if known	Lucas Stapleton Johnson & Partners Pty ltd

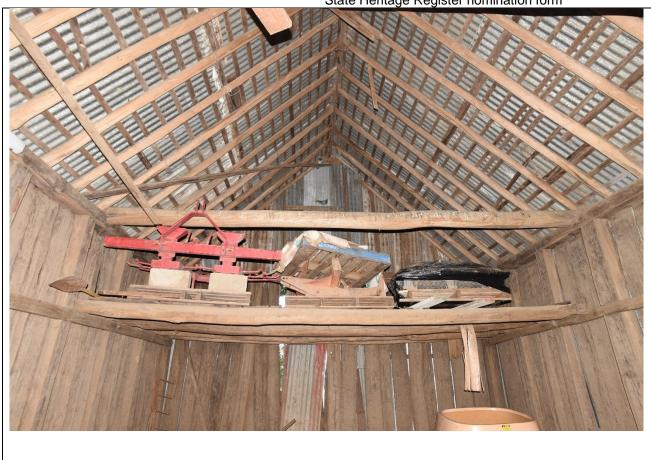
Caption*	Interior of barn at No. 235 Wilberforce Road, Wilberforce showing roof construction with shingle battens and loft
Date of photograph*	May 2023
Name of photographer*	Kate Denny
Copyright holder, if known	Lucas Stapleton Johnson & Partners Pty ltd

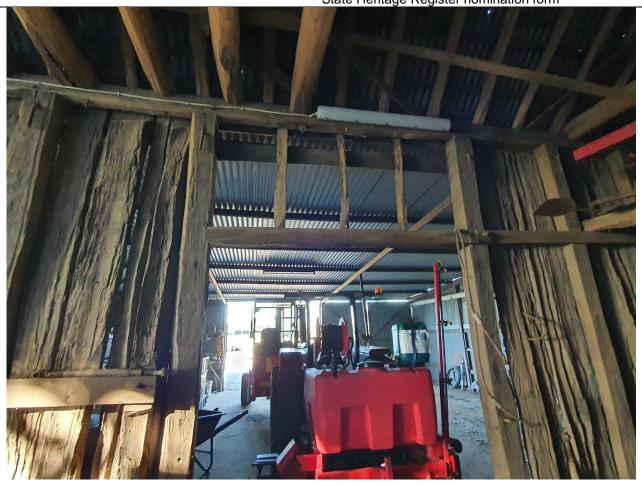
Caption*	Interior of barn at No. 235 Wilberforce Road, Wilberforce looking through to later addition skillion.
Date of photograph*	May 2023
Name of photographer*	Kate Denny
Copyright holder, if known	Lucas Stapleton Johnson & Partners Pty ltd

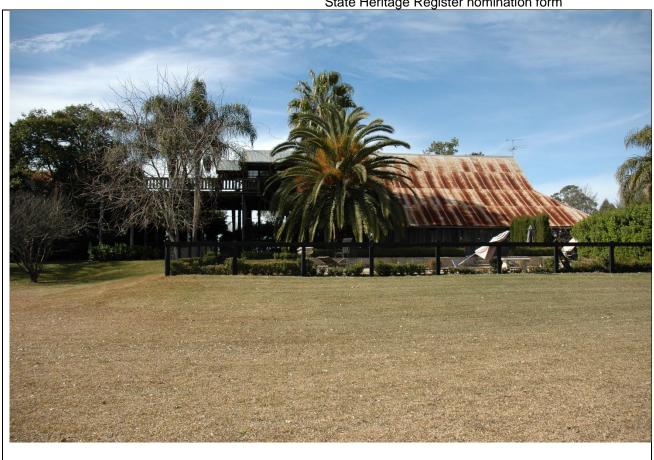
Caption*	Barn A (west elevation) at No. 265 Pitt Town Bottoms Road, Pitt Town Bottoms
Date of photograph*	2009
Name of photographer*	Graham Edds
Copyright holder, if known	Graham Edds & Associates

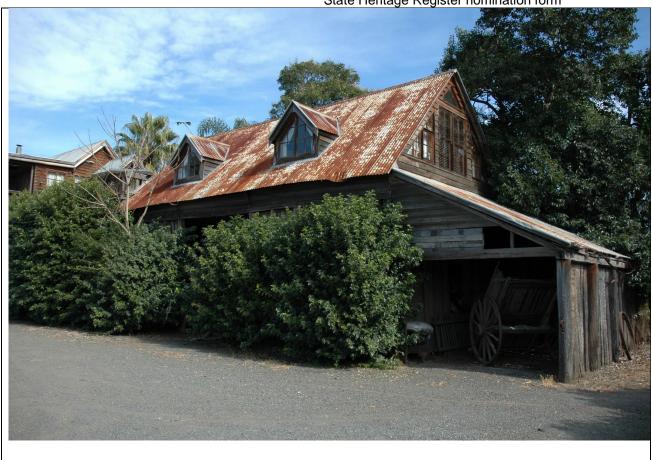
Caption*	Barn B (east and north elevations) at No. 265 Pitt Town Bottoms Road, Pitt Town Bottoms
Date of photograph*	2009
Name of photographer*	Graham Edds
Copyright holder, if known	Graham Edds & Associates

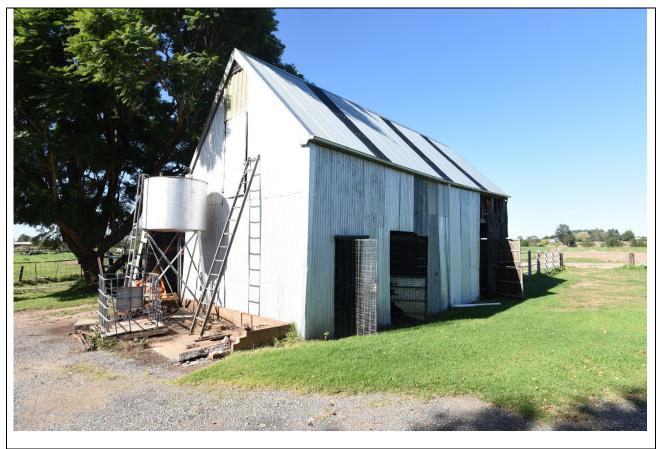
Caption*	Barn A at No. 331 Freemans Reach Road, Freemans Reach
Date of photograph*	May 2023
Name of photographer*	Kate Denny
Copyright holder, if known	Lucas Stapleton Johnson & Partners

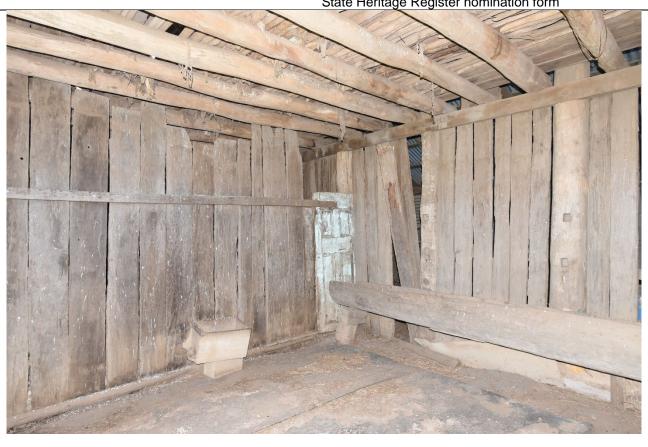
Caption*	Interior of Barn A at No. 331 Freemans Reach Road, Freemans Reach with round timber posts closely spaced, resting on round timber loft floor beams, and hollowed out tree trunk trough. Note remains of maize still attached to loft floor.
Date of photograph*	May 2023
Name of photographer*	Kate Denny
Copyright holder, if known	Lucas Stapleton Johnson & Partners

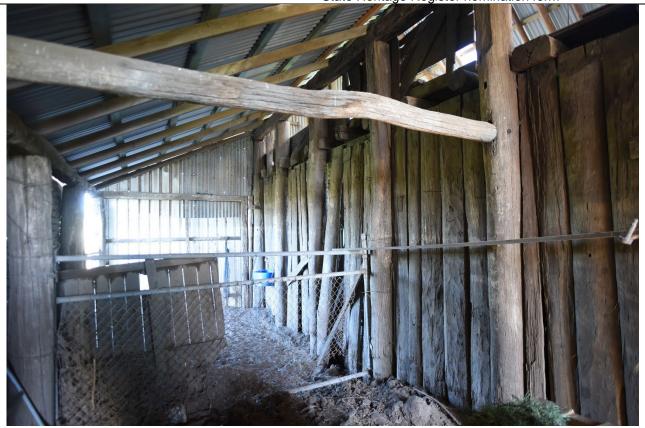
Caption*	Interior of skillion of Barn A at No. 331 Freemans Reach Road, Freemans Reach
Date of photograph*	May 2023
Name of photographer*	Kate Denny
Copyright holder, if known	Lucas Stapleton Johnson & Partners

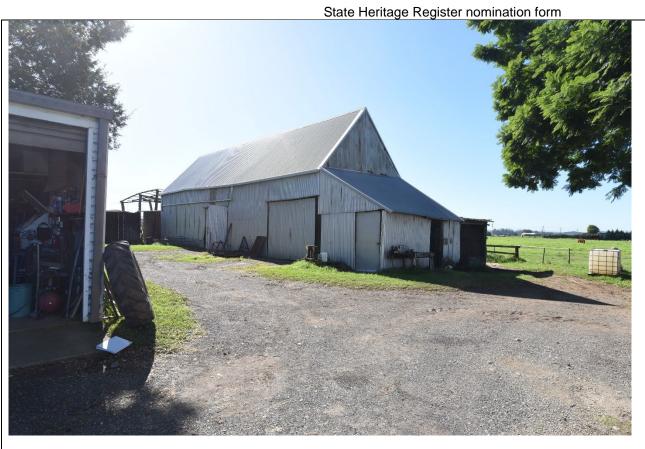
Caption*	Barn B at No. 331 Freemans Reach Road, Freemans Reach
Date of photograph*	May 2023
Name of photographer*	Kate Denny
Copyright holder, if known	Lucas Stapleton Johnson & Partners

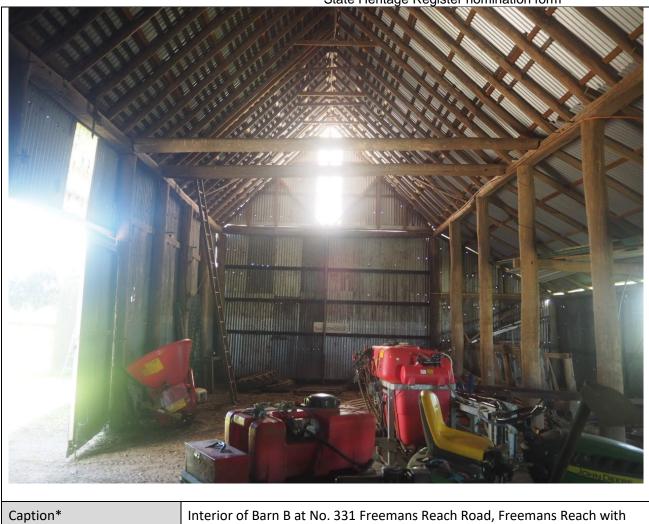
Caption*	Interior of Barn B at No. 331 Freemans Reach Road, Freemans Reach with shingle battens.	
Date of photograph*	May 2023	
Name of photographer*	Kate Denny	
Copyright holder, if known	Lucas Stapleton Johnson & Partners

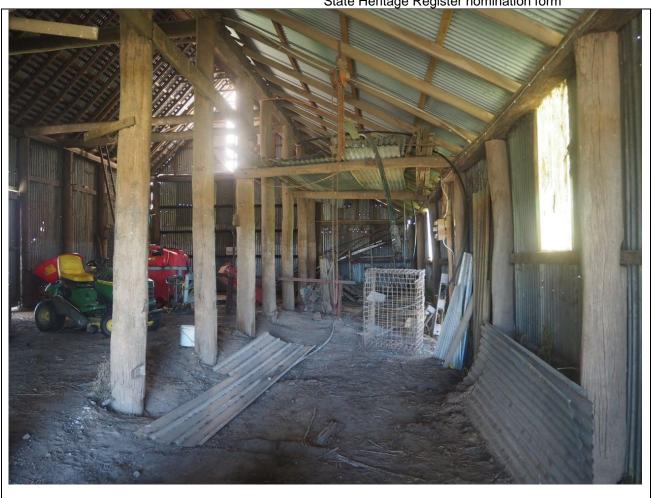
Caption*	Interior of skillion of Barn B at No. 331 Freemans Reach Road, Freemans Reach.	
Date of photograph*	May 2023	
Name of photographer*	Kate Denny	
Copyright holder, if known	Lucas Stapleton Johnson & Partners

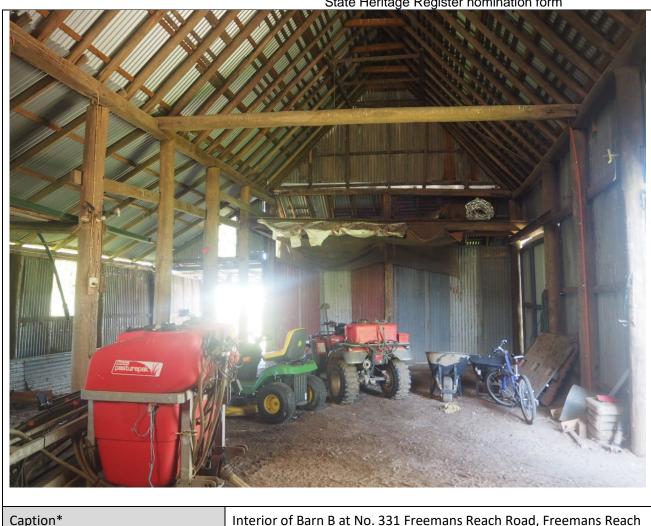
Caption*	Interior of Barn B at No. 331 Freemans Reach Road, Freemans Reach with remains of loft.	
Date of photograph*	May 2023	
Name of photographer*	Kate Denny	
Copyright holder, if known	Lucas Stapleton Johnson & Partners

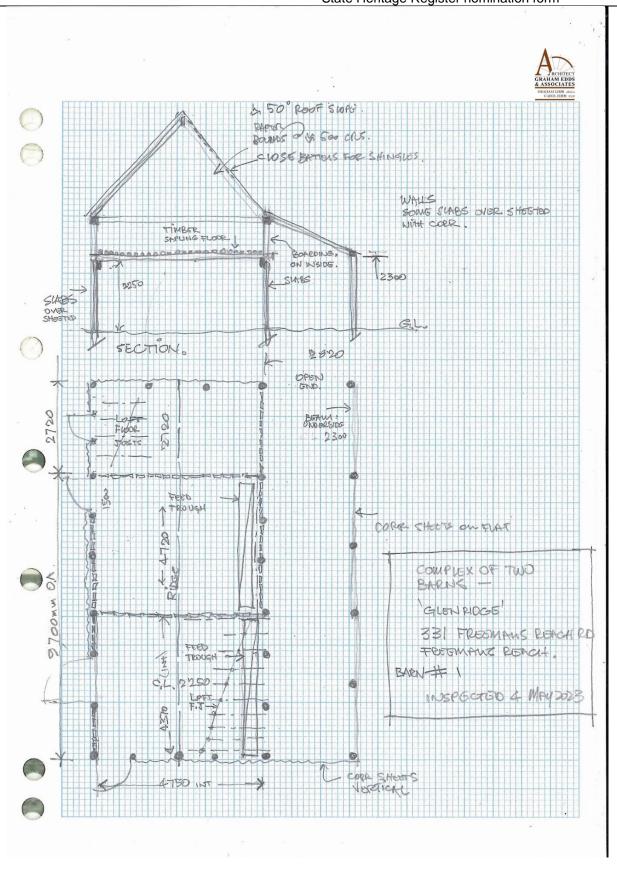
Caption*	Sketch plan of Barn A at No. 331 Freemans Reach Road, Freemans Reach	
Date of photograph*	May 2023	
Name of photographer*	Graham Edds	
Copyright holder, if known	Graham Edds & Associates

State Heritage Register nomination form 1.7 2.25 POST ROOF STRUCTURES WITH SHINGLE BATTONS SIDE SKILLION BAYS. RIDGS X 705 0 40 Ø POSTS MORNES DOUBLE d Tonon 4 PAFFEES 2 4 550 cls COMPLEKOF TWO BARNS . 5340mm OF Side. Skillian GLONRIDGE MR RIDGE 331 FREEMANS REACH 0 ROND FROMMUS REACH 00 BARN # 2 LARGE BARN UNDGE 0 VISITED 4 MAY 2023 BEAM 208 Davels PUATE 175mm DEORS 0 O HOOR 3170 + Beam 200W END SKILLION LIBAO_ Skillio FURT ROOF 6000 min O.A.

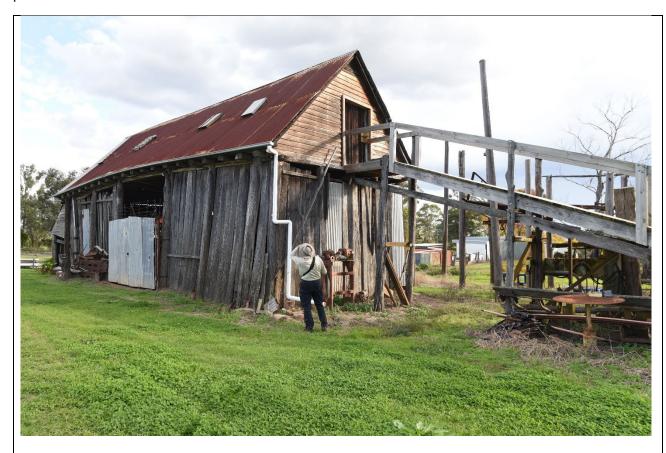
Caption*	The barn at No. 353 Pitt Town Bottoms Road, Pitt Town Bottoms
Date of photograph*	May 2023
Name of photographer*	Kate Denny
Copyright holder, if known	Lucas Stapleton Johnson & Partners

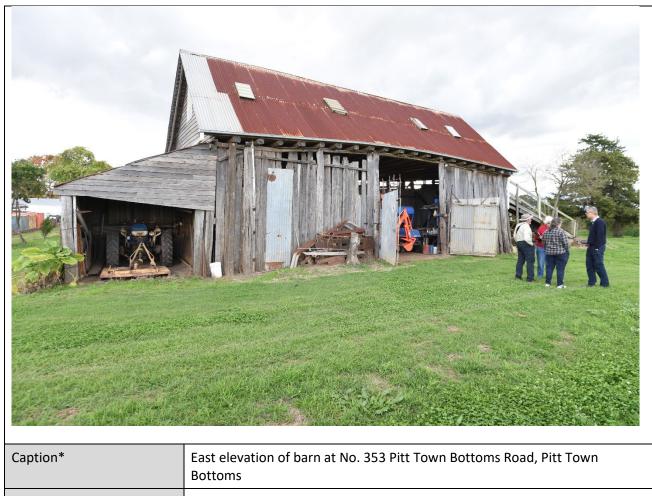
Caption*	East elevation of barn at No. 353 Pitt Town Bottoms Road, Pitt Town Bottoms
Date of photograph*	May 2023
Name of photographer*	Sean Johnson
Copyright holder, if known	Lucas Stapleton Johnson & Partners Pty ltd
