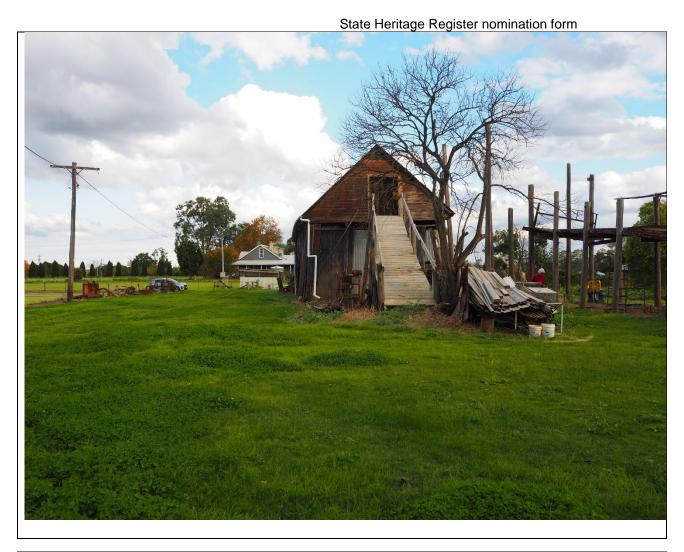
Caption*	North elevation of barn and entry ramp to loft level at No. 353 Pitt Town Bottoms Road, Pitt Town Bottoms	
Date of photograph*	May 2023	
Name of photographer*	Sean Johnson	
Copyright holder, if known	Lucas Stapleton Johnson & Partners Pty ltd

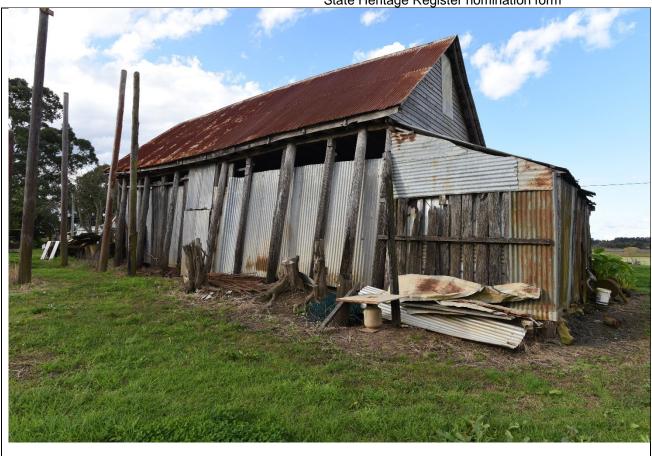
Caption*	West elevation of barn at No. 353 Pitt Town Bottoms Road, Pitt Town Bottoms	
Date of photograph*	May 2023	
Name of photographer*	Sean Johnson	
Copyright holder, if known	Lucas Stapleton Johnson & Partners Pty ltd

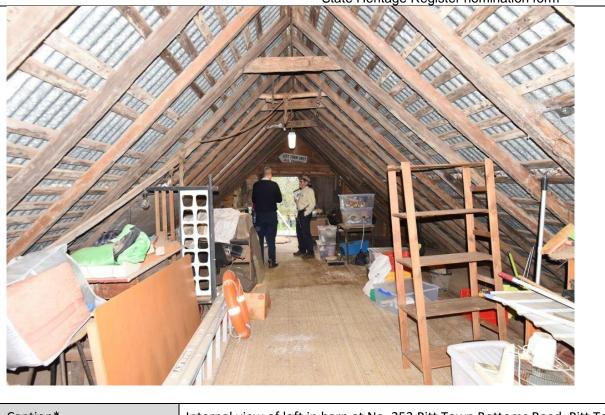
Caption*	Internal view of loft in barn at No. 353 Pitt Town Bottoms Road, Pitt Town Bottoms	
Date of photograph*	May 2023	
Name of photographer*	Sean Johnson	
Copyright holder, if known	Lucas Stapleton Johnson & Partners Pty ltd

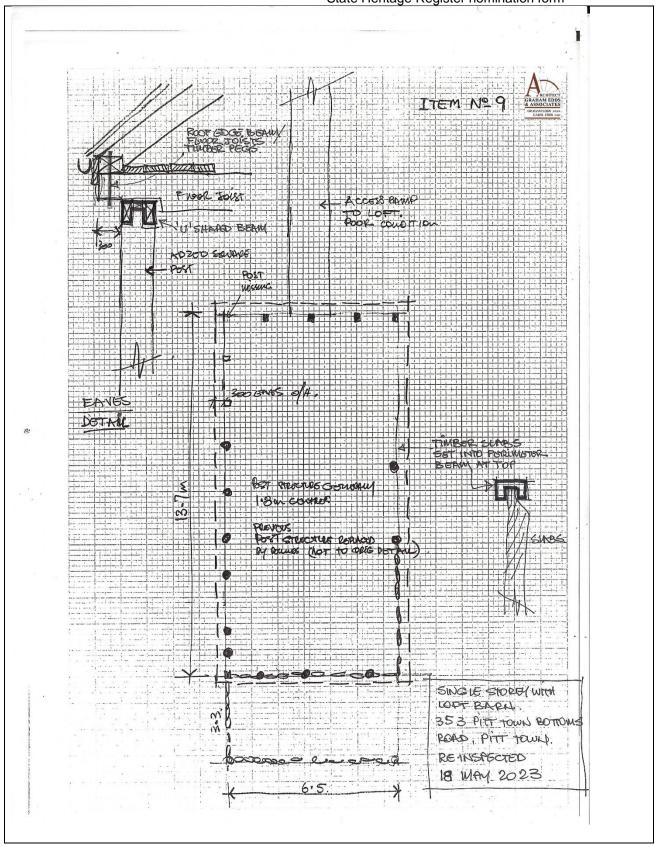
Caption*	Sketch plan of barn at No. 353 Pitt Town Bottoms Road, Pitt Town Bottoms	
Date of photograph*	May 2023	
Name of photographer*	Graham Edds	
Copyright holder, if known	Graham Edds & Associates

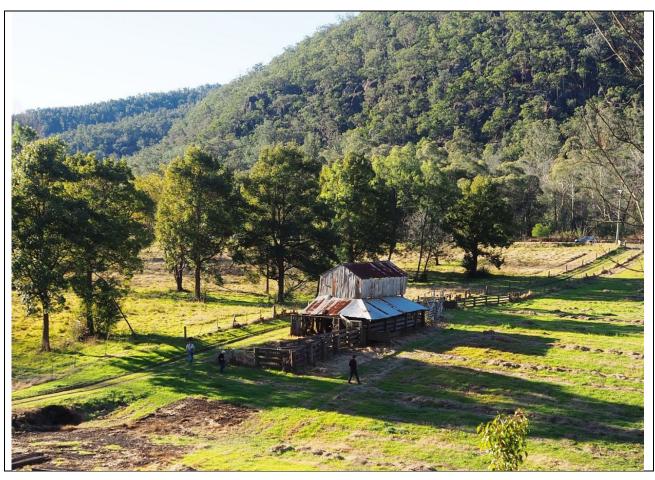
Caption*	The two storey barn with skillions at No. 995 Upper Colo Road, Upper Colo
Date of photograph*	June 2023
Name of photographer*	Kate Denny
Copyright holder, if known	Lucas Stapleton Johnson & Partners

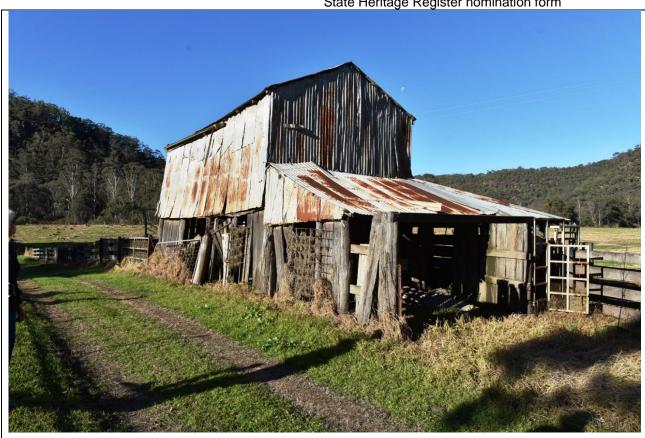
Caption*	North and west elevations of barn at No. 995 Upper Colo Road, Upper Colo
Date of photograph*	June 2023
Name of photographer*	Sean Johnson
Copyright holder, if known	Lucas Stapleton Johnson & Partners Pty ltd

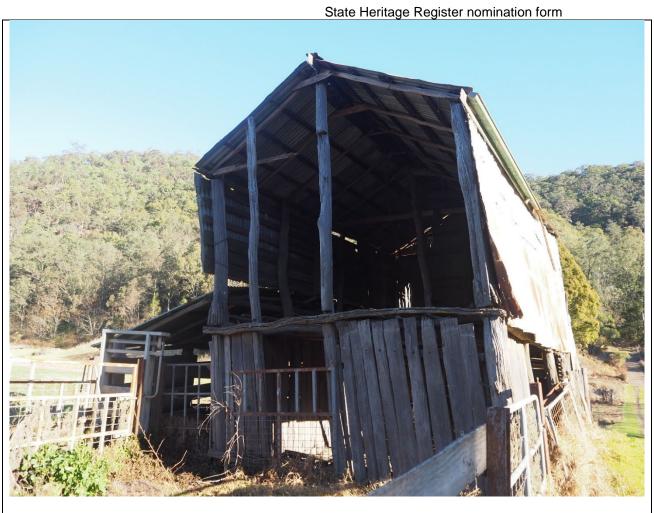
Caption*	East elevation of barn at No. 995 Upper Colo Road, Upper Colo
Date of photograph*	June 2023
Name of photographer*	Sean Johnson
Copyright holder, if known	Lucas Stapleton Johnson & Partners Pty ltd

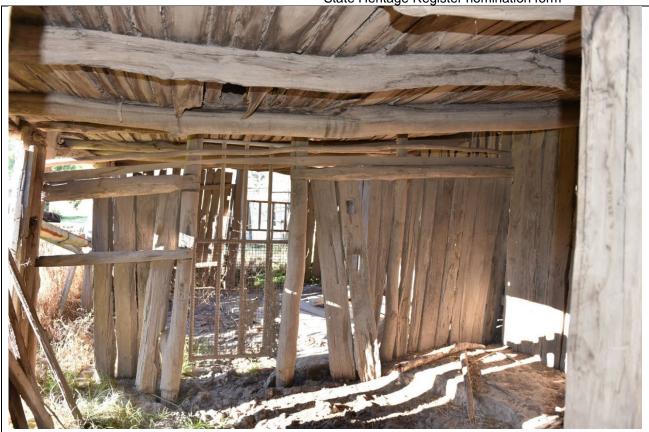
Caption*	Ground level interior of barn at No. 995 Upper Colo Road, Upper Colo	
Date of photograph*	June 2023	
Name of photographer*	Sean Johnson	
Copyright holder, if known	Lucas Stapleton Johnson & Partners Pty ltd

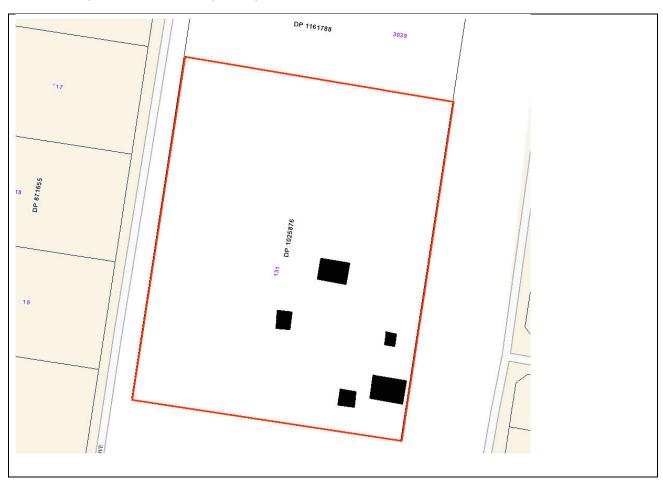
Source of map or plan	SixMaps, annotated by LSJ Architects, 2024
Description of the boundary, if required	Allotment boundaries of Lot 131 DP 1025876

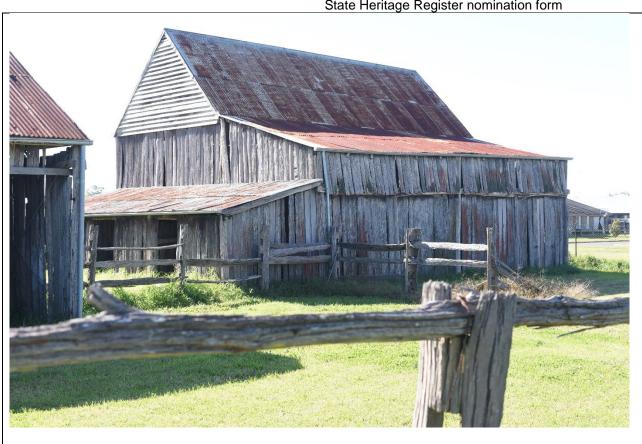
Caption*	Barn A at Bona Vista complex
Date of photograph*	May 2023
Name of photographer*	S. Johnson
Copyright holder, if known	Lucas Stapleton Johnson & Partners

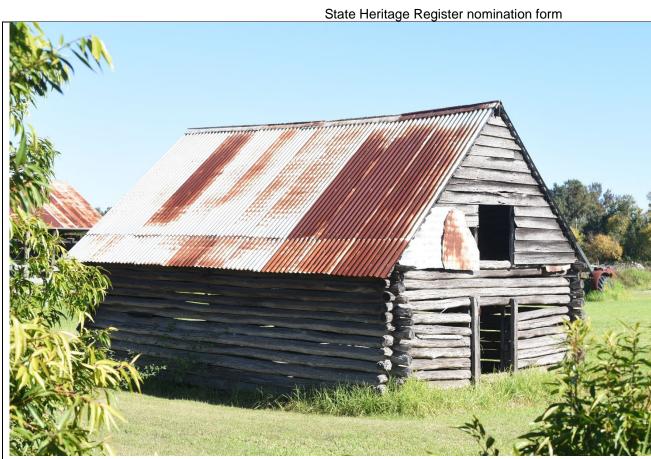
Caption*	Barn B at Bona Vista complex
Date of photograph*	May 2023
Name of photographer*	S. Johnson
Copyright holder, if known	Lucas Stapleton Johnson & Partners

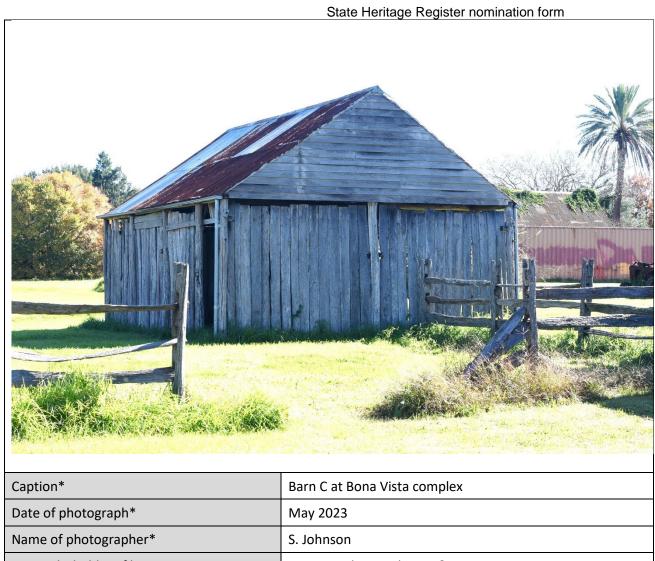
Caption*	Barn C at Bona Vista complex
Date of photograph*	May 2023
Name of photographer*	S. Johnson
Copyright holder, if known	Lucas Stapleton Johnson & Partners

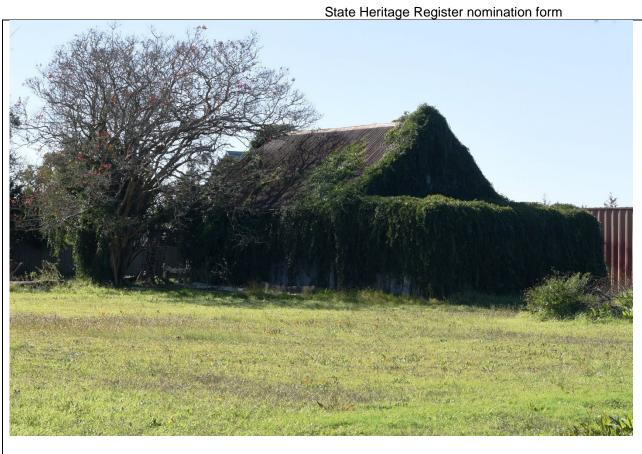
Caption*	Barn D at Bona Vista complex
Date of photograph*	May 2023
Name of photographer*	S. Johnson
Copyright holder, if known	Lucas Stapleton Johnson & Partners

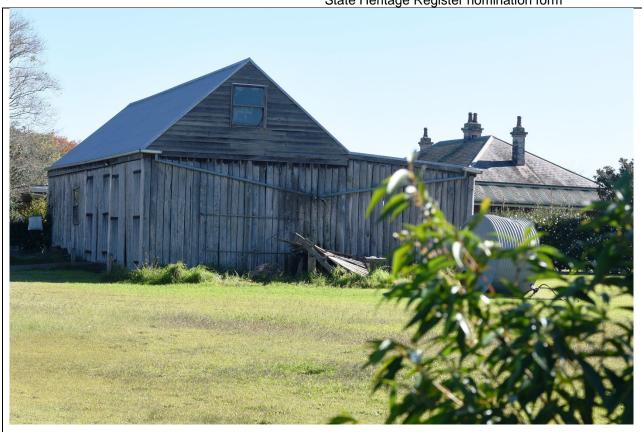
Caption*	Barn E at Bona Vista complex
Date of photograph*	May 2023
Name of photographer*	S. Johnson
Copyright holder, if known	Lucas Stapleton Johnson & Partners

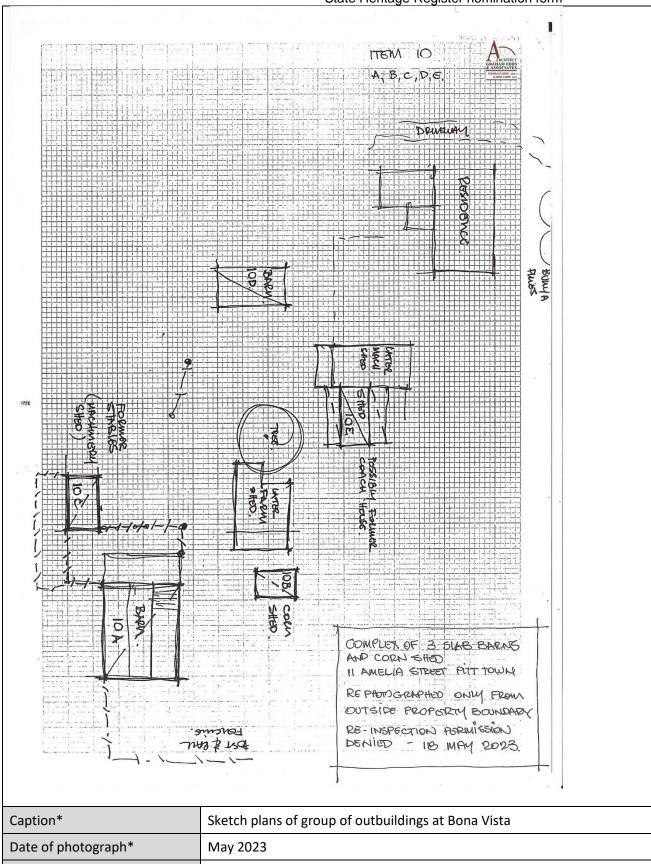
Caption*	Sketch plans of group of outbuildings at Bona Vista		
Date of photograph*	May 2023		
Name of photographer*	G. Edds		
Copyright holder, if known	Graham Edds & Associates

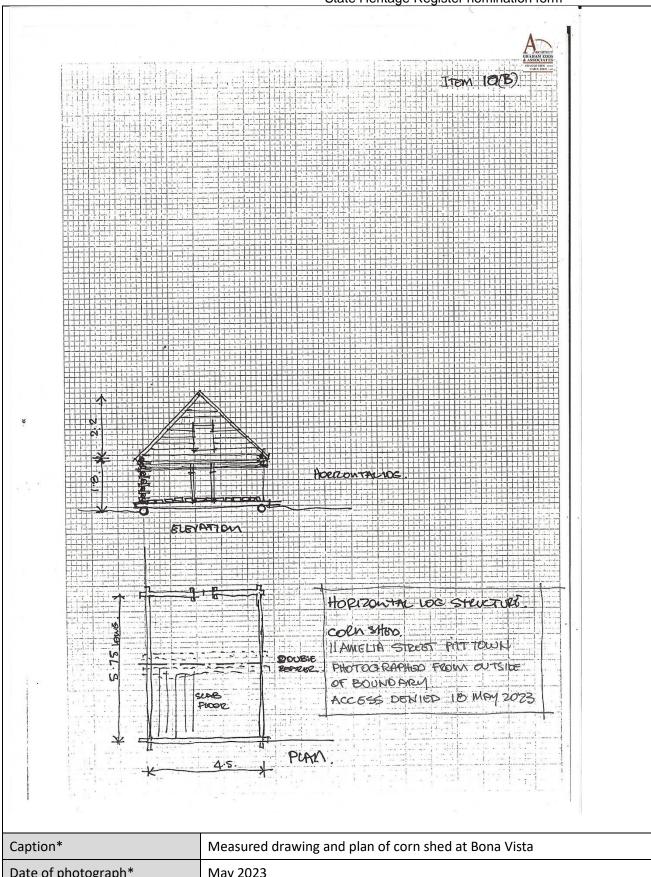
Caption*	Measured drawing and plan of corn shed at Bona Vista		
Date of photograph*	May 2023		
Name of photographer*	G. Edds		
Copyright holder, if known	Graham Edds & Associates

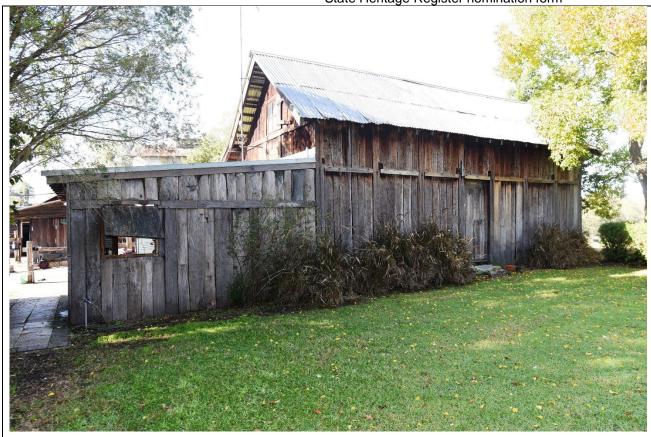
Caption*	West elevation of barn at 143 Threlkeld Drive, Cattai
Date of photograph*	May 2023
Name of photographer*	S. Johnson
Copyright holder, if known	Lucas Stapleton Johnson & Partners Pty Ltd

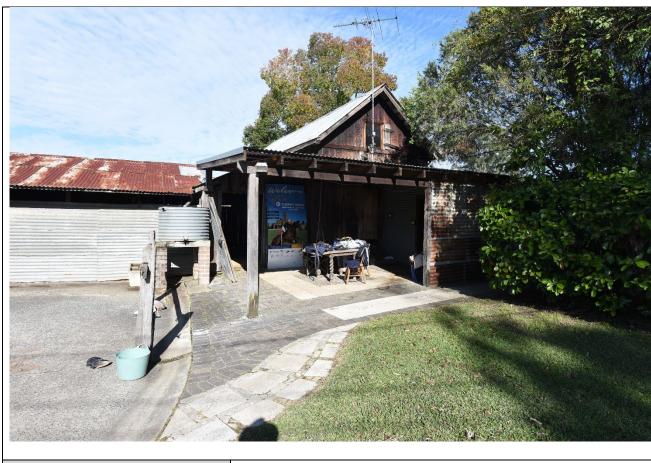
Caption*	North elevation of barn at 143 Threlkeld Drive, Cattai
Date of photograph*	May 2023
Name of photographer*	S. Johnson
Copyright holder, if known	Lucas Stapleton Johnson & Partners Pty Ltd

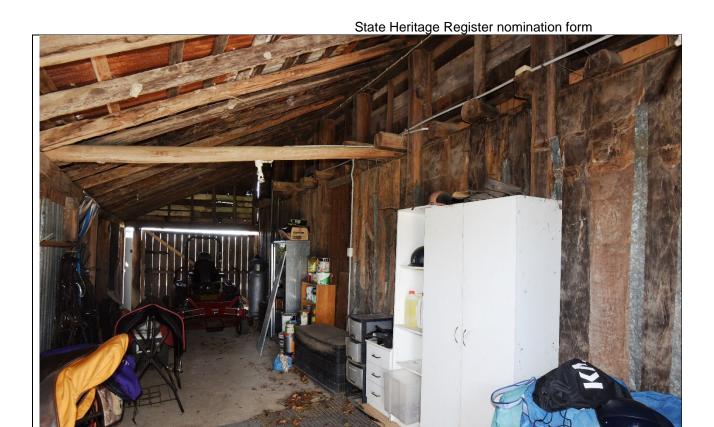
Caption*	Interior view of skillion of barn at 143 Threlkeld Drive, Cattai
Date of photograph*	May 2023
Name of photographer*	S. Johnson
Copyright holder, if known	Lucas Stapleton Johnson & Partners Pty Ltd

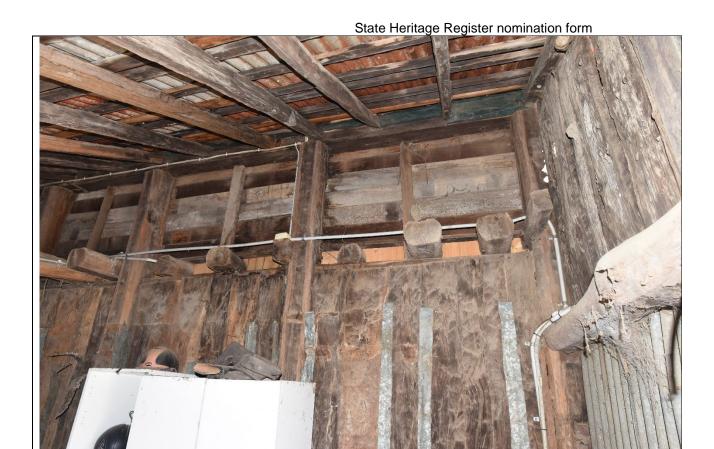
Caption*	Detail of timber construction of skillion of barn at 143 Threlkeld Drive, Cattai
Date of photograph*	May 2023
Name of photographer*	S. Johnson
Copyright holder, if known	Lucas Stapleton Johnson & Partners Pty Ltd

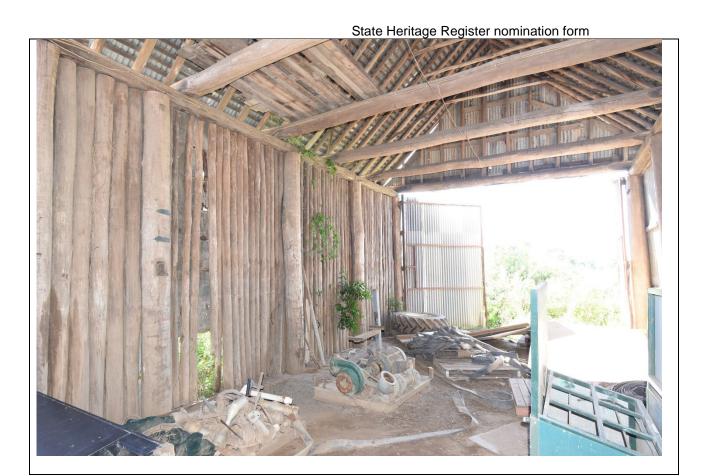
Caption*	Interior view of barn at 56 Freemans Reach Road, Freemans Reach
Date of photograph*	May 2023
Name of photographer*	Sean Johnson
Copyright holder, if known	Lucas Stapleton Johnson & Partners Pty ltd

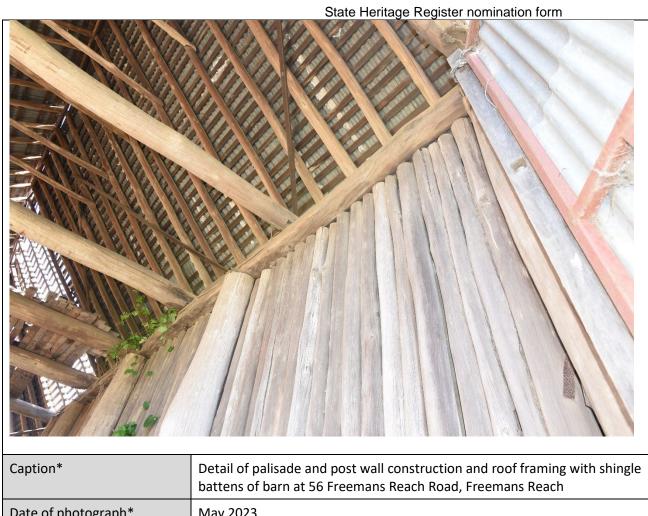
Caption*	Detail of palisade and post wall construction and roof framing with shingle battens of barn at 56 Freemans Reach Road, Freemans Reach
Date of photograph*	May 2023
Name of photographer*	Sean Johnson
Copyright holder, if known	Lucas Stapleton Johnson & Partners Pty ltd

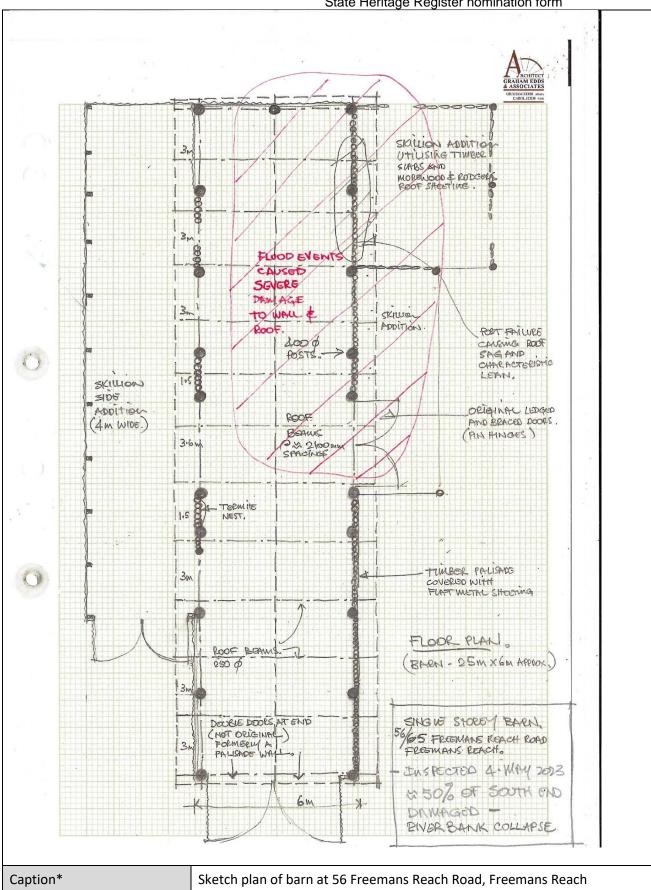
Caption*	Sketch plan of barn at 56 Freemans Reach Road, Freemans Reach
Date of photograph*	May 2023
Name of photographer*	Graham Edds
Copyright holder, if known	Graham Edds & Associates

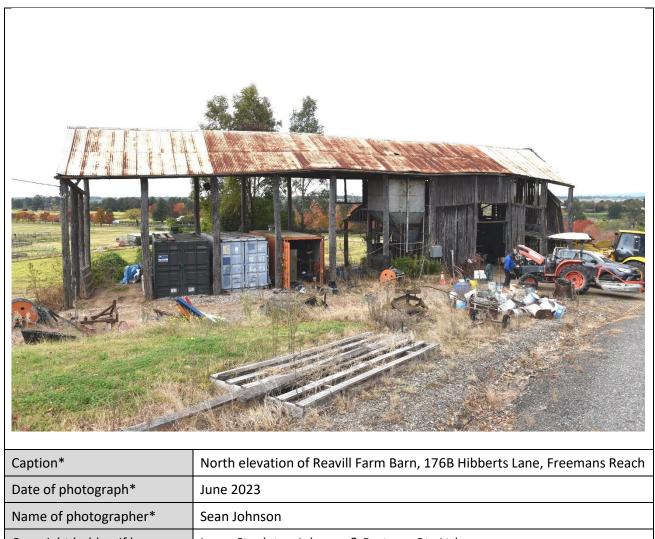
Caption*	North elevation of Reavill Farm Barn, 176B Hibberts Lane, Freemans Reach
Date of photograph*	June 2023
Name of photographer*	Sean Johnson
Copyright holder, if known	Lucas Stapleton Johnson & Partners Pty Ltd

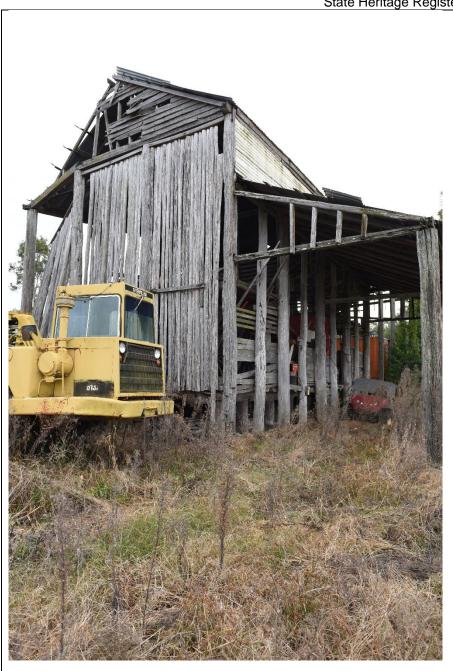
Caption*	West elevation of Reavill Farm Barn, 176B Hibberts Lane, Freemans Reach
Date of photograph*	June 2023
Name of photographer*	Sean Johnson
Copyright holder, if known	Lucas Stapleton Johnson & Partners Pty Ltd

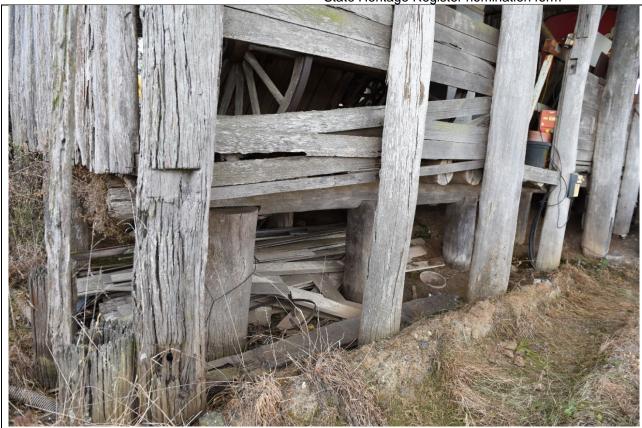
Caption*	Detail of ground floor structure of Reavill Farm Barn
Date of photograph*	June 2023
Name of photographer*	Sean Johnson
Copyright holder, if known	Lucas Stapleton Johnson & Partners Pty Ltd

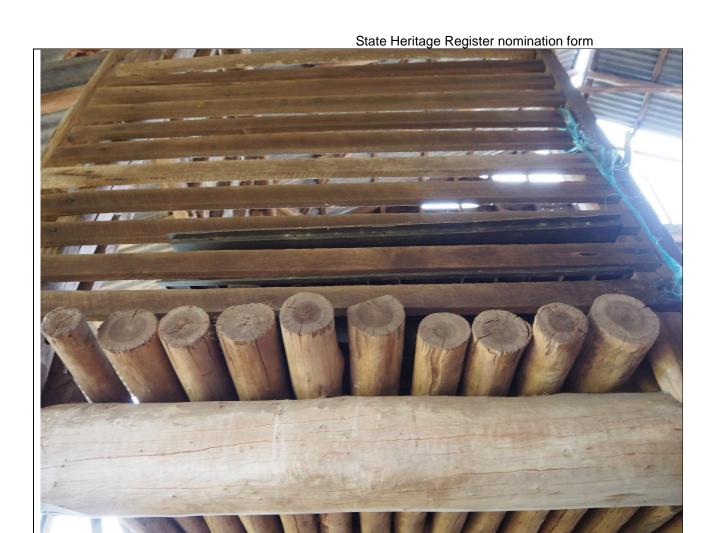
Caption*	Detail of underside of upper floor of Reavill Farm Barn
Date of photograph*	June 2023
Name of photographer*	Sean Johnson
Copyright holder, if known	Lucas Stapleton Johnson & Partners Pty Ltd

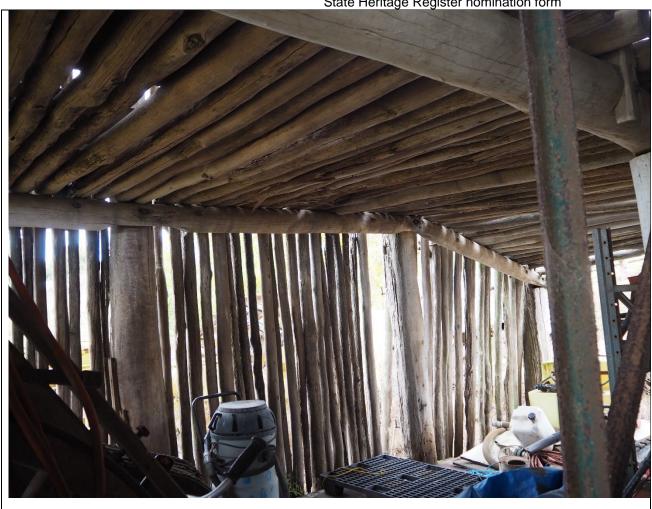
Caption*	Detail of palisade wall cladding and flooring to loft of Reavill Farm Barn
Date of photograph*	June 2023
Name of photographer*	Sean Johnson
Copyright holder, if known	Lucas Stapleton Johnson & Partners Pty Ltd

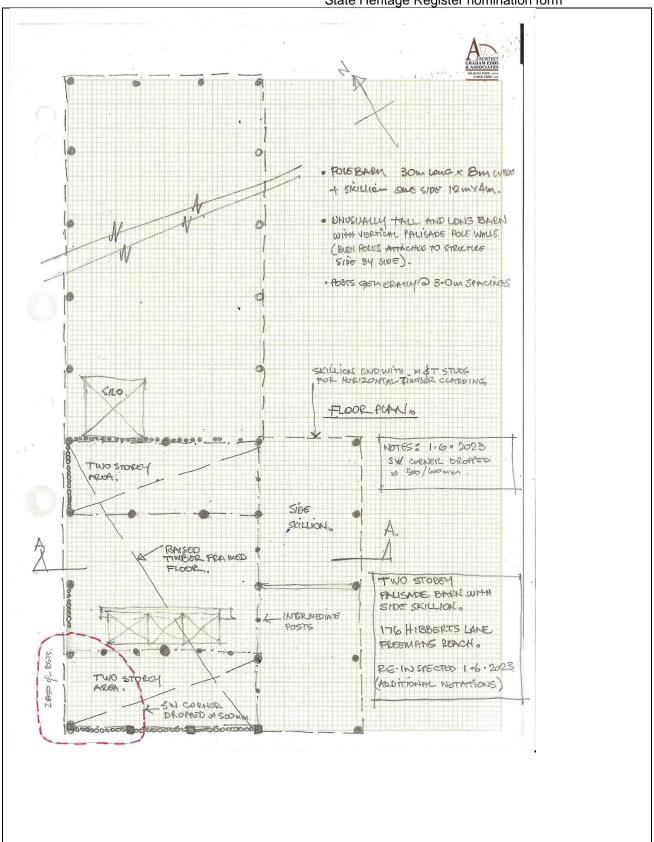
Caption*	Sketch plan of barn at 176B Hibberts Lane, Freemans Reach
Date of photograph*	June 2023
Name of photographer*	Graham Edds
Copyright holder, if known	Graham Edds & Associates

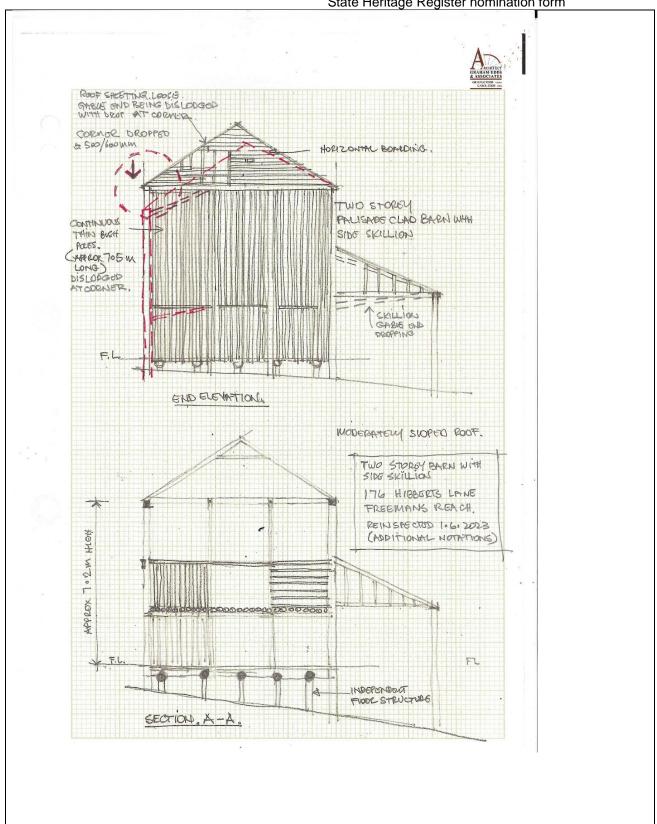
Caption*	Sketch elevations of barn at 176B Hibberts Lane, Freemans Reach
Date of photograph*	June 2023
Name of photographer*	Graham Edds
Copyright holder, if known	Graham Edds & Associates

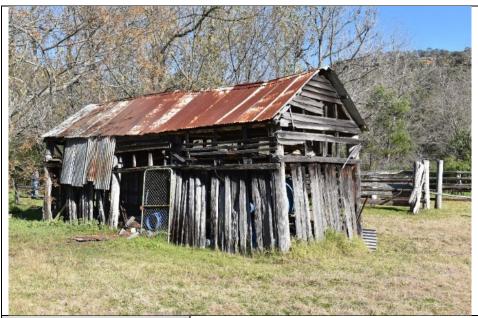
Caption*	Barn 4 from the east
Date of photograph*	30th June 2023
Name of photographer*	Sean Johnson
Copyright holder, if known	Lucas Stapleton Johnson & Partners Pty Ltd

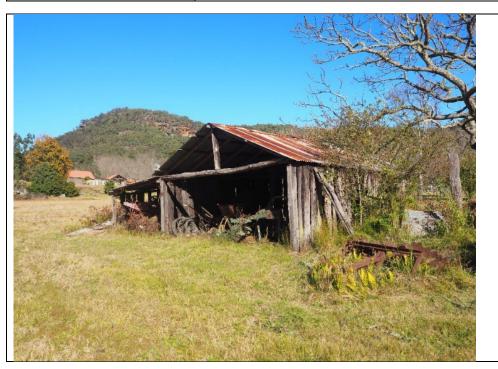
Caption*	Barn 5 from the north-east
Date of photograph*	30th June 2023
Name of photographer*	Sean Johnson
Copyright holder, if known	Lucas Stapleton Johnson & Partners Pty Ltd

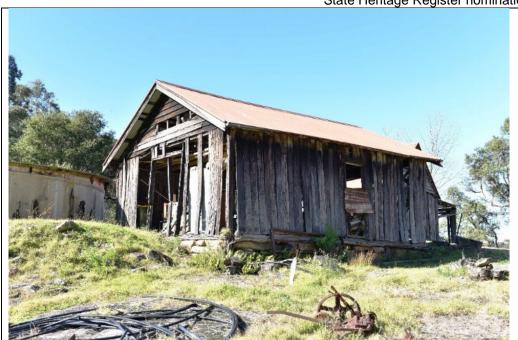
Caption*	Barn 7 from the north
Date of photograph*	30th June 2023
Name of photographer*	Sean Johnson
Copyright holder, if known	Lucas Stapleton Johnson & Partners Pty Ltd

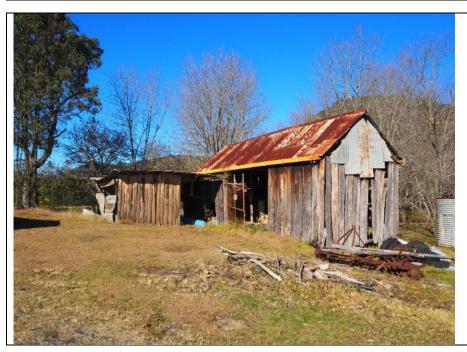
Caption*	Barn 8 from the north
Date of photograph*	30th June 2023
Name of photographer*	Sean Johnson
Copyright holder, if known	Lucas Stapleton Johnson & Partners Pty Ltd

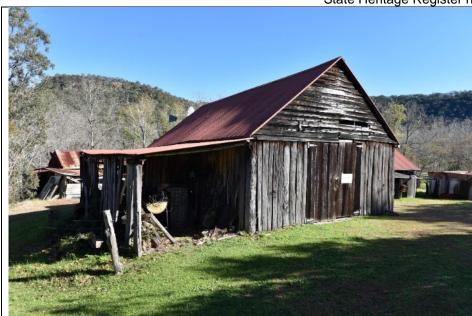
Caption*	Barn 9 from the north
Date of photograph*	30th June 2023
Name of photographer*	Sean Johnson
Copyright holder, if known	Lucas Stapleton Johnson & Partners Pty Ltd

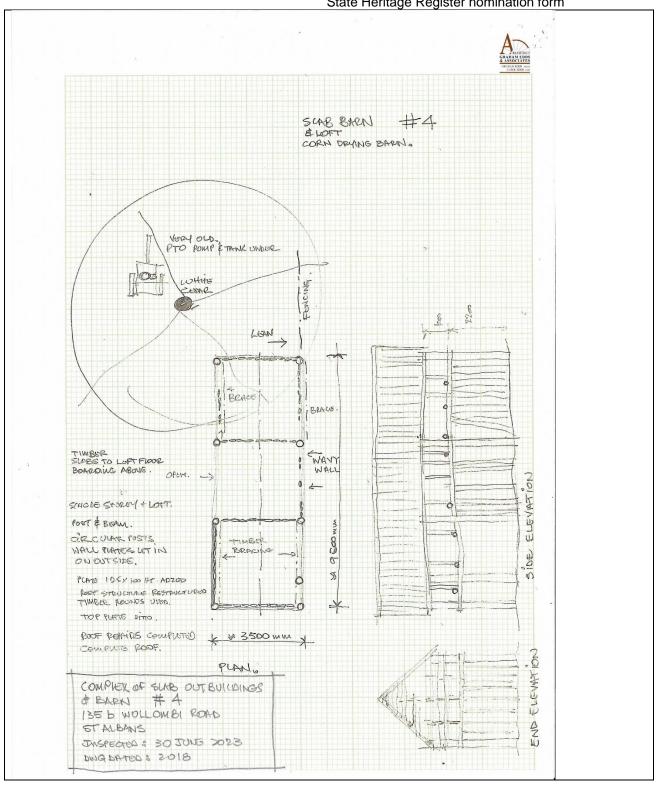
Caption*	Sketch plan and elevations of Barn 4
Date of photograph*	30th June 2023
Name of photographer*	Graham Edds
Copyright holder, if known	Graham Edds & Associates

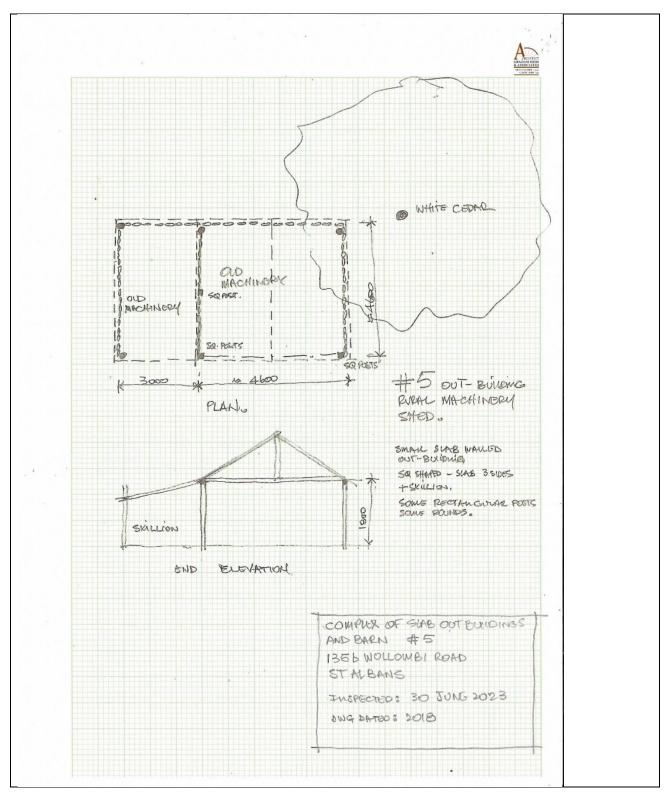
Caption*	Sketch plan and elevations of Barn 5
Date of photograph*	30th June 2023
Name of photographer*	Graham Edds
Copyright holder, if known	Graham Edds & Associates

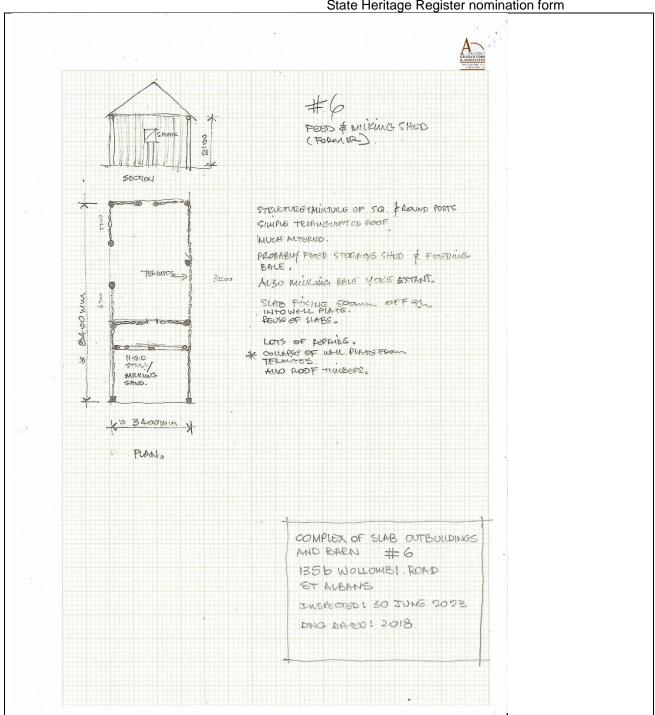
Caption*	Sketch plan and elevations of Barn 6
Date of photograph*	30th June 2023
Name of photographer*	Graham Edds
Copyright holder, if known	Graham Edds & Associates

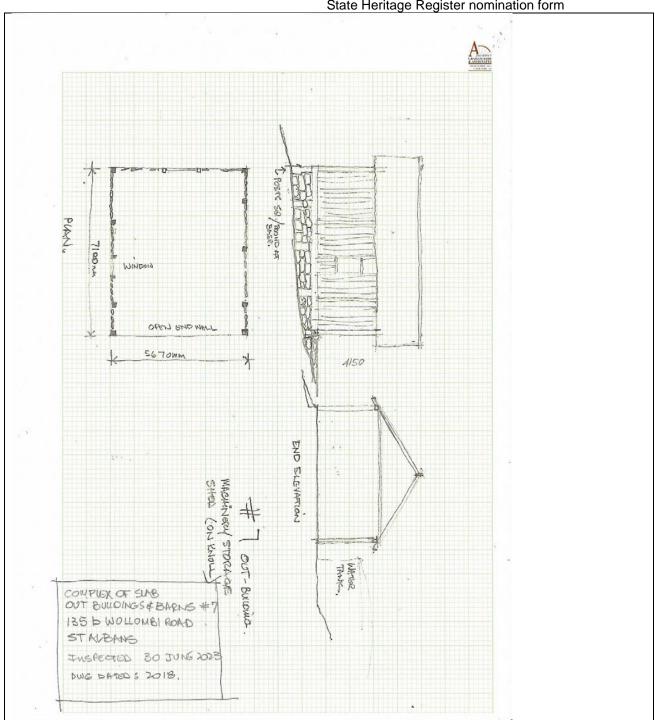
Caption*	Sketch plan and elevations of Barn 7
Date of photograph*	30th June 2023
Name of photographer*	Graham Edds
Copyright holder, if known	Graham Edds & Associates

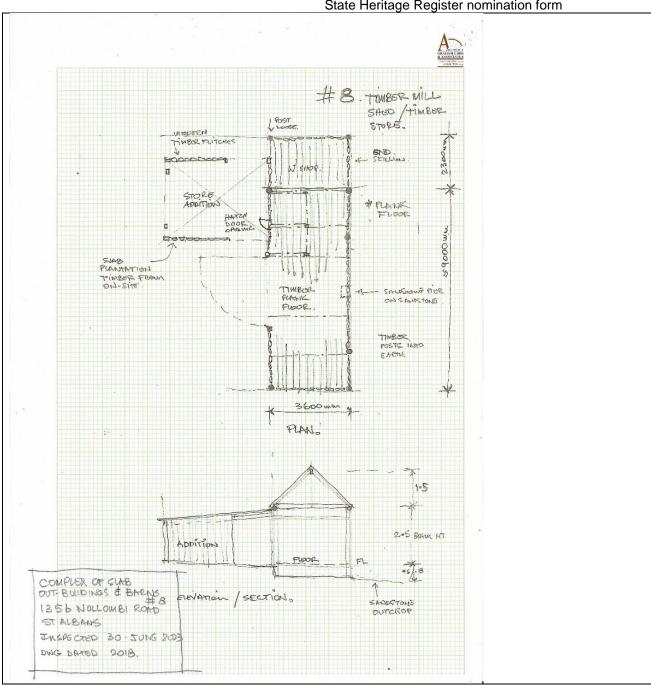
Caption*	Sketch plan and elevations of Barn 8
Date of photograph*	30th June 2023
Name of photographer*	Graham Edds
Copyright holder, if known	Graham Edds & Associates

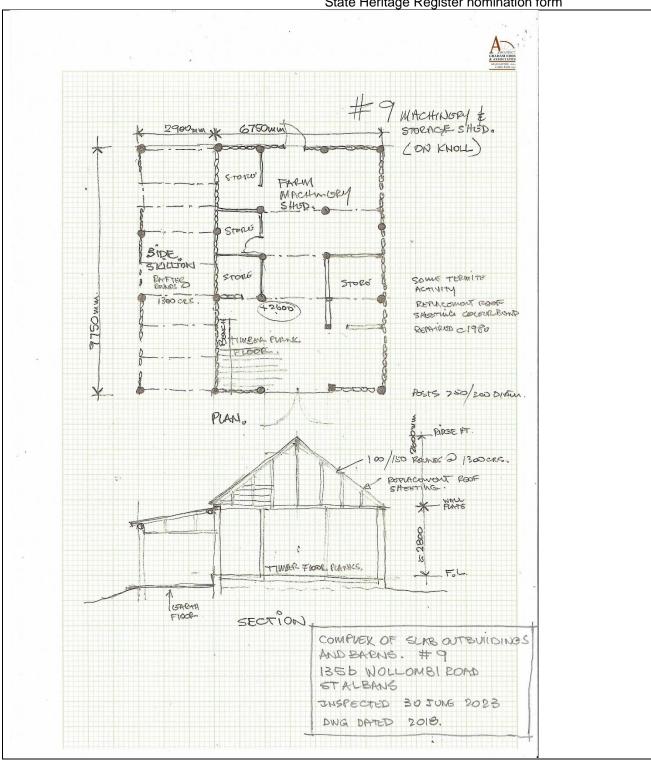
Caption*	Sketch plan and elevations of Barn 9
Date of photograph*	30th June 2023
Name of photographer*	Graham Edds
Copyright holder, if known	Graham Edds & Associates
