Geotechnical and Salinity Assessment Report

**REDBANK EXPANSION AREA (KEMSLEY PARK)
GROSE VALE ROAD, NORTH RICHMOND
PRELIMINARY GEOTECHNICAL ASSESSMENT**

**REPORT 12261/44-AA-R1
16 JULY 2024**

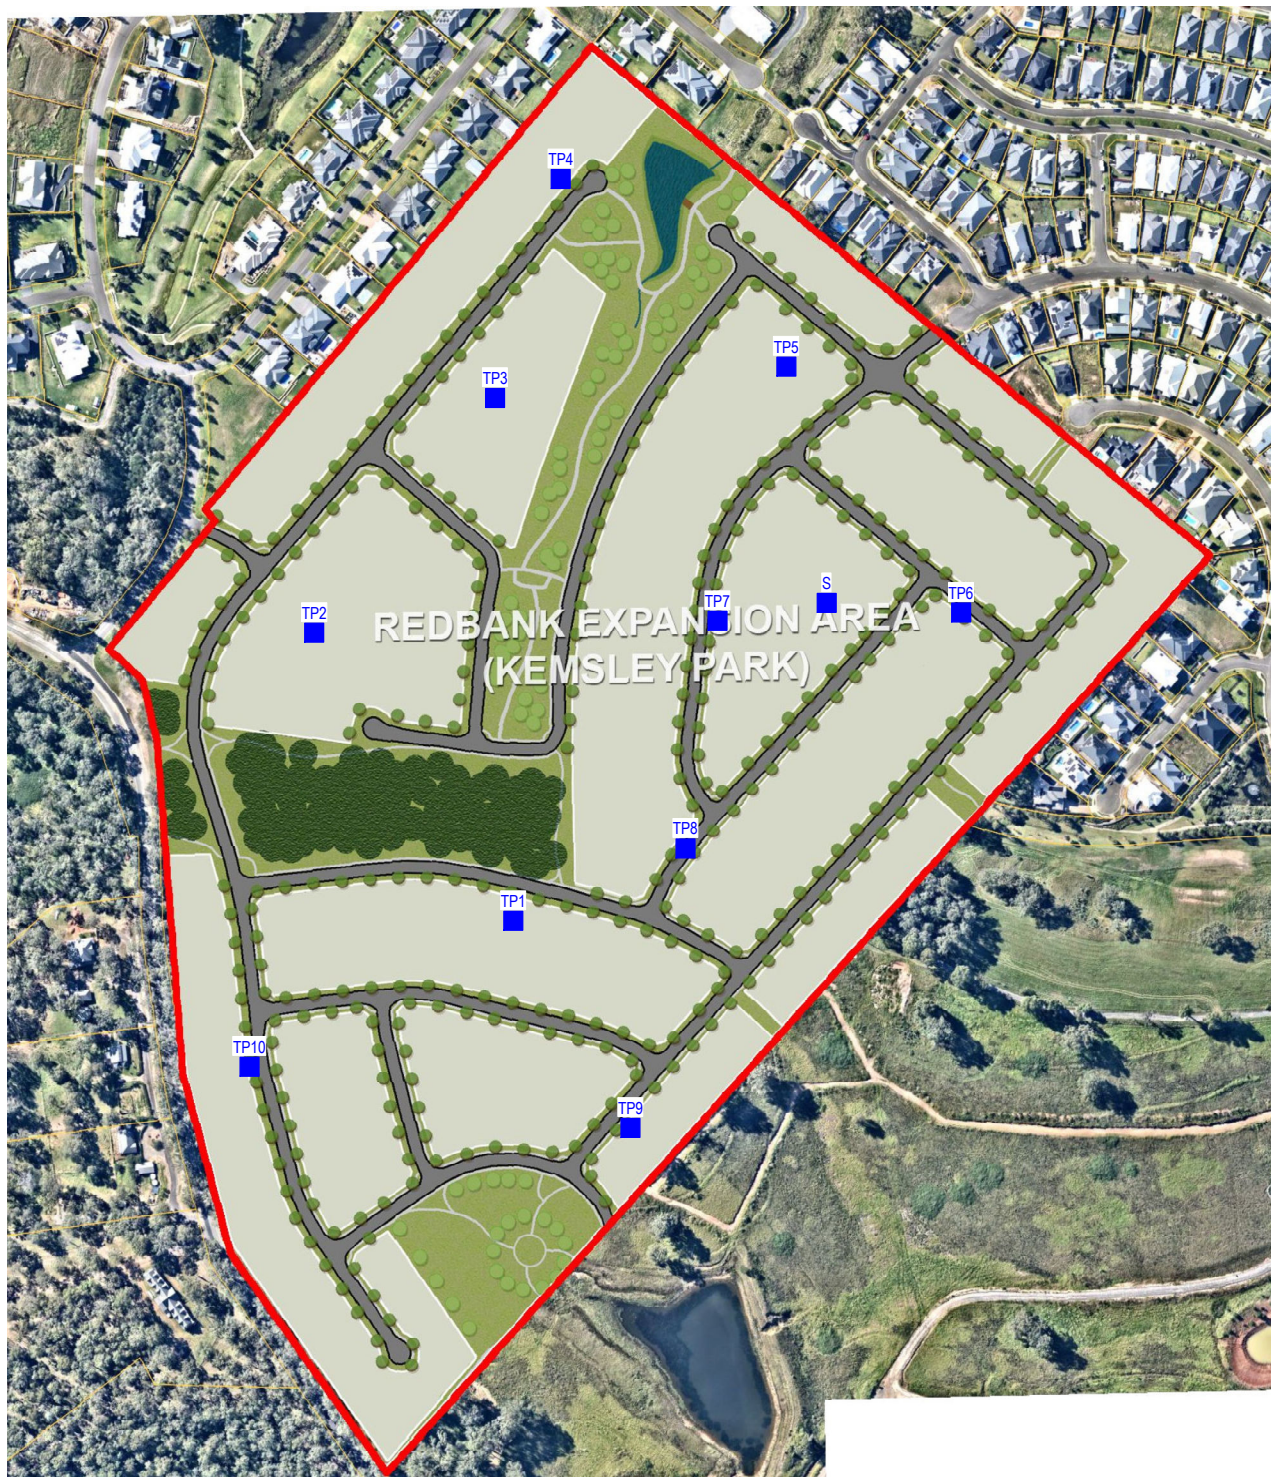
**DRAWING NO 12261/44-AA1
(Test Pit Location Plan)**

■ Test Pit
