ITEM DETAILS	
NAME	Two storey Slab Carriage House and Stables
ADDRESS	4 Bensons Lane, Richmond
LOCAL GOVT AREA	Hawkesbury
PARISH	Ham Common
LOT/DP	12 DP 11828989
SHI No.	1743058
EXISTING HERITAGE ITEM	N
RECOMMENDED MANAGEMENT	
MANAGEMENT SUMMARY	Not recommended for State listing Recommend for Local listing.

ITEM DETAILS	
NAME	Single Storey Town Slab Barn with Side Skillion
OTHER/FORMER NAMES	House and Slab Barn
ADDRESS	118 Francis Street, Richmond
LOCAL GOVT AREA	Hawkesbury
PARISH	Ham Common
LOT/DP	Lot 1 DP 571910
SHI No.	1743057
EXISTING HERITAGE ITEM?	N
RECOMMENDED MANAGEMENT	
MANAGEMENT SUMMARY	Not recommended for State or local listing.

ITEM DETAILS	
NAME	Group of three barns- part of historic homestead
OTHER/FORMER NAMES	Hobartville
ADDRESS	36 & 40 Inalls Lane & 16 William Cox Drive, Richmond
LOCAL GOVT AREA	Hawkesbury
PARISH	Ham Common
LOT/DP	Lot 1 and 2 DP 596558
SHI No.	1743059
EXISTING HERITAGE ITEM?	Y- Item I14 (SHI 1741548) and SHR 00035 (SHI 5045232)
RECOMMENDED MANAGEMENT	
MANAGEMENT SUMMARY	Retain as State item
	Retain as Local item

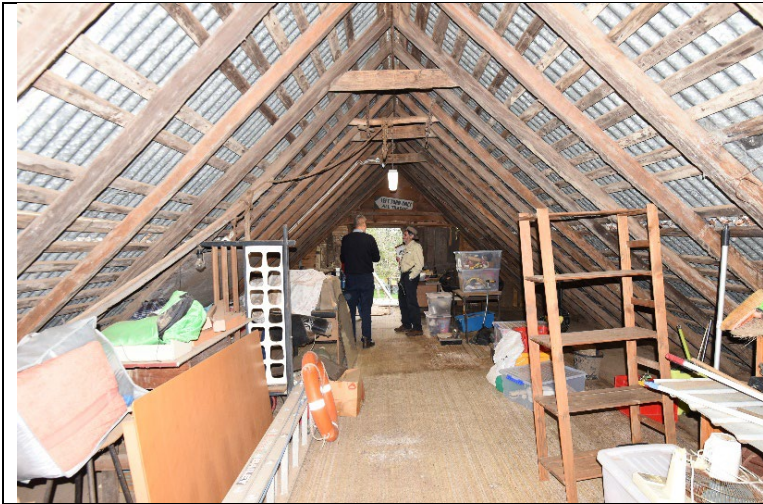
Caption: Barn at No.353 Pitt Town Bottoms Road, Pitt Town Bottoms (interior of loft)
 Photographer: S. Johnson
 Copyright Owner: Lucas Stapleton Johnson & Partners Pty Ltd
 Date: May 2023

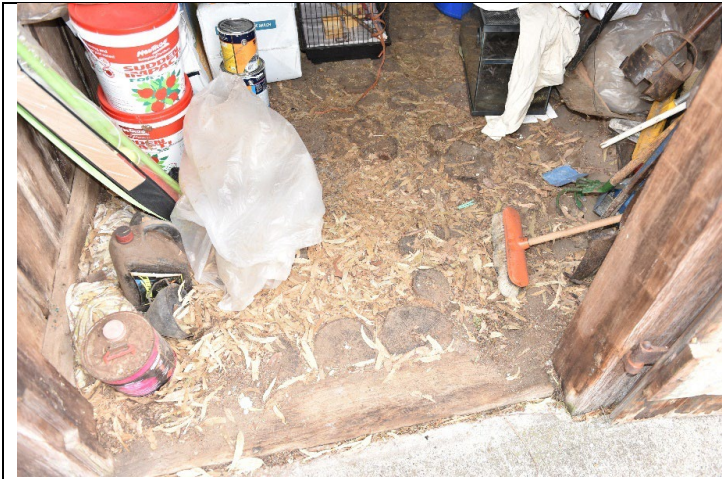
FLOORING (GROUND)	Round timber sets in stables section, concrete floor in cart house.
FLOORING (LOFT)	Timber boarding
FLOORING (SKILLION)	N/A
INTERNAL STRUCTURE	Early timber posts and slab partitions.
OTHER (Fixings?)	Bolted joints between posts and longitudinal beams
CURRENT USE	Storage on ground floor, accommodation in loft.
CHANGES FROM 2010?	None.
HISTORY	
<p>Thomas Gordon, free-settler, was granted 100 acres (Portion 58, Parish Ham Common) on 16 July 1804 in the district of Mulgrave Place, bounded on the east by Wilson and on the west by William Carlisle. William Carlisle, free settler, had been granted his land (Portion 57) in the same year.</p> <p>In 1811, Gordon transferred 50 acres at Mulgrave Place to William Carlisle for a working bullock. In that same year, Carlisle married Mary Ann Gordon, Thomas Gordon's daughter. Carlisle and Gordon had known each other in England and emigrated together to NSW.</p> <p>William Gordon was a farmer, missionary, coach painter and school teacher, who had a zeal to bring Christianity to the Maori people at the Bay of Islands in New Zealand, spending a number of years at Samuel Marsden's mission there.</p> <p>In 1822, William Carlisle advertised a 50 acre farm at Richmond for sale. The property was described as having high lands free from floods on which "is a good weatherboarded and shingled house, a barn, and other conveniences fenced in; with an orchard etc." Timber had been cut on 43 acres and almost 30 acres had been cleared. Crops were growing on 20 acres. Half the purchase money was to be taken in good sheep or horned cattle.</p> <p>By a deed of bargain and sale dated 10 June 1822, William Carlisle, transferred that 50 acres to Edward Smith Hall, esquire of Sydney for £200. It was more correctly described as 50 acres bounded on the east by the other half of Thomas Gordon's 100 acre grant, and on the west by Carlisle's farm. The transfer also included a piece of land containing 2 acres adjoining together with a cottage and outbuildings. This separate piece of land is the location of Benson House.</p> <p>Subsequently, on 14 and 15 July 1836, by a deed of lease and release, Edward Smith Hall, of Sydney, esquire, and his wife Sarah conveyed the land to John Burns, Richmond, farmer for £500. The land was the same as described in June 1822, including the cottage and all other buildings. John Burns later died.</p> <p>On 9 August 1842, a deed of release in trust was signed with the following parties, 1st John Fawcett, Richmond, farmer, and his wife, Elizabeth, who was the widow of John Burns of Richmond deceased, 2nd William Bowman, Richmond, esquire, trustee 3rd William Murray Benson, Richmond, farmer, who was the son of Elizabeth Fawcett, originally Elizabeth Burns.</p> <p>The land was the same as described in June 1822, including the cottage with other buildings. The land would be held by Bowman in trust for the benefit of John Fawcett for the term of his natural life, and then for the benefit of Elizabeth Fawcett for the term of her natural life, and then to William Murray Benson.</p> <p>Elizabeth Fawcett died at Richmond on 21 April 1844, aged 76. After the death of his wife, John Fawcett, promised to marry a much younger woman, but when he withdrew his promise, he was charge for breach of promise and found guilty. A payment of £50 was due to the woman who he had jilted. John Fawcett died aged 58 on 28 September 1847.</p> <p>William Murray Benson died 26 February 1859, leaving his property to his wife, Marian. On 6 January 1870, Marion Benson, of Richmond, widow gifted the property to her son William Benson, Richmond, farmer. By the 1890s, via marriage, the property was in the ownership of the Ridge family.</p>

Caption: Detail of log floor to Stables at 4 Bensons Lane, Richmond
Photographer: S. Johnson
Copyright Owner: Lucas Stapleton Johnson & Partners
Date: June 2023

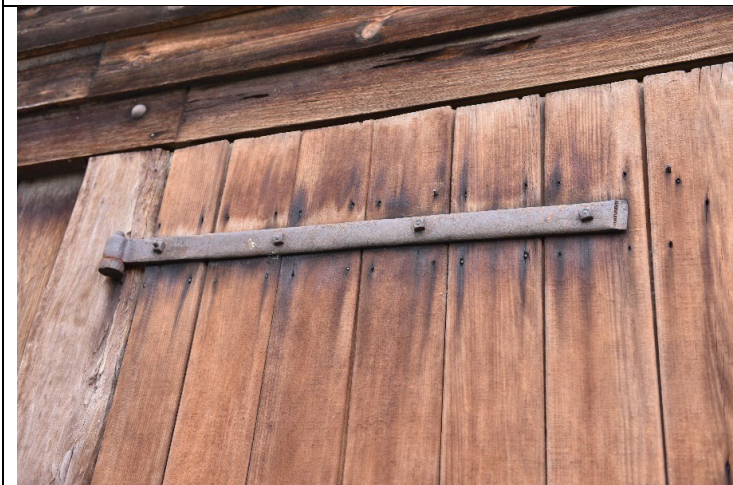
Caption: Detail of forged iron hinge of Stables and Coach house at 4 Bensons Lane, Richmond
Photographer: S. Johnson
Copyright Owner: Lucas Stapleton Johnson & Partners
Date: June 2023

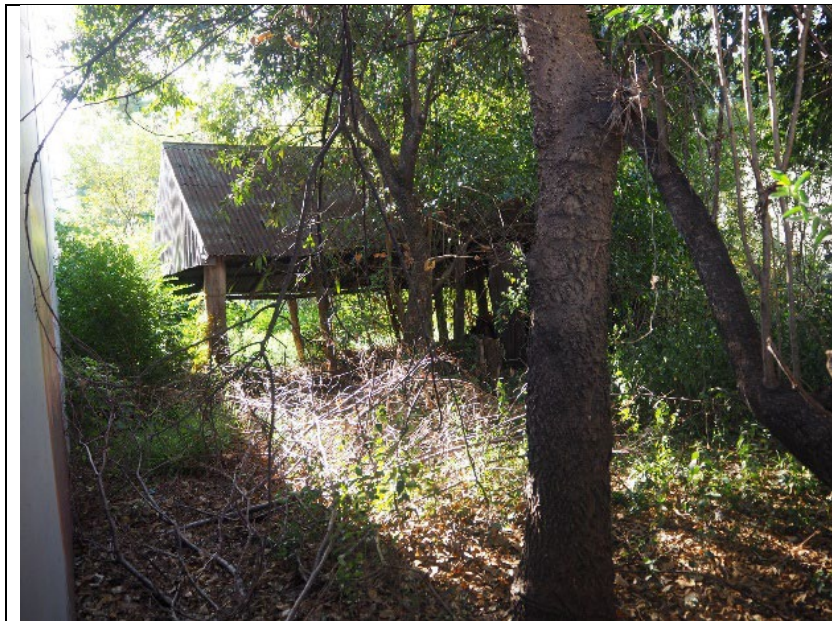
ITEM CLASSIFICATION	
ITEM TYPE	Built
ITEM GROUP	Farming and Grazing
ITEM CATEGORY	Barn
DESCRIPTION	
CIRCA	Y
PERIOD	Late 19 th century
MODIFICATION/DATES	Slabs and skillion removed since 2010.
CURRENT USE	Abandoned
FORMER USE	Barn
<p>Site access not provided in 2023.</p> <p>The following description is from the 2010 Hawkesbury Slab Barn Study, Graham Edds and Associates.</p> <p>The barn is in poor condition with little surviving original fabric.</p> <p>A single storey town barn within the rear yard of a mid-19th century town cottage property. Access to the property was not available so the following is provided from observation from Francis Street and the Council carpark to the rear.</p> <p>The barn is a small structure rectangular in shape with gabled roof and a skillion roof along one side of the long axis (facing the cottage).</p> <p>Structure:</p> <p>A post and beam structure utilising round poles and beams, walls clad with vertical slabs for the full wall height, simply supported roof structure clad with corrugated metal sheeting and skillion similarly structured and clad.</p>

Caption: Barn at 118 Francis Street, Richmond (exterior)
Photographer: K. Denny
Copyright Owner: Lucas Stapleton Johnson & Partners Pty Ltd
Date: June 2023

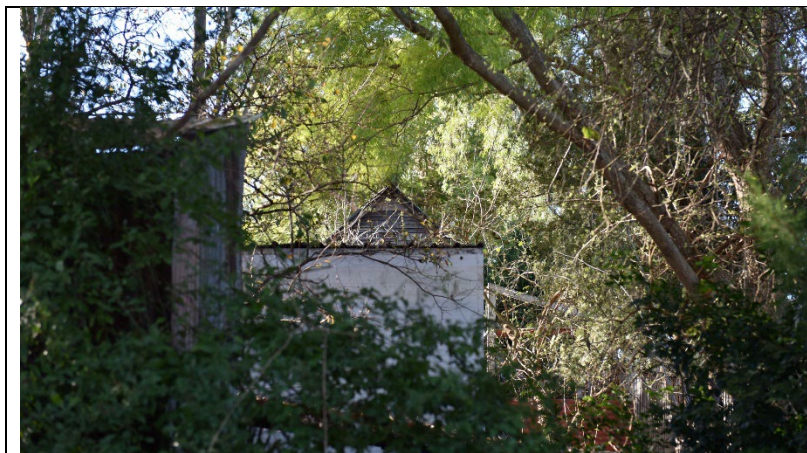
ITEM CLASSIFICATION	
ITEM TYPE	Built
ITEM GROUP	Farming and Grazing
ITEM CATEGORY	Barn
DESCRIPTION	
CIRCA	Y
PERIOD	Early 19 th century?
MODIFICATION/DATES	Relocated 1977
CURRENT USE	?
FORMER USE	Barn
2023: Access not provided. Photographed from public road only.	
HISTORY	
HISTORICAL NOTES	[2010 inventory sheet] A re-sited and altered two storey slab barn. The slab barn was originally located in Macquarie Street, Windsor and associated in the 19th century with Samuel Marsden's Tannery. It was purchased 1977, dismantled and relocated to Clear Oaks, a highly significant historic site in Richmond.
INTEGRITY/INTACTNESS	Resited and altered- site inspection required to determine integrity and condition. Significance level cannot be determined without a site inspection but representational significance only.

Caption: Barn at 135 Francis Street, Richmond (exterior)
 Photographer: S. Johnson
 Copyright Owner: Lucas Stapleton Johnson & Partners Pty Ltd
 Date: July 2023

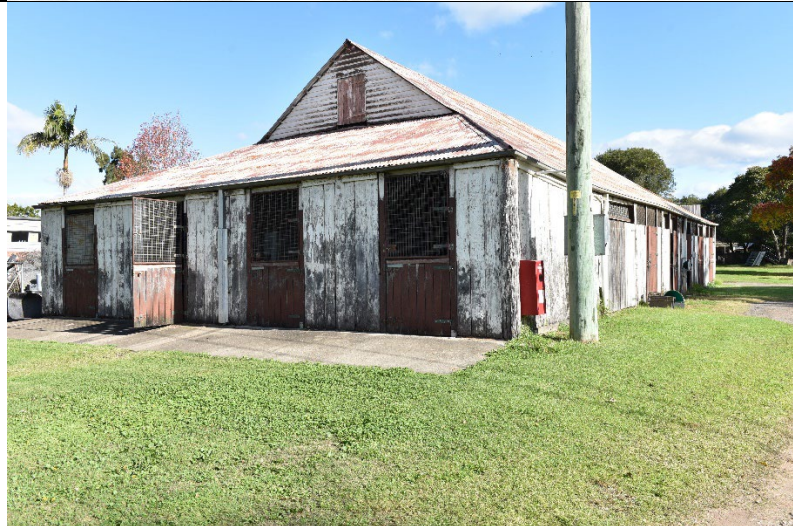
NO. OF BAYS	Six
ROOF STRUCTURE	Roof framing replaced with 100 x 50 rafters @ 900 crs. Condition: Good Date: Late 20 th century?
LOFT	Remains of loft floor frame evidence and wall framing for weatherboard cladding. Condition: N/A Date: Early 19 th century
SKILLION 1	Skillions wrap around three sides and are integral with the main barn structure. Condition: Good
ROOF CLADDING:	Corrugated iron in short sheets. Condition: Moderate Date: Mid-20 th century?

WALL CLADDING	Vertical timber slabs remain around three sides of the eastern skillion only. Elsewhere there are vertical timber planks. Condition: Moderate Date: Early 19 th century but with extensive later modifications
OPENINGS	Stable doors have been inserted on north, east and south sides and double doors to the loading dock at the western end.
FLOORING (GROUND)	Brick flooring generally but raised timber floor in north-western
FLOORING (LOFT)	None
FLOORING (SKILLION)	As above.
CURRENT USE	Feed shed and stables
CHANGES FROM 2010?	None
DESCRIPTION BARN 2 'BOTTOM STABLES'	
MAIN BARN STRUCTURE	A relatively low barn but large on plan (15 x 8m) with a loft originally as evidenced by the loft door in the east end. It is constructed with round pole columns, rafters and beams and has later added verandahs along each long side. Gable walls have posts at close centres to support the wide span. Condition: Good Date: Early 19 th century

Caption: Barn 1 at 331 Hobartville, 36-40 Inalls Lane, Richmond (exterior)
Photographer: S. Johnson
Copyright Owner: Lucas Stapleton Johnson & Partners Pty Ltd
Date: June 2023

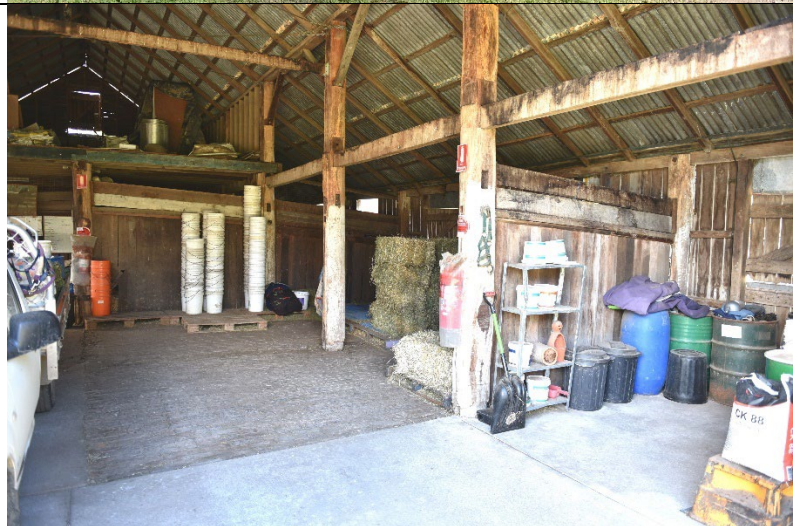
Caption: Barn 1 at 331 Hobartville, 36-40 Inalls Lane, Richmond (interior)
Photographer: S. Johnson
Copyright Owner: Lucas Stapleton Johnson & Partners Pty Ltd
Date: June 2023

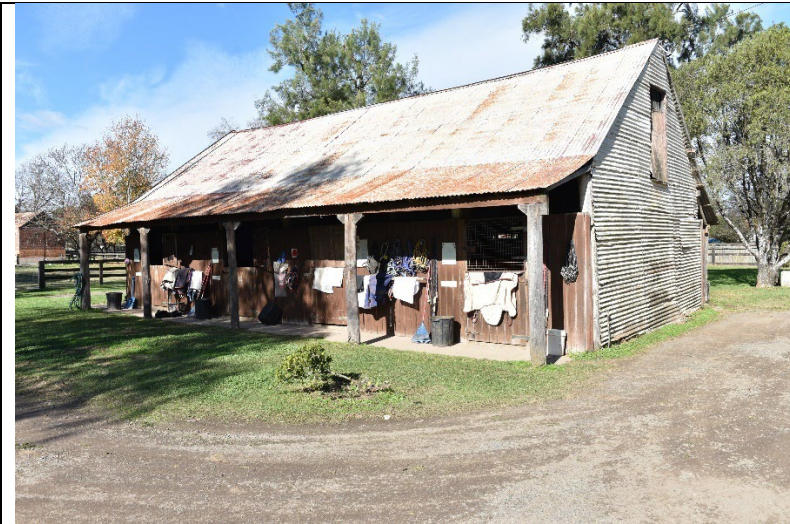
NO. OF BAYS	Six
ROOF STRUCTURE	Round pole rafters with collar ties and shingle battens. Condition: Good Date: Early 19 th century
LOFT	Removed
ROOF CLADDING:	Corrugated iron short sheets Condition: Moderate Date: Early or mid-20 th century?
WALL CLADDING	Vertical planks to long sides, horizontal corrugated iron to gable ends. Condition: Moderate Date: Early or mid-20 th century?
OPENINGS	Stable doors both sides.
FLOORING (GROUND)	Concrete slab
CURRENT USE	Stables
CHANGES FROM 2010?	None
DESCRIPTION BARN 3 'OLD BARN'	
MAIN BARN STRUCTURE	Large round posts are trenched at the top to take rectangular longitudinal beams with bolted connections. Large square cross beams have iron tie bars at mid span connected to the top of each rafter. Slabs are stockpiled within the barn but there is no evidence of their use in cladding the walls of this barn. Condition: Moderate – tops of posts have been repaired in places and longitudinal beams spliced or replaced. Date: Late 19 th early 20 th century?

Caption: Barn 2 at 331 Hobartville, 36-40 Inalls Lane, Richmond (exterior)
Photographer: S. Johnson
Copyright Owner: Lucas Stapleton Johnson & Partners Pty Ltd
Date: June 2023

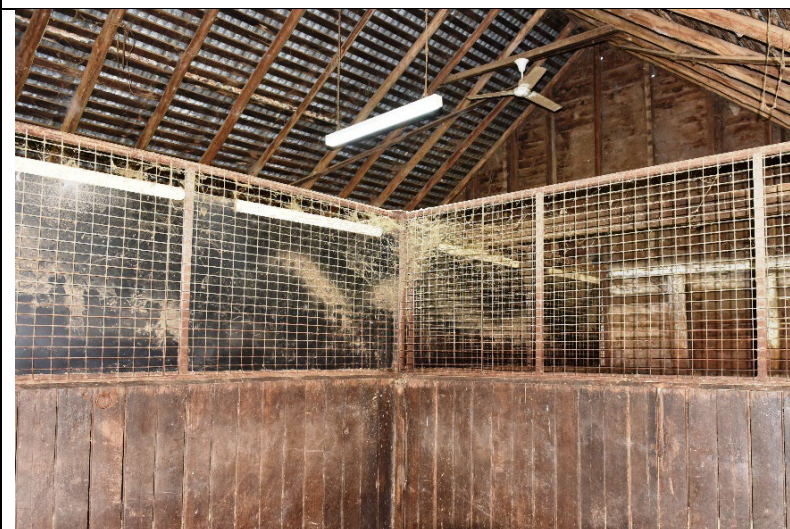
Caption: Barn 2 at 331 Hobartville, 36-40 Inalls Lane, Richmond (interior)
Photographer: S. Johnson
Copyright Owner: Lucas Stapleton Johnson & Partners Pty Ltd
Date: June 2023

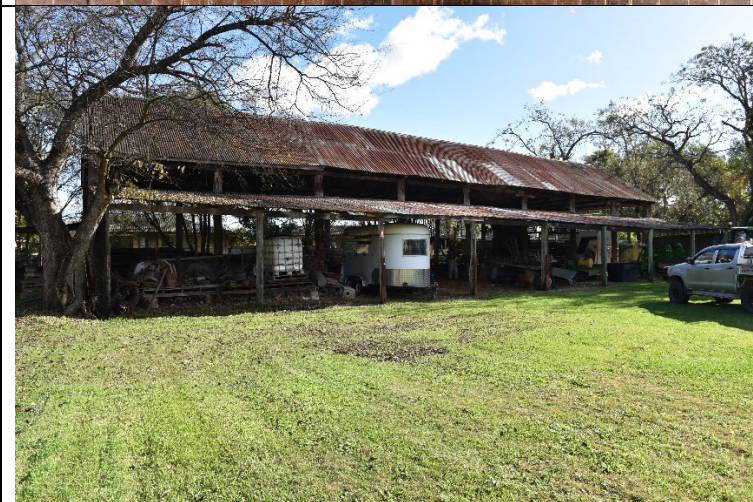
ROOF STRUCTURE	Each pair of sawn rafters is triangulated by connection to a large rectangular cross beam and the sag in the latter member is limited by vertical iron tie rods connected to the apex of the roof. Condition: Moderate Date: Late 19 th early 20 th century?
SKILLION 1	Low pitched skillion on east side intersects with the main barn approximately 1m below the eaves. It is constructed of round pole rafters with sawn battens for iron roofing. Condition: Moderate Date: Late 19 th early 20 th century?
ROOF CLADDING:	Corrugated iron in short sheets. Condition: Moderate. Date: Late 19 th early 20 th century?
WALL CLADDING	None
OPENINGS	Sides are open
FLOORING (GROUND)	Earthen
FLOORING (SKILLION)	Earthen
OTHER (Fixings?)	Bolted with some later strengthening
CURRENT USE	Machinery shed and storage
HISTORY	
<p>The Hobartville estate, including the main house and associated outbuildings, the group of three barns and other agricultural outbuildings, is located on a 100 acre grant made to James Blackman in 1802 and 400 acres made to surgeon Edward Luttrell in 1804.</p> <p>In 1816, William Cox Jr. purchased Luttrell's grant and the property become known as Hobartville and was advertised as having a house, garden and out offices. By 1818, Cox had also purchased Blackman's grant.</p> <p>On the death of William Cox in 1850, the estate was left to his eldest son, yet another William, but with a life interest to his widow, Elizabeth. She moved permanently to England in 1864 and William had another property, so they passed Hobartville to another son, Sloper Cox who lived there until 1877.</p> <p>In 1877 it was bought by Andrew Town, who established his famous horse stud and sales there. In 1900, the property was sold to Percy Reynolds who continued the use of the place as a thoroughbred stud. Reynolds had been born at Tocal Station, Paterson. The Reynolds family built up Australia's most renowned Hereford cattle herd in the 1930s.</p> <p>Although the original estate lands have been subdivided and sold for residential development, the property still retains a large amount of land and continues to operate as a stud facility.</p>

Caption: Barn 3 at 331 Hobartville, 36-40 Inalls Lane, Richmond (exterior)
Photographer: S. Johnson
Copyright Owner: Lucas Stapleton Johnson & Partners Pty Ltd
Date: June 2023

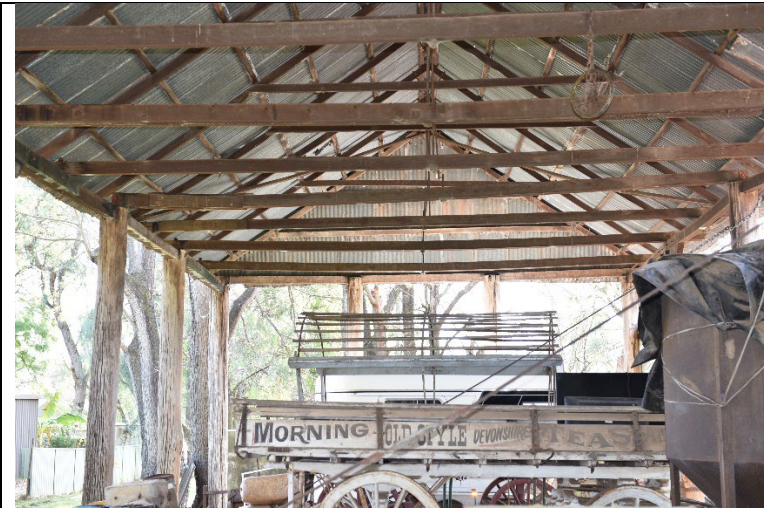
Caption: Barn 3 at 331 Hobartville, 36-40 Inalls Lane, Richmond (interior looking north)
Photographer: S. Johnson
Copyright Owner: Lucas Stapleton Johnson & Partners Pty Ltd
Date: June 2023

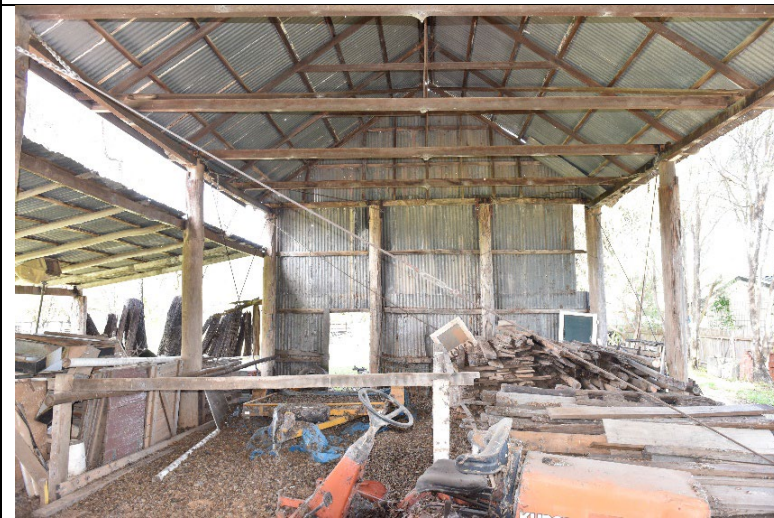
Caption: Barn 3 at 331 Hobartville, 36-40 Inalls Lane, Richmond (interior looking south)
Photographer: S. Johnson
Copyright Owner: Lucas Stapleton Johnson & Partners Pty Ltd
Date: June 2023

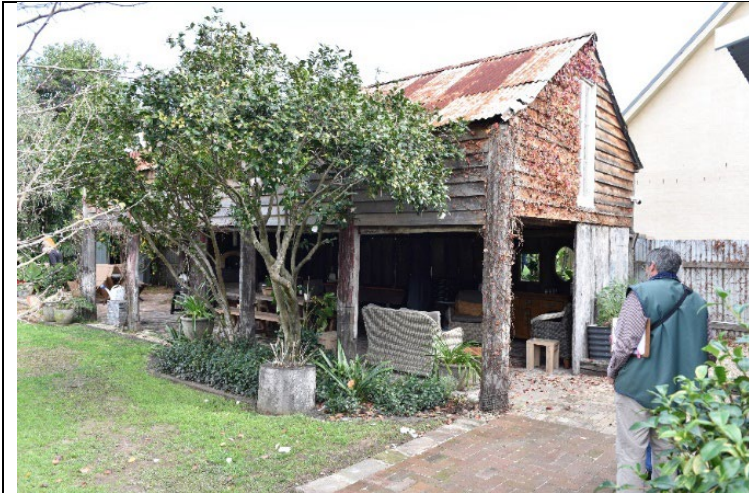
ROOF CLADDING:	Corrugated iron short sheets Condition: Poor Date: Mid-20 th century?
WALL CLADDING	Vertical timber slabs (some 400 wide) up to loft floor level. Weatherboards to loft level and gables, early beaded weatherboards to western side, other weatherboards are more recent. Condition: Moderate Date: Mid 19 th century with late 20 th century repairs
OPENINGS	All bays are open on eastern side and at each end.
FLOORING (GROUND)	Brick paving
FLOORING (LOFT)	Timber boarding
OTHER (Fixings?)	Beams let into and bolted to posts.

Caption: The town barn at No. 102 Lennox Street, Richmond (exterior).
Photographer: S. Johnson
Copyright Owner: Lucas Stapleton Johnson & Partners
Date: May 2023

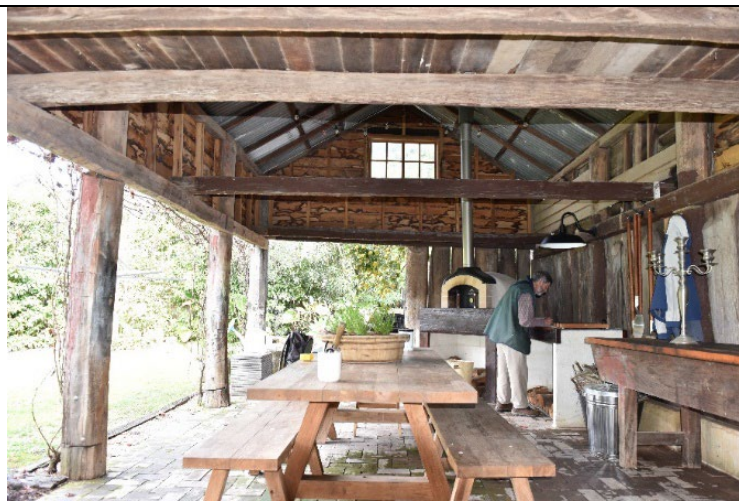
Caption: The town barn at No. 102 Lennox Street, Richmond (interior).
Photographer: S. Johnson
Copyright Owner: Lucas Stapleton Johnson & Partners
Date: May 2023

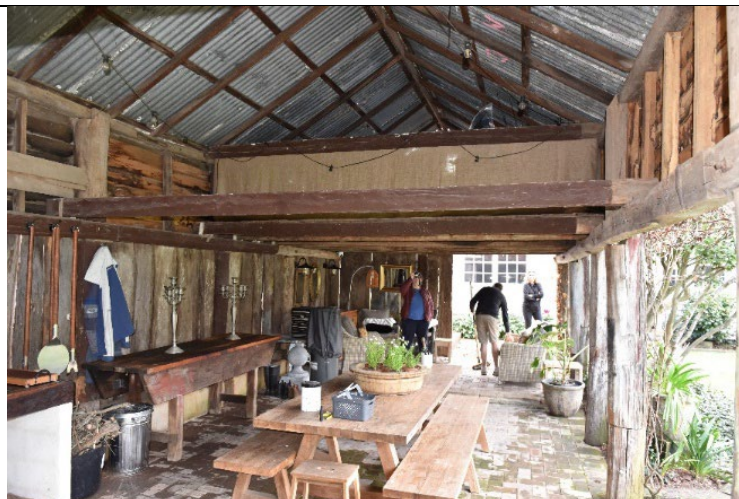
Caption: The town barn at No. 102 Lennox Street, Richmond (interior).
Photographer: S. Johnson
Copyright Owner: Lucas Stapleton Johnson & Partners
Date: May 2023

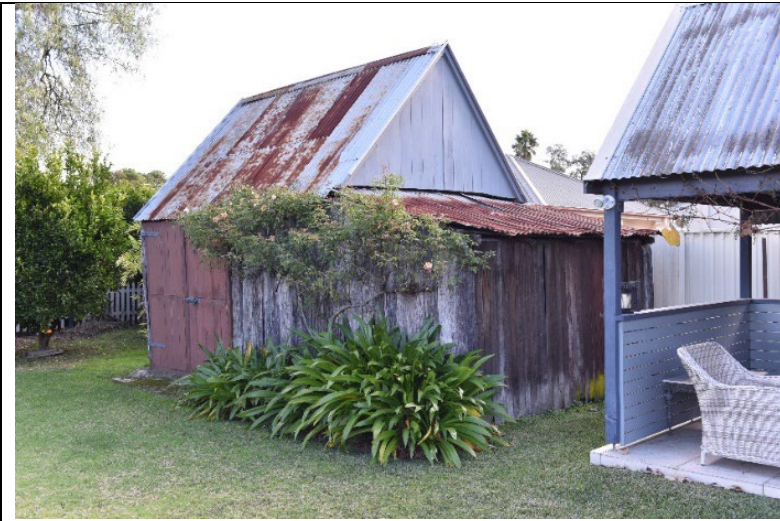
ITEM CLASSIFICATION	
ITEM TYPE	Built
ITEM GROUP	Farming and Grazing
ITEM CATEGORY	Barn/shed
DESCRIPTION	
PERIOD	Early 19 th century (pre 1841)
MODIFICATION/DATES	Mid 20 th century
CURRENT USE	Storage
FORMER USE	Barn/shed
LOCATION ON SITE:	Behind two-storey Georgian townhouse approximately 50m south of the road (approximately the same location as shown on 1841 survey).
MAIN BARN STRUCTURE	A small square town barn/shed composed of adzed square posts, sawn eaves beams and slender pole cross beams. Condition: Moderate Date: Early 19 th century.
NO. OF BAYS	Two
ROOF STRUCTURE	Rafters are split timber pitched at 45°. Battens are suitable for iron. Condition: Moderate Date: Early 19 th century.
SKILLION 1	Pole rafters supported on pole edge beam. Condition: Moderate Date: Early 19 th century.
ROOF CLADDING:	Corrugated iron short sheets. Condition: Moderate Date: Mid-20 th century?
WALL CLADDING	Vertical timber slabs with shaped tops. Vertical timber boarding to gable is modern. Condition: Moderate Date: Early 19 th & late 20 th century

Caption: The town barn at No. 158 March Street, Richmond (exterior).
Photographer: S. Johnson
Copyright Owner: Lucas Stapleton Johnson & Partners
Date: May 2023

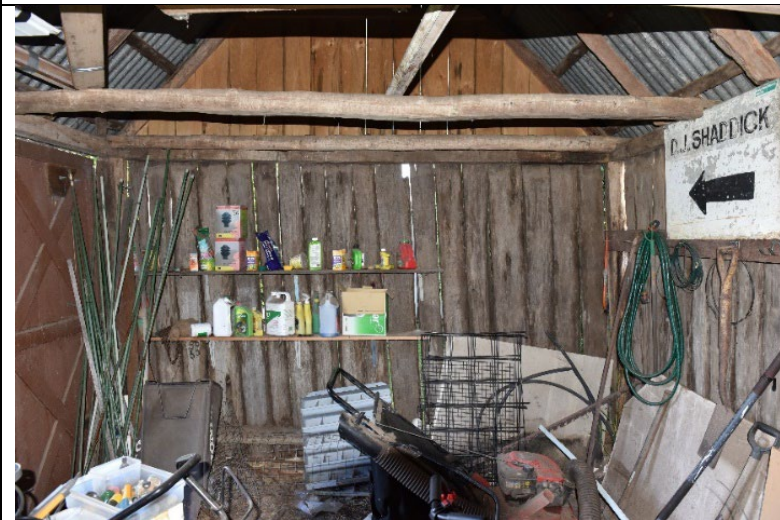
Caption: The town barn at No. 158 March Street, Richmond (interior).
Photographer: S. Johnson
Copyright Owner: Lucas Stapleton Johnson & Partners
Date: May 2023

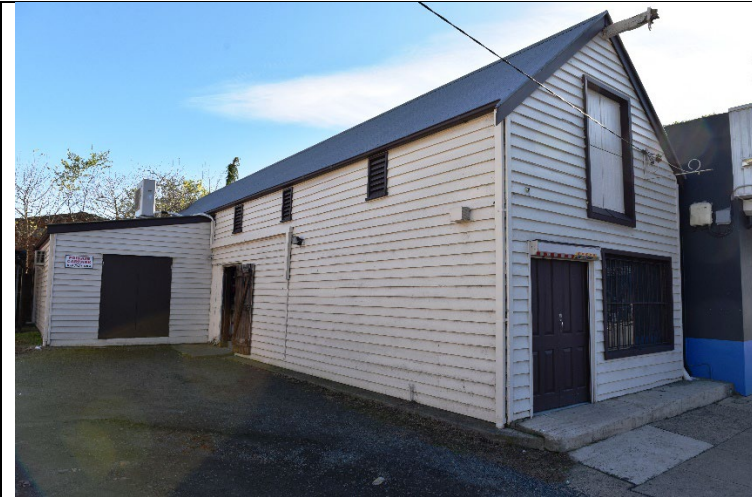
LOFT	Loft is well built (rebuilt?) with deep joists spanning between longitudinal beams, herringbone strutting, tonged and grooved flooring and wall linings of beaded horizontal boards. Date: Mid to late 19 th century (potentially)
SKILLION 1	Skillion addition to half the length of the southern side of the barn. Condition: Good. Date: Mid to late 19 th century (potentially)
ROOF CLADDING:	Corrugated steel long sheets. Condition: Good Date: Mid to late 19 th century (potentially)
WALL CLADDING	Vertical timber slabs with cover strips of galvanized steel. Weatherboard outer cladding added later.

Condition: good Date: Mid to late 19 th century (potentially)
OPENINGS	The loft has a door on the street front with a beam over for hoisting in goods. There are a series of louvred ventilation openings in the loft wall.
FLOORING (GROUND)	Concrete slab
FLOORING (LOFT)	Timber boarding
FLOORING (SKILLION)	Not known
INTERNAL STRUCTURE	Stair and additional support posts have been inserted under loft floor beam.
OTHER (Fixings?)	Bolts with square nuts indicating late 19 th early 20 th century construction.
CURRENT USE	Warehouse
CHANGES FROM 2010?	Change of use.
HISTORY	
<p>The barn at No. 239 Windsor Street, Richmond is located on Lot 3 Section 4 of the Richmond Town Plan. This land forms part of a grant of 15 September 1841 to John Stephenson, Richmond for 1 acre 2 roods 9 perches. It had been promised to him by Lachlan Macquarie.</p> <p>On 28 & 29 June 1842, by a deed of lease and release, John Stephenson conveyed 30½ perches bounded on the south west by Windsor Street 63 feet 5 inches and on the south east by West Market Street, 132 feet to Abraham Cornwell for £120. Cornwell was described as a settler and he owned substantial amounts of land including in Emu Plains as well as throughout the town of Richmond. Cornwell owned the property for many years. According to Sam Boughton's reminiscences published in the <i>Hawkesbury Herald</i> in 1903, the site was used for a bakery. Occupiers included a man named Williams, followed by James Martin Kelly, and then Frederick Withers. All would have been tenants of Abraham Cornwell.</p> <p>On 19 September 1881, Abraham Cornwell of Richmond, tanner conveyed the 30½ perches described as in the 1842 deed to Thomas Chalmers, Richmond, baker for £1000. From the time of his purchase, Thomas Chalmers occupied the land as a bakery. In 1897, he demolished the existing buildings facing Windsor Street and erected Chalmers buildings on the corner.</p> <p>Chalmers died in 1899 leaving the property to his wife, Mary. He had previously conducted a flour mill at Clarendon, and then as a miller in the old brewery, buildings, at Windsor.</p>

Caption: The town barn at No. 239 Windsor, Richmond (exterior).
Photographer: S. Johnson
Copyright Owner: Lucas Stapleton Johnson & Partners
Date: May 2023

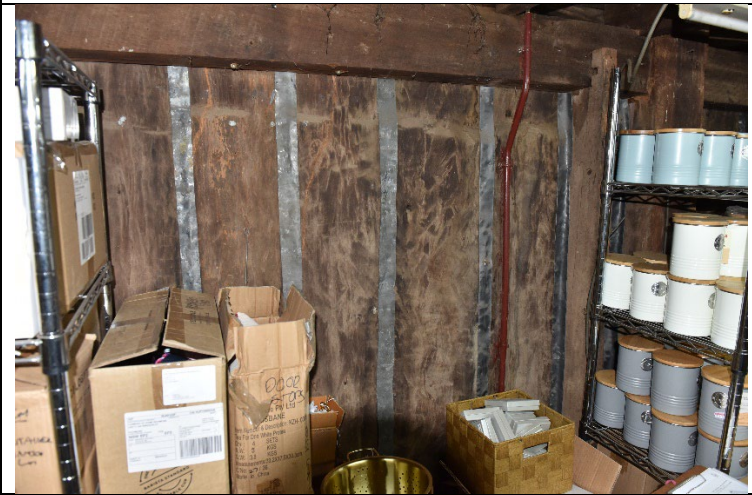
<p>extending through to the eaves level, loft floor joists notched over beams with herringbone strutting and vertical timber slabs with cover strips of galvanised steel.</p> <p>The town barn has the potential to provide further information into mid to late 19th century commercial practices within the township and in its overall form and configuration, it is a representative example of an historic timber framed barn type found throughout the Hawkesbury City local government area.</p>	
ASSESSED SIGNIFICANCE TYPE	Local
CRITERIA A) HISTORICAL	<p>The barn at No. 239 Windsor Street, Richmond is of some historical significance as a surviving mid to late 19th century town barn, associated with a notable Victoria row of shopfronts, the Chalmers Building, constructed 1897.</p> <p>As a town barn, the building would have been used in association with farm lands located outside of the town of Windsor, emphasising the continued importance of agriculture in the district well into the 20th century.</p> <p><i>Meets the criterion on a Local level.</i></p>

Caption: surviving original slabs at the town barn at No. 239 Windsor, Richmond (interior).
Photographer: S. Johnson
Copyright Owner: Lucas Stapleton Johnson & Partners
Date: May 2023

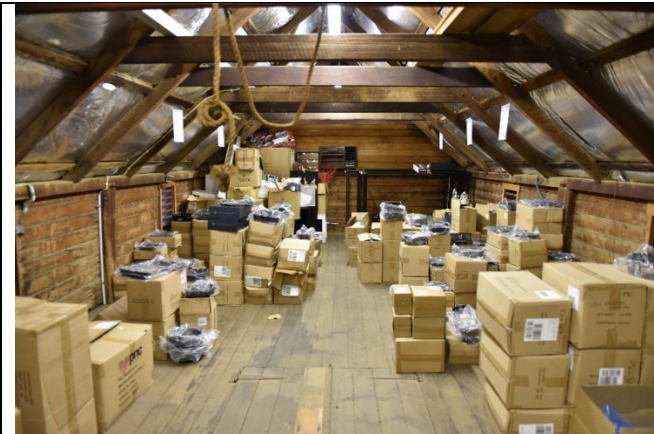
Caption: The town barn at No. 239 Windsor, Richmond (loft interior).
 Photographer: S. Johnson
 Copyright Owner: Lucas Stapleton Johnson & Partners
 Date: May 2023

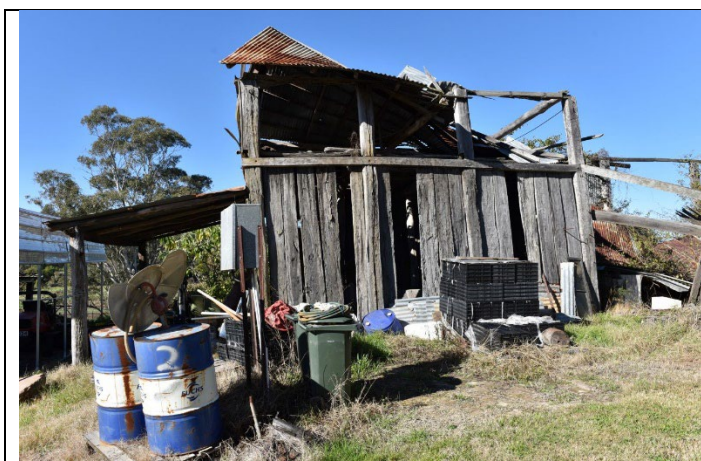
INTEGRITY/INTACTNESS	Mostly collapsed- only 3 bays of 8 remain.
-----------------------------	--

Caption: Barn at 888 Sackville Road, Sackville (exterior)
Photographer: LSJ
Copyright Owner: Lucas Stapleton Johnson & Partners Pty Ltd
Date: June 2023

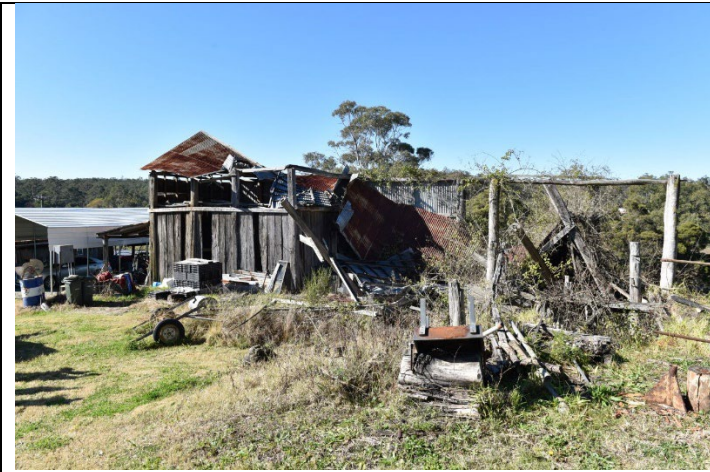
Caption: Barn at 888 Sackville Road, Sackville (exterior)
Photographer: LSJ
Copyright Owner: Lucas Stapleton Johnson & Partners Pty Ltd
Date: June 2023

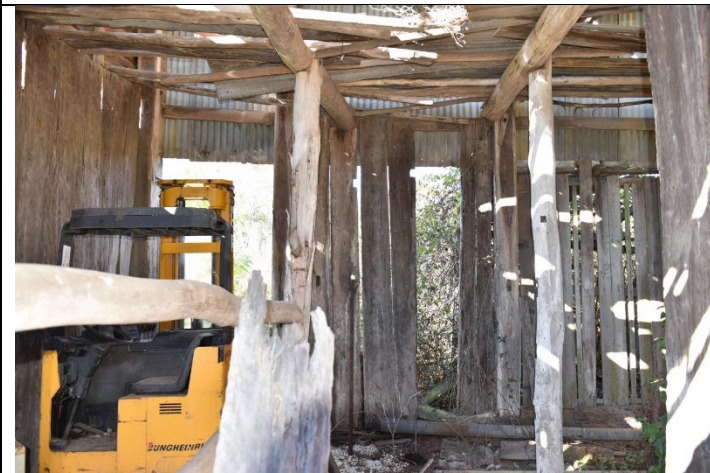
Caption: Barn at 888 Sackville Road, Sackville (interior)
Photographer: LSJ
Copyright Owner: Lucas Stapleton Johnson & Partners Pty Ltd
Date: June 2023

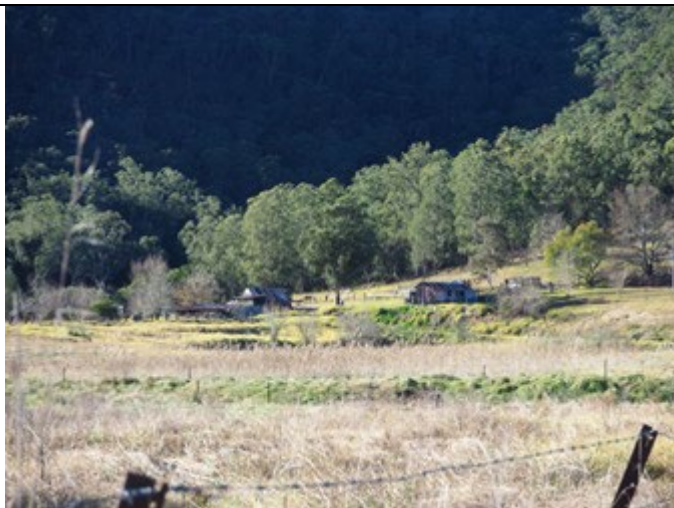
ROOF CLADDING:	Corrugated iron in short sheets. Condition: Not known Date: late 19 th century
WALL CLADDING	Vertical timber slabs, weatherboards in gables. Condition: Not known Date: late 19 th century
OPENINGS	Double door at end of barn only.
FLOORING (GROUND)	Raised timber floor with some areas slatted for drying.
FLOORING (SKILLION)	Raised timber floor with some areas slatted for drying.

<p>Caption: Barn at No. 1834 Settlers Road, St Albans Photographer: K. Denny Copyright Owner: Lucas Stapleton Johnson & Partners Date: June 2023</p>
---	---

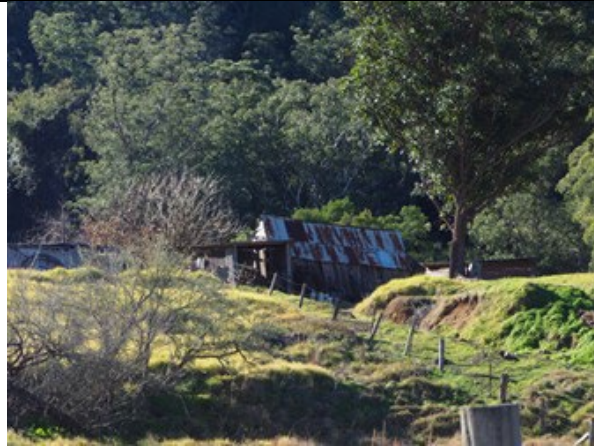
Caption: Barn at No. 1834 Settlers Road, St Albans
Photographer: K. Denny
Copyright Owner: Lucas Stapleton Johnson & Partners
Date: June 2023

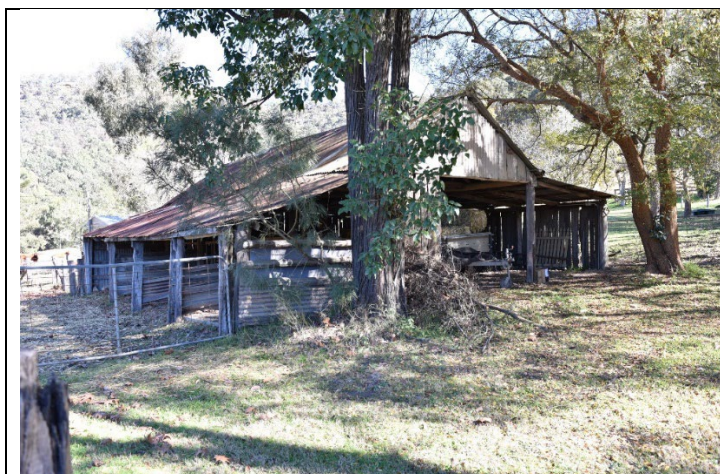
Caption: Milking Shed at No. 239 Upper MacDonald Road, St Albans (exterior)
Photographer: S. Johnson
Copyright Owner: Lucas Stapleton Johnson & Partners
Date: June 2023

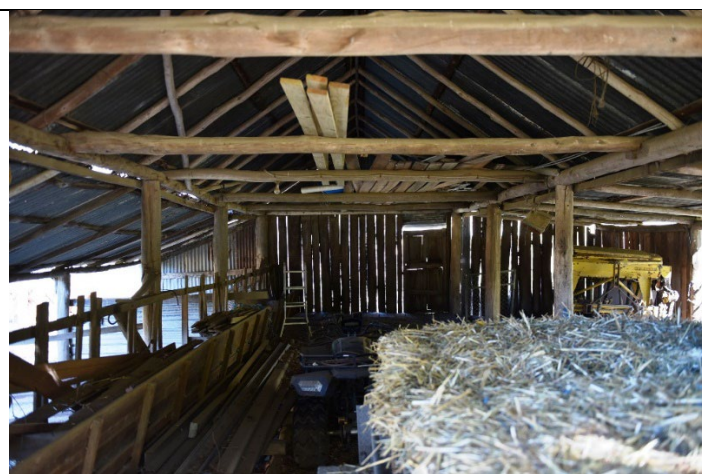
Caption: Milking Shed at No. 239 Upper MacDonald Road, St Albans (interior)
Photographer: S. Johnson
Copyright Owner: Lucas Stapleton Johnson & Partners
Date: June 2023

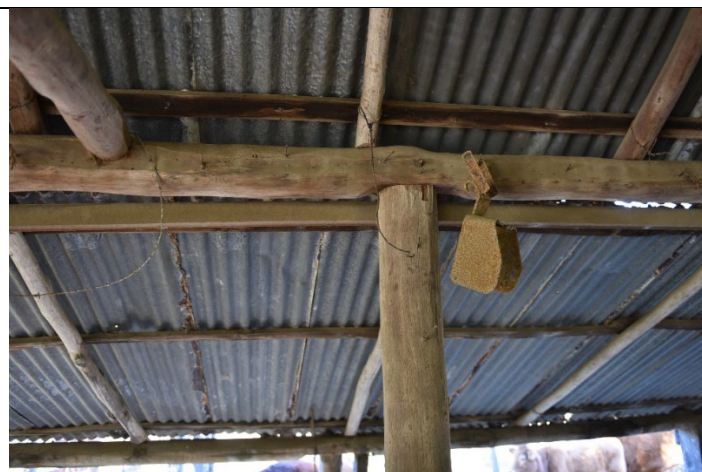
Caption: Detail of Milking Shed at No. 239 Upper MacDonald Road, St Albans (exterior)
Photographer: S. Johnson
Copyright Owner: Lucas Stapleton Johnson & Partners
Date: June 2023

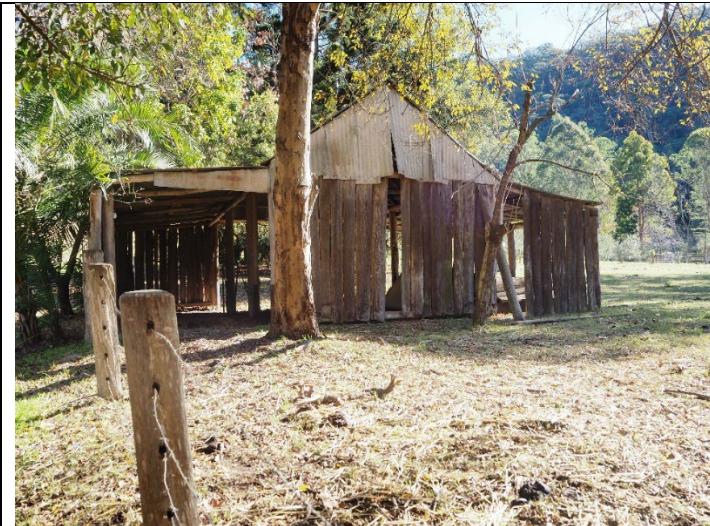
Caption: Barn at No. 239 Upper MacDonald Road, St Albans (exterior)

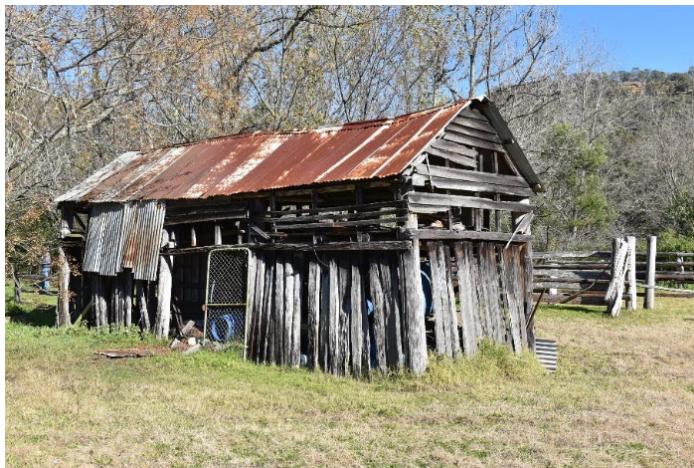
Caption: Barn 4 at 135A & B Wollombi Road (exterior)
Photographer: LSJ
Copyright Owner: Lucas Stapleton Johnson & Partners Pty Ltd
Date: June 2023

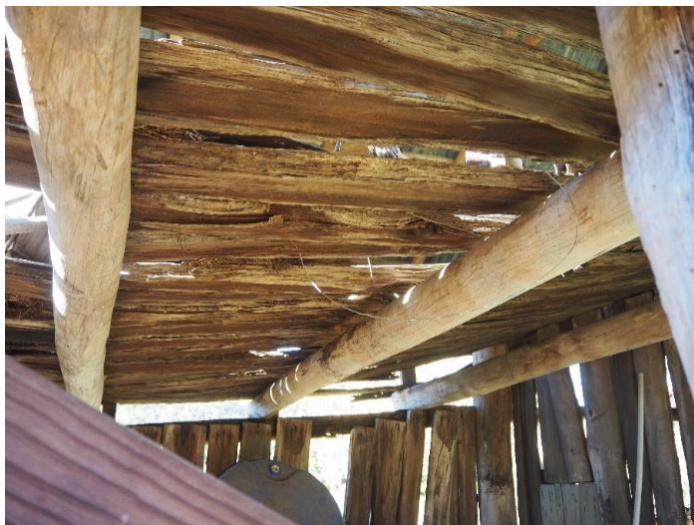
Caption: Barn 4 at 135A & B Wollombi Road (interior underside of loft)
Photographer: LSJ
Copyright Owner: Lucas Stapleton Johnson & Partners Pty Ltd
Date: June 2023

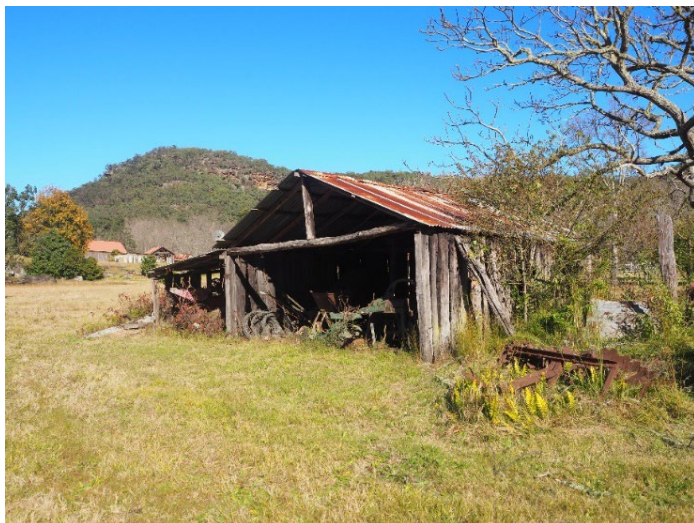
Caption: Barn 5 at 135A & B Wollombi Road (exterior)
Photographer: LSJ
Copyright Owner: Lucas Stapleton Johnson & Partners Pty Ltd
Date: June 2023

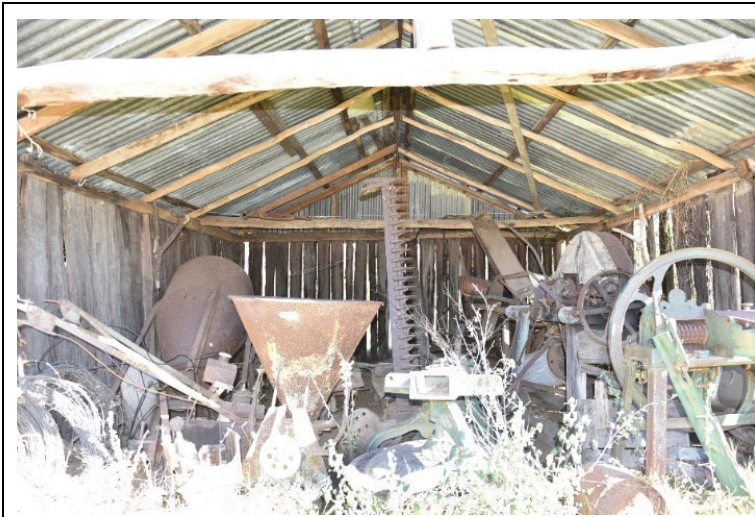
Caption: Barn 5 at 135A & B Wollombi Road (interior)
Photographer: LSJ
Copyright Owner: Lucas Stapleton Johnson & Partners Pty Ltd
Date: June 2023

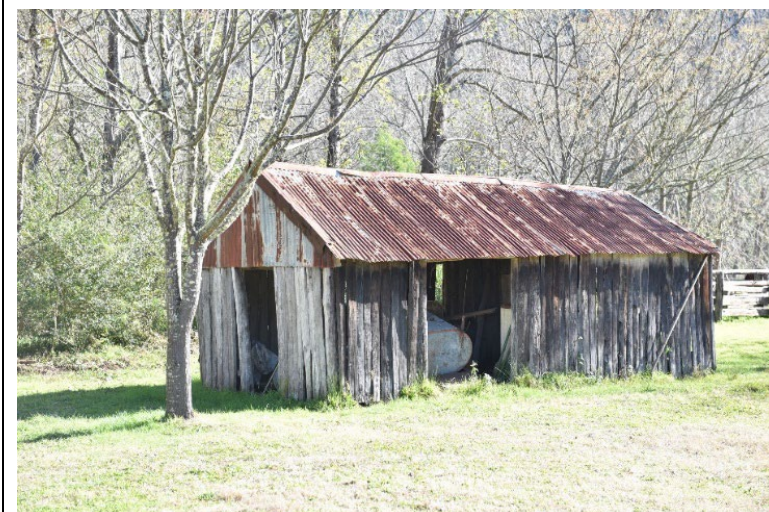
Caption: Barn 6 at 135A & B Wollombi Road (exterior)
Photographer: LSJ
Copyright Owner: Lucas Stapleton Johnson & Partners Pty Ltd
Date: June 2023

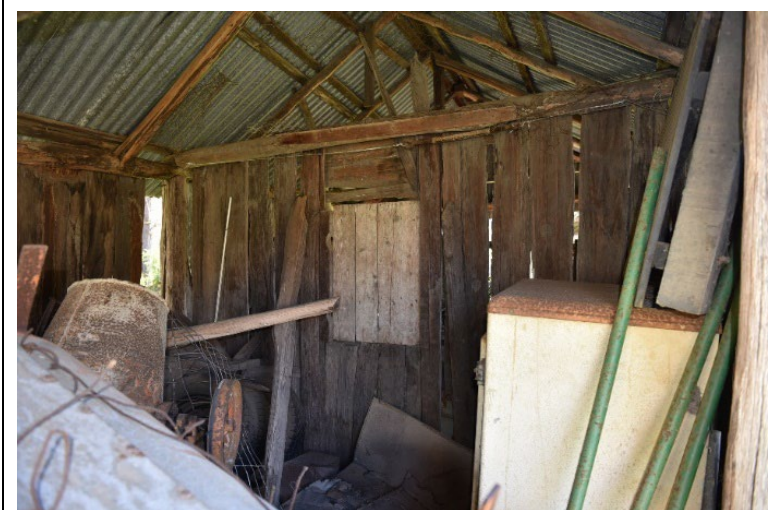
Caption: Barn 6 at 135A & B Wollombi Road (interior)
Photographer: LSJ
Copyright Owner: Lucas Stapleton Johnson & Partners Pty Ltd
Date: June 2023

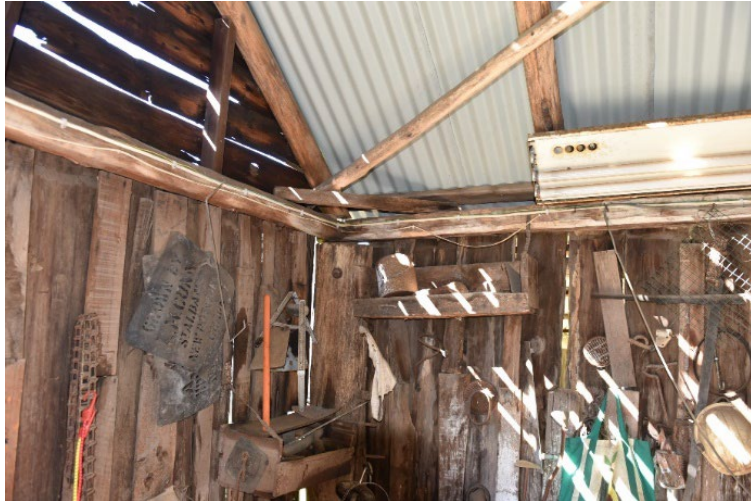
Caption: Barn 9 at 135A & B Wollombi Road (interior joint)
 Photographer: LSJ
 Copyright Owner: Lucas Stapleton Johnson & Partners Pty Ltd
 Date: June 2023

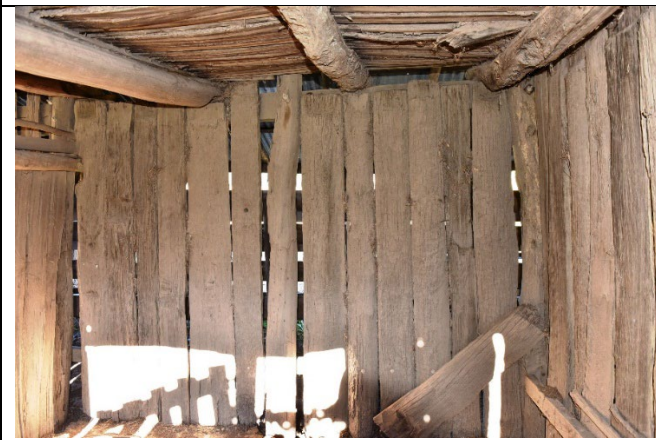
Caption: Interior detail of barn at No. 995 Upper Colo Road, Upper Colo
Photographer: S. Johnson
Copyright Owner: Lucas Stapleton Johnson & Partners
Date: June 2023

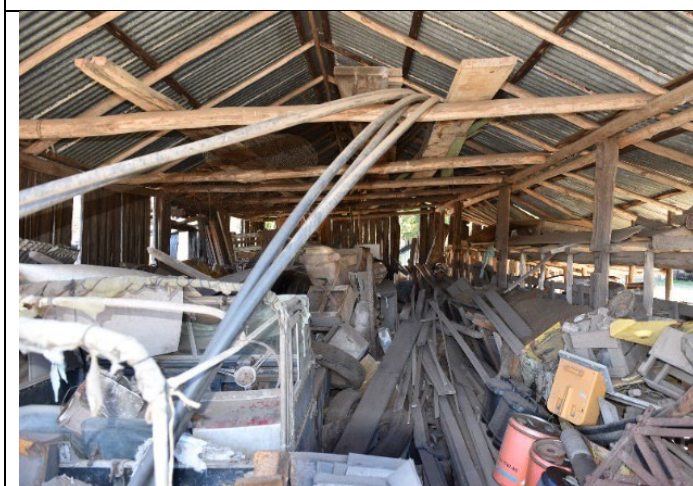
CRITERIA G) REPRESENTATIVE	<p>The barn at 1764 Upper MacDonald Road, Higher MacDonald is representative of the long history of agricultural development within the floodplains of the MacDonald River, which commenced in the early 19th century and continues today. The basic form of the barn with gabled roof, loft and skillion, is representative of the typical form of barn found throughout the district. <i>Meets the criterion on a Local level.</i></p>
INTEGRITY/INTACTNESS	Moderate/Poor condition

Caption: Barn at 1764 Upper MacDonald Road, Higher MacDonald (interior)
Photographer: S. Johnson
Copyright Owner: Lucas Stapleton Johnson & Partners Pty Ltd
Date: June 2023

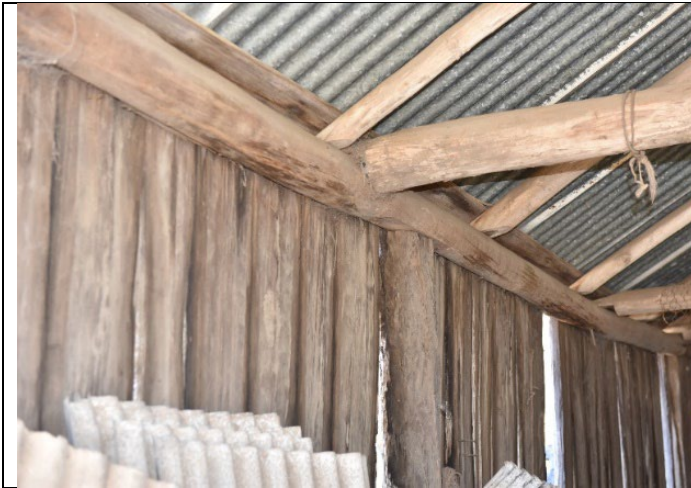
Caption: Detail of post/beam junction in barn at 1764 Upper MacDonald Road, Higher MacDonald
 Photographer: S. Johnson
 Copyright Owner: Lucas Stapleton Johnson & Partners Pty Ltd
 Date: June 2023

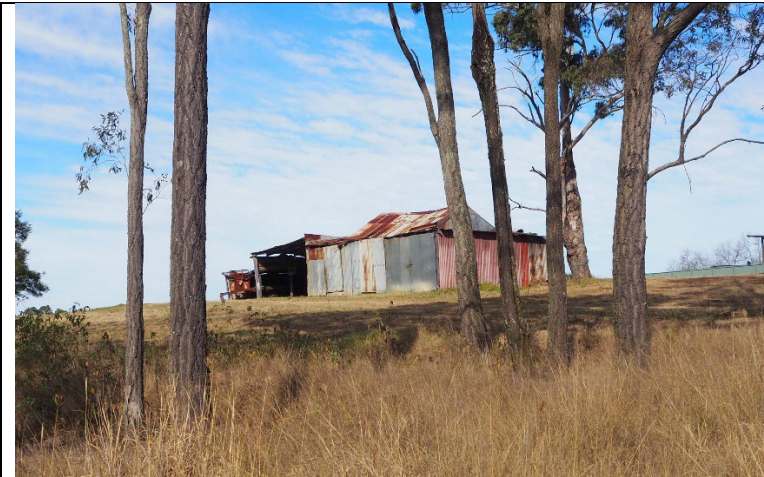
Caption: Barn at 8 Burdekin Road, Wilberforce (exterior)
Photographer: K. Denny
Copyright Owner: Lucas Stapleton Johnson & Partners Pty Ltd
Date: July 2023

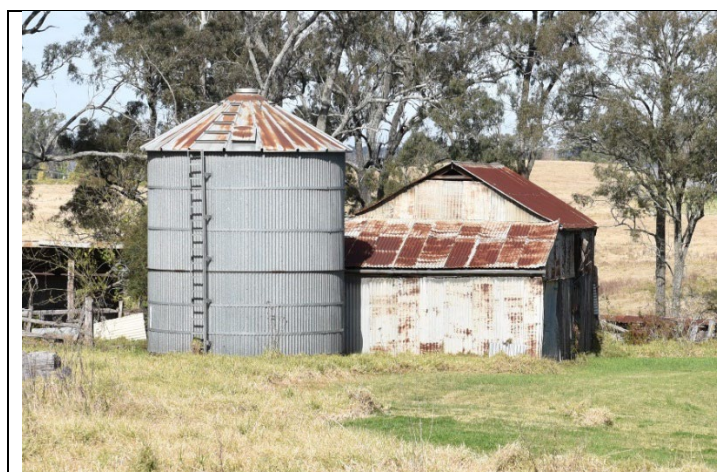
Caption: Barn and silo at 86 King Road, Wilberforce Road, Freemans Reach (exterior)
Photographer: S. Johnson
Copyright Owner: Lucas Stapleton Johnson & Partners Pty Ltd
Date: June 2023
