ITEM DETAILS	
NAME	Two storey Slab Carriage House and Stables
ADDRESS	4 Bensons Lane, Richmond
LOCAL GOVT AREA	Hawkesbury
PARISH	Ham Common
LOT/DP	12 DP 11828989
SHI No.	1743058
EXISTING HERITAGE ITEM	N
RECOMMENDED MANAGEMENT	
MANAGEMENT SUMMARY	Not recommended for State listing Recommend for Local listing.

ITEM DETAILS	
NAME	Single Storey Town Slab Barn with Side Skillion
OTHER/FORMER NAMES	House and Slab Barn
ADDRESS	118 Francis Street, Richmond
LOCAL GOVT AREA	Hawkesbury
PARISH	Ham Common
LOT/DP	Lot 1 DP 571910
SHI No.	1743057
EXISTING HERITAGE ITEM?	N
RECOMMENDED MANAGEMENT	
MANAGEMENT SUMMARY	Not recommended for State or local listing.

ITEM DETAILS	
NAME	Group of three barns- part of historic homestead
OTHER/FORMER NAMES	Hobartville
ADDRESS	36 & 40 Inalls Lane & 16 William Cox Drive, Richmond
LOCAL GOVT AREA	Hawkesbury
PARISH	Ham Common
LOT/DP	Lot 1 and 2 DP 596558
SHI No.	1743059
EXISTING HERITAGE ITEM?	Y- Item I14 (SHI 1741548) and SHR 00035 (SHI 5045232)
RECOMMENDED MANAGEMENT	
MANAGEMENT SUMMARY	Retain as State item
	Retain as Local item

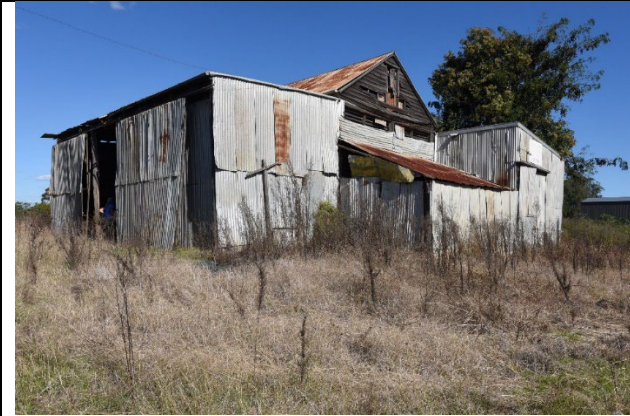
SKILLION 2	Western skillion has a low pitched roof with sawn rafters and battens and corrugated iron cladding. Remains of timber floor at north end, stepped concrete floor at south end. Date: Early 20 th century Condition: Poor
SKILLION 3	Eastern skillion has a flattish roof with sawn rafters and battens and corrugated iron cladding.

Date: Mid 20 th century? Condition: Poor
ROOF CLADDING:	Corrugated iron, short sheets. Condition: Poor
WALL CLADDING	Remains of vertical timber slabs on western side of both slatted drying enclosures at each end of main barn, remains of weatherboard cladding to upper level of central bay of barn, elsewhere corrugated iron. Condition: Poor
OPENINGS	Doorways in skillions, one side of main barn completely open to skillion.
FLOORING (GROUND)	Earthen
FLOORING (LOFT)	Timber boarding Condition: Moderate
FLOORING (SKILLION)	Earthen
INTERNAL STRUCTURE	Slatted drying enclosures at each end of barn. The southern enclosure has a raised ventilated floor of round poles. The northern one has no raised floor but a loft. Condition: Moderate
HISTORY	
<p>No. 87 Wilberforce Road, Wilberforce forms part of a grant of 30 acres of 19 November 1794 to James Richards to be known as Richards Farm (Portion 66, Parish Wilberforce) on the River Hawkesbury in the district of Mulgrave Place bounded on the north-east by Henry Hyams land and on the south west by Thomas Gosper.</p> <p>James Richards had been sentenced 7 years' transportation and arrived in NSW on the <i>Scarborough</i> as part of the First Fleet.</p> <p>On 2 June 1809, James Richards of Hawkesbury, dealer transferred 30 acres known as Richards farm and 15 acres part of Hyams Farm to John Norman, Hawkesbury for £400. John Norman of Windsor mortgaged both parcels of land to Samuel Terry, merchant of Sydney on 20 December 1815. On 24 March 1817, Norman transferred his interest in two farms mortgaged to Samuel Terry and Edward Eagar to Dennis Conway, containing all the farms, 'a Farm House, Houses, Land & premises'. Conway never appears to have confirmed his interest to this land.</p> <p>John Norman died shortly afterwards. Edward Eagar to whom Norman had mortgaged the land on 1 January 1817, successfully brought an action for debt against Norman's estate. An auction notice announced that the estate of John Norman deceased would be auctioned on 2 July, including 54 acres being Richards' farm and part of Hyam's farm. No details of buildings on the two grants were included in the notice. Both Richards' farm and 15 acres, half of Hyam Farm were purchased at the auction by Edward Eagar.</p> <p>By some means, which does not appear to have been recorded, the land came into the hands of Samuel Terry, ex-convict and successful merchant landowner. Samuel Terry gave his son John Terry the estate of Box Hill plus other land on 12 May 1831. On 7 and 8 September 1835, this land was settled on trustees for the benefit of John Terry and his children.</p> <p>On 1 January 1836, Richards' farm was leased for five years from Eleanor Terry to John Hogan. On 1 March 1854, Eleanor Terry leased 30 acres at Wilberforce for five years to John Barret. By a deed of release dated 17 February 1862 with the following parties, 1st John Hosking and John Richard</p>

Caption: Barn at 87 Wilberforce Road, Wilberforce (exterior)
Photographer: S. Johnson
Copyright Owner: Lucas Stapleton Johnson & Partners Pty Ltd
Date: May 2023

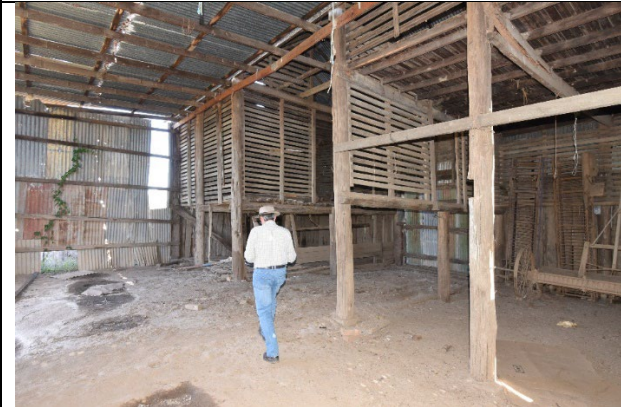
Caption: Barn at 87 Wilberforce Road, Wilberforce (interior)
Photographer: S. Johnson
Copyright Owner: Lucas Stapleton Johnson & Partners Pty Ltd
Date: May 2023

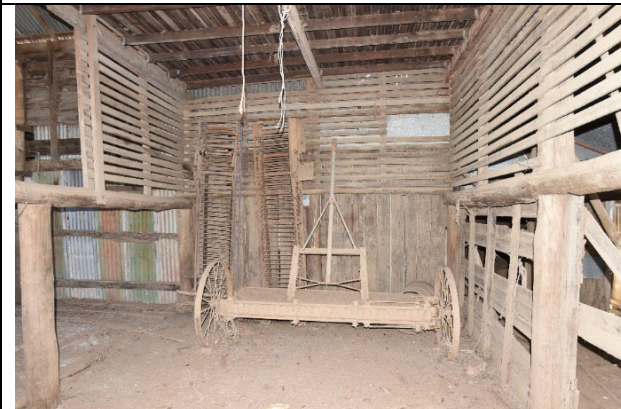
Caption: Barn at 87 Wilberforce Road, Wilberforce (interior)
Photographer: S. Johnson
Copyright Owner: Lucas Stapleton Johnson & Partners Pty Ltd
Date: May 2023

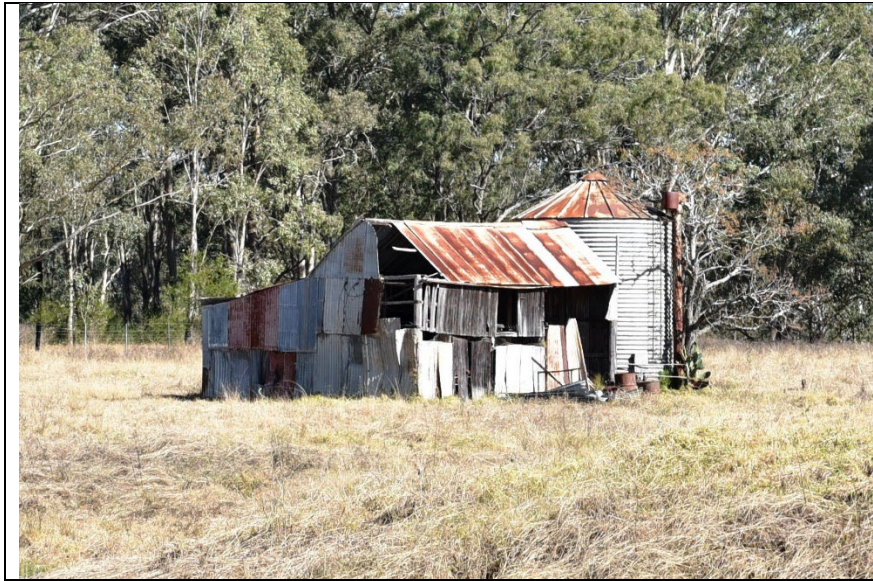
ITEM CLASSIFICATION	
ITEM TYPE	Built
ITEM GROUP	Farming and Grazing
ITEM CATEGORY	Barn
DESCRIPTION	
CIRCA	Y
PERIOD	Late 19 th – early 20 th century
CURRENT USE	?
FORMER USE	Barn
LOCATION ON SITE:	The barn with later attached metal clad silo, is in the middle of a paddock approximately 125m south of McKinnons Road. Associated with an early 20 th century weatherboard cottage.
MAIN BARN STRUCTURE	A small barn with loft and side skillion. The body of the barn is approximately 9 x 4m on plan. Condition: Poor
NO. OF BAYS	Three (assumed)
ROOF STRUCTURE	The roof is pitched at approximately 30° and has battens suitable for corrugated iron roofing. Condition: Poor
LOFT	Not inspected.
SKILLION	The skillion is approximately 3m wide and located along the southern side of the barn. It was not inspected. Condition: Not known
ROOF CLADDING:	Corrugated iron Condition: Poor
WALL CLADDING	Two lifts of vertical timber slabs with corrugated iron to gable end. Condition: Poor.

Caption: Barn at No. 55 McKinnons Road, Wilberforce.
Photographer: S. Johnson
Copyright Owner: Lucas Stapleton Johnson & Partners
Date: July 2023

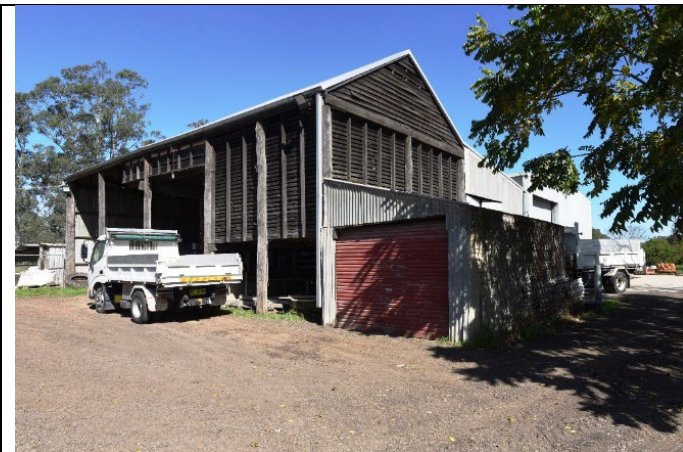
ITEM CLASSIFICATION	
ITEM TYPE	Built
ITEM GROUP	Farming and Grazing
ITEM CATEGORY	Barn
DESCRIPTION	
CIRCA	Y
PERIOD	Early 20 th century
CURRENT USE	Machinery store
FORMER USE	Barn
LOCATION ON SITE	Alongside (to the west of) Federation period weatherboard bungalow
MAIN BARN STRUCTURE	Single-storey barn with partial loft and lower-level mezzanine, round timber posts, sawn rectangular longitudinal beams and cross beams. End bays have diagonal bracing in plane of eaves. Date: Early 20 th century Condition: Good
NO. OF BAYS	Five (2 small 3 large).
ROOF STRUCTURE	Sawn rafters, some collar ties, sawn battens at wide centres for sheeting. Date: Early 20 th century Condition: Good
LOFT	Loft structure only in middle bay and cantilevered over half of one additional bay. Boarded sides with gaps for ventilation. Date: Early 20 th century
SKILLION 1	Single-storey skillion to the western side. End skillion to northern end. Date: Early 20 th century

Caption: Barn at 63 Wilberforce Road, Wilberforce (exterior)
 Photographer: S. Johnson
 Copyright Owner: Lucas Stapleton Johnson & Partners
 Date: May 2023

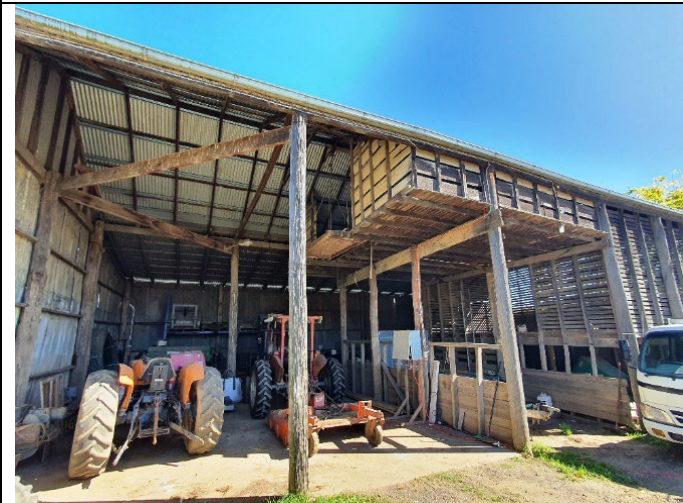
Caption: Barn at 63 Wilberforce Road, Wilberforce (interior)
 Photographer: S. Johnson
 Copyright Owner: Lucas Stapleton Johnson & Partners
 Date: May 2023

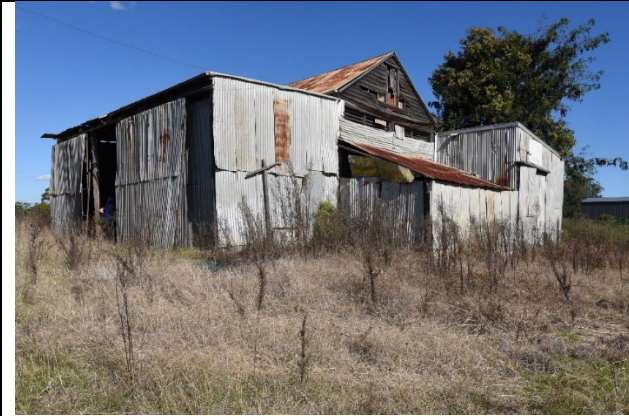
SKILLION 2	Western skillion has a low pitched roof with sawn rafters and battens and corrugated iron cladding. Remains of timber floor at north end, stepped concrete floor at south end. Date: Early 20 th century Condition: Poor
SKILLION 3	Eastern skillion has a flattish roof with sawn rafters and battens and corrugated iron cladding.

Date: Mid 20 th century? Condition: Poor
ROOF CLADDING:	Corrugated iron, short sheets. Condition: Poor
WALL CLADDING	Remains of vertical timber slabs on western side of both slatted drying enclosures at each end of main barn, remains of weatherboard cladding to upper level of central bay of barn, elsewhere corrugated iron. Condition: Poor
OPENINGS	Doorways in skillions, one side of main barn completely open to skillion.
FLOORING (GROUND)	Earthen
FLOORING (LOFT)	Timber boarding Condition: Moderate
FLOORING (SKILLION)	Earthen
INTERNAL STRUCTURE	Slatted drying enclosures at each end of barn. The southern enclosure has a raised ventilated floor of round poles. The northern one has no raised floor but a loft. Condition: Moderate
HISTORY	
<p>No. 87 Wilberforce Road, Wilberforce forms part of a grant of 30 acres of 19 November 1794 to James Richards to be known as Richards Farm (Portion 66, Parish Wilberforce) on the River Hawkesbury in the district of Mulgrave Place bounded on the north-east by Henry Hyams land and on the south west by Thomas Gosper.</p> <p>James Richards had been sentenced 7 years' transportation and arrived in NSW on the <i>Scarborough</i> as part of the First Fleet.</p> <p>On 2 June 1809, James Richards of Hawkesbury, dealer transferred 30 acres known as Richards farm and 15 acres part of Hyams Farm to John Norman, Hawkesbury for £400. John Norman of Windsor mortgaged both parcels of land to Samuel Terry, merchant of Sydney on 20 December 1815. On 24 March 1817, Norman transferred his interest in two farms mortgaged to Samuel Terry and Edward Eagar to Dennis Conway, containing all the farms, 'a Farm House, Houses, Land & premises'. Conway never appears to have confirmed his interest to this land.</p> <p>John Norman died shortly afterwards. Edward Eagar to whom Norman had mortgaged the land on 1 January 1817, successfully brought an action for debt against Norman's estate. An auction notice announced that the estate of John Norman deceased would be auctioned on 2 July, including 54 acres being Richards' farm and part of Hyam's farm. No details of buildings on the two grants were included in the notice. Both Richards' farm and 15 acres, half of Hyam Farm were purchased at the auction by Edward Eagar.</p> <p>By some means, which does not appear to have been recorded, the land came into the hands of Samuel Terry, ex-convict and successful merchant landowner. Samuel Terry gave his son John Terry the estate of Box Hill plus other land on 12 May 1831. On 7 and 8 September 1835, this land was settled on trustees for the benefit of John Terry and his children.</p> <p>On 1 January 1836, Richards' farm was leased for five years from Eleanor Terry to John Hogan. On 1 March 1854, Eleanor Terry leased 30 acres at Wilberforce for five years to John Barret. By a deed of release dated 17 February 1862 with the following parties, 1st John Hosking and John Richard</p>

Caption: Barn at 87 Wilberforce Road, Wilberforce (exterior)
Photographer: S. Johnson
Copyright Owner: Lucas Stapleton Johnson & Partners Pty Ltd
Date: May 2023

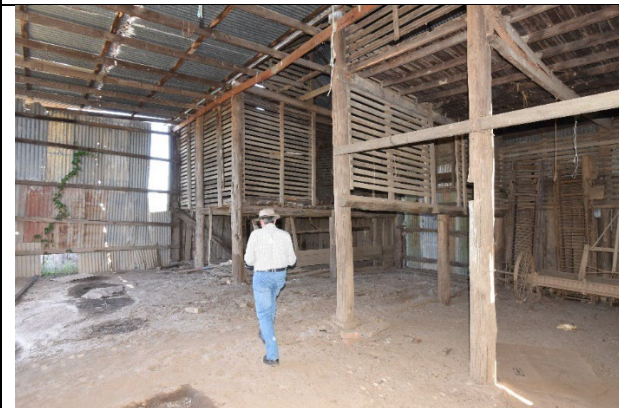
Caption: Barn at 87 Wilberforce Road, Wilberforce (interior)
Photographer: S. Johnson
Copyright Owner: Lucas Stapleton Johnson & Partners Pty Ltd
Date: May 2023

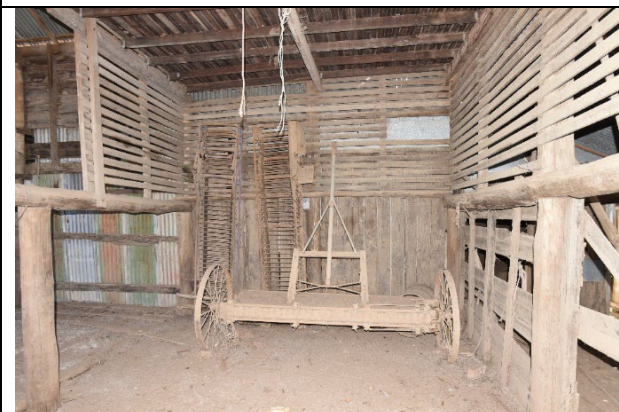
Caption: Barn at 87 Wilberforce Road, Wilberforce (interior)
Photographer: S. Johnson
Copyright Owner: Lucas Stapleton Johnson & Partners Pty Ltd
Date: May 2023

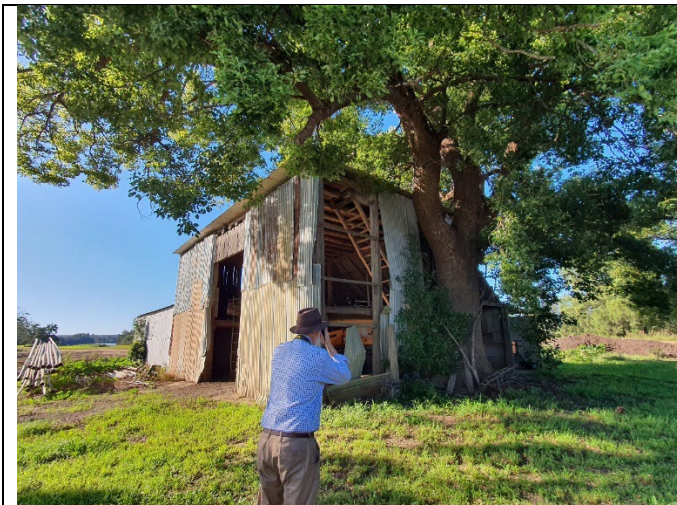
Caption: Barn at 191 Wilberforce Road, Wilberforce (exterior)
Photographer: K. Denny
Copyright Owner: Lucas Stapleton Johnson & Partners
Date: May 2023

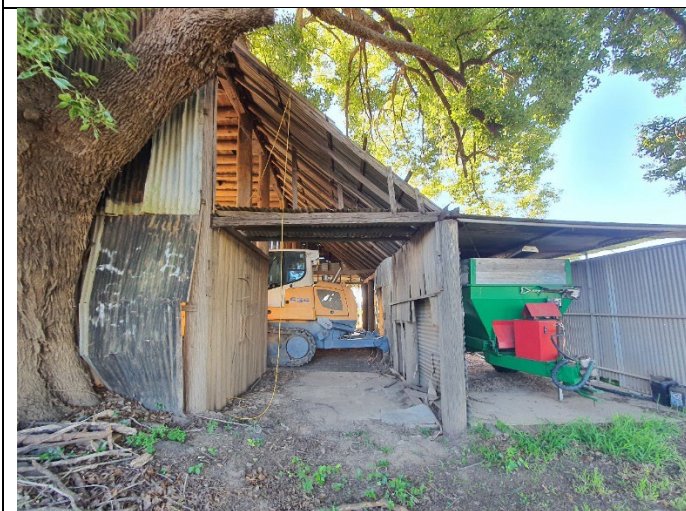
SKILLION 1	Steep 45° skillion along whole eastern side of barn. Pole rafters and sawn battens for corrugated iron. Date: Mid – late 19 th century? Condition: Moderate
ROOF CLADDING:	Corrugated iron sheets laid flat on loft floor. Condition: Moderate
WALL CLADDING	Remains of vertical timber slabs on southern end of main barn and an upper level of vertical slabs in central bay. Remains of weatherboard cladding to skillion gables, elsewhere corrugated iron. Date: Mid – late 19 th century?
OPENINGS	Main doorway in centre of front wall. Skillion open at ends.
FLOORING (GROUND)	Earthen (cement screed at one end)
FLOORING (LOFT)	Timber boarding Date: Mid – late 19 th century?

Caption: Barn at 191 Wilberforce Road, Wilberforce (exterior and skillion)
Photographer: K. Denny
Copyright Owner: Lucas Stapleton Johnson & Partners
Date: May 2023

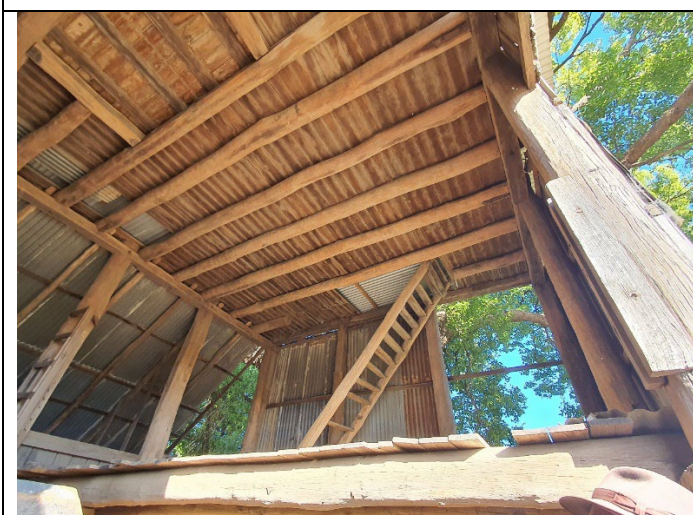
Caption: Barn at 191 Wilberforce Road, Wilberforce (interior)
Photographer: K. Denny
Copyright Owner: Lucas Stapleton Johnson & Partners
Date: May 2023

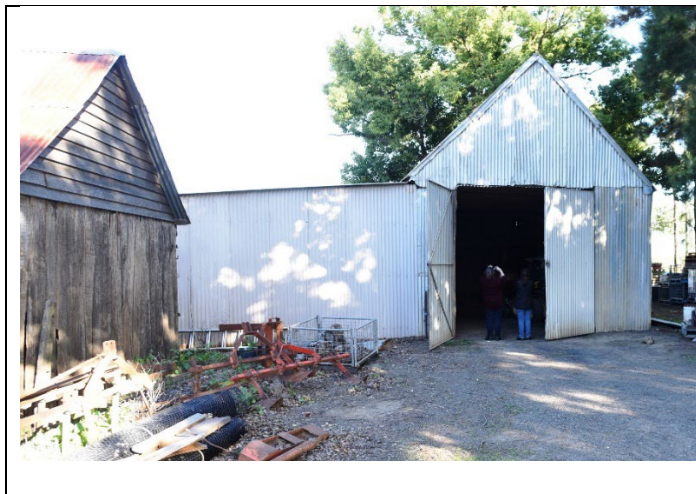
LOFT	Small loft structure supported on pole beams at southern end approximately 1.0m below eaves level. Larger loft at eaves level consisting of closely spaced round beams and loose flooring in centre only. Condition: Good
SKILLION 1	Shallow pitched skillion on eastern side Condition: Good Date: Late 20 th century?
ROOF CLADDING:	Corrugated iron short sheets. Condition: Moderate
WALL CLADDING	Vertical timber slabs except in central doorways which have timber ventilation grilles over. Exterior now clad in corrugated steel. Condition: Good

Date: Early 19 th century?
OPENINGS	Central doorways in both sides of barn with ventilated panels over.
FLOORING (GROUND)	Earthen
FLOORING (LOFT)	Timber boarding
FLOORING (SKILLION)	Concrete.
INTERNAL STRUCTURE	Large, round, closely spaced beams to loft floors.
OTHER (Fixings?)	Camphor laurel tree at southern end causing damage. Post/ beam pegged mortice and tenon joints Wooden pegs used to join cross beams to longitudinal beams.
DESCRIPTION: BARN B	
MAIN BARN STRUCTURE	Small barn or garage constructed of round posts, adzed squared longitudinal beams. Condition: Moderate
NO. OF BAYS	Three
ROOF STRUCTURE	Bush pole rafters. Bracing and central tie added later. No shingle battens. Condition: Moderate Date: Late 19 th century?
LOFT	Small loft supported on poles 300mm below eaves level in western end. Condition: Moderate Date: Late 19 th century?
SKILLION 1	N/A
ROOF CLADDING:	Corrugated iron makers name: Gospel Oak (1850-1939). Condition: Moderate

Caption: Barn A at 253 Wilberforce Road, Wilberforce (exterior)
 Photographer: S. Johnson
 Copyright Owner: Lucas Stapleton Johnson & Partners Pty Ltd
 Date: May 2023

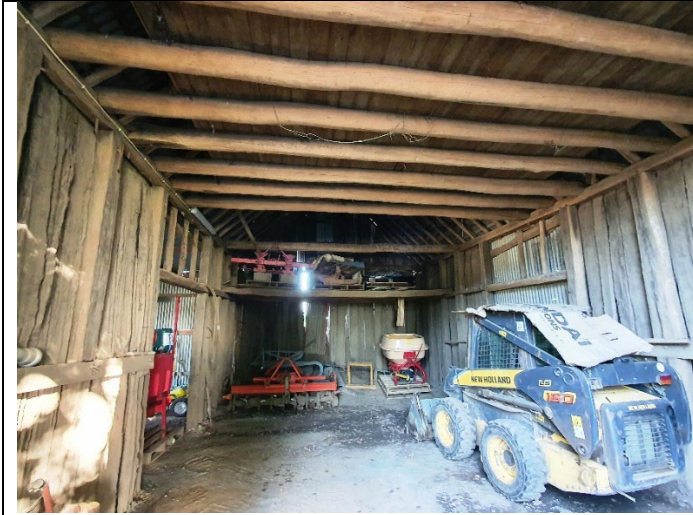
Caption: Barn A at 253 Wilberforce Road, Wilberforce (interior)
Photographer: S. Johnson
Copyright Owner: Lucas Stapleton Johnson & Partners Pty Ltd
Date: May 2023

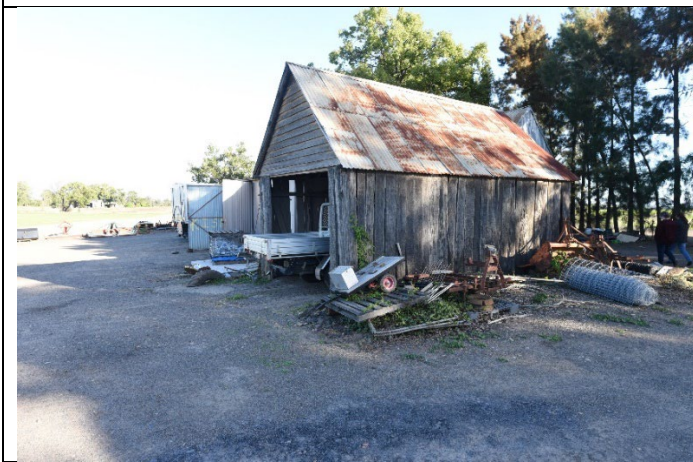
WALL CLADDING	Vertical timber slabs, weatherboard cladding to gables, elsewhere corrugated iron. Condition: Moderate Date: Late 19 th century?
OPENINGS	Large doorway in gable end only.
FLOORING (GROUND)	Earthen
FLOORING (LOFT)	Loose timber boarding Condition: Moderate Date: Late 19 th century?
FLOORING (SKILLION)	N/A
INTERNAL STRUCTURE	Large, round, closely spaced beams to mezzanine and loft floors. Condition: Moderate Date: Late 19 th century?
OTHER (Fixings?)	Iron bolts and straps used to join beams to posts. Condition: Moderate Date: Late 19 th century?
HISTORY	
<p>Matthew/Matthias Lock (various Locke) was granted 30 acres (Portion 60, Parish Wilberforce) in the district of Mulgrave Place on the River Hawkesbury on 19 November 1794. Lock had been transported to Australia for 7 years, arriving in 1790.</p> <p>Lock originally concentrated on growing maize but switched to wheat, which had a ready market. Later, Lock acquired his neighbour David Lankey's 30 acre grant (Portion 61, Parish Wilberforce), and he eventually became one of the most successful ex-convict landholders in the district,</p>

Caption: Barn B at 253 Wilberforce Road, Wilberforce (exterior)
Photographer: S. Johnson
Copyright Owner: Lucas Stapleton Johnson & Partners Pty Ltd
Date: May 2023

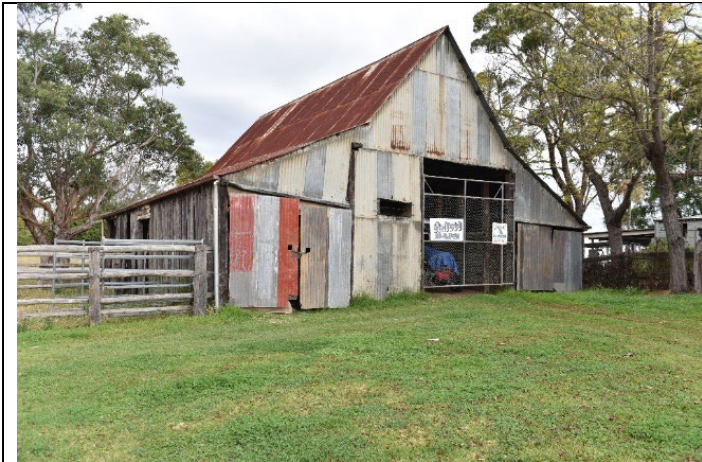
Caption: Barn at Australiana Pioneer Village, No. 496 Wilberforce Road, Wilberforce (exterior)
Photographer: S. Johnson
Copyright Owner: Lucas Stapleton Johnson & Partners
Date: July 2023

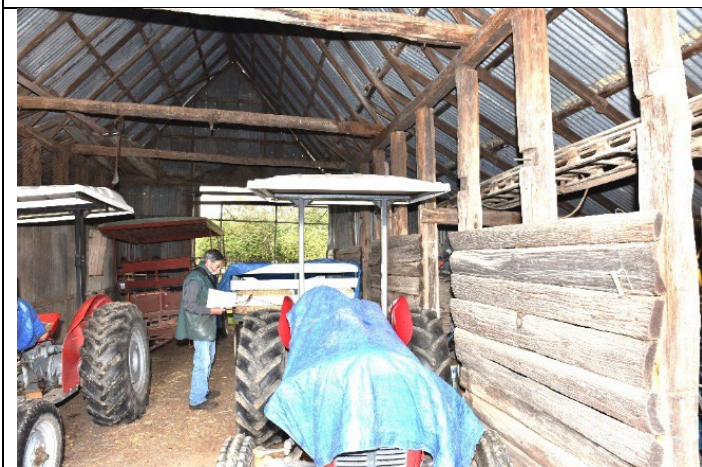
Caption: Barn at Australiana Pioneer Village, No. 496 Wilberforce Road, Wilberforce (interior)
Photographer: S. Johnson
Copyright Owner: Lucas Stapleton Johnson & Partners
Date: July 2023

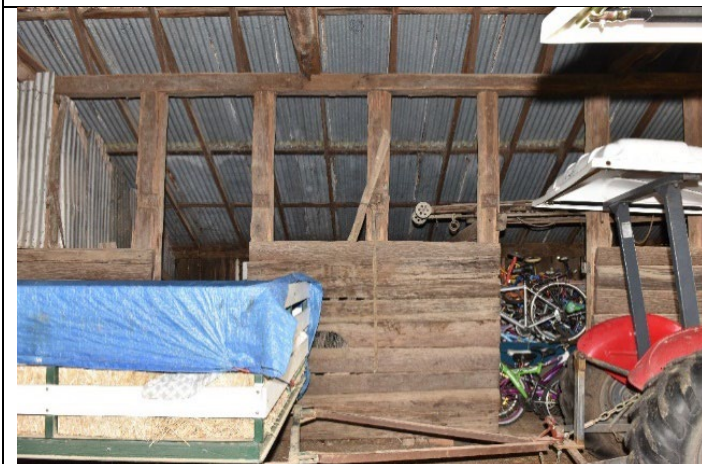
Caption: Detail of posts and beam separating main barn from skillion (note evidence of loft support), No. 496 Wilberforce Road, Wilberforce
Photographer: S. Johnson
Copyright Owner: Lucas Stapleton Johnson & Partners
Date: July 2023

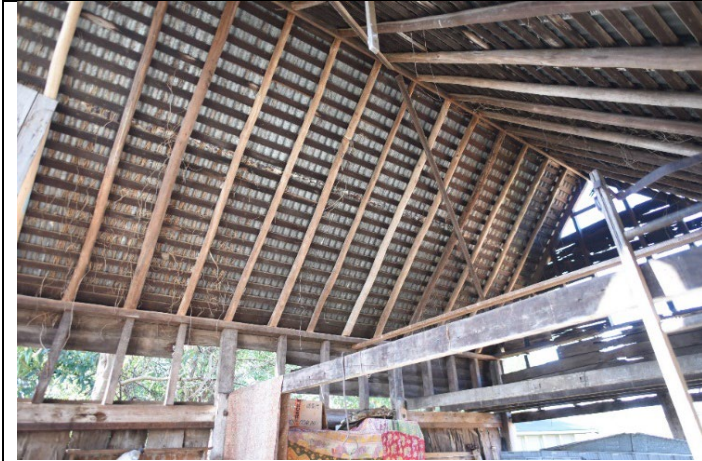
Caption: The town barn at No. 4 Catherine Street, Windsor (interior).
Photographer: S. Johnson
Copyright Owner: Lucas Stapleton Johnson & Partners
Date: May 2023

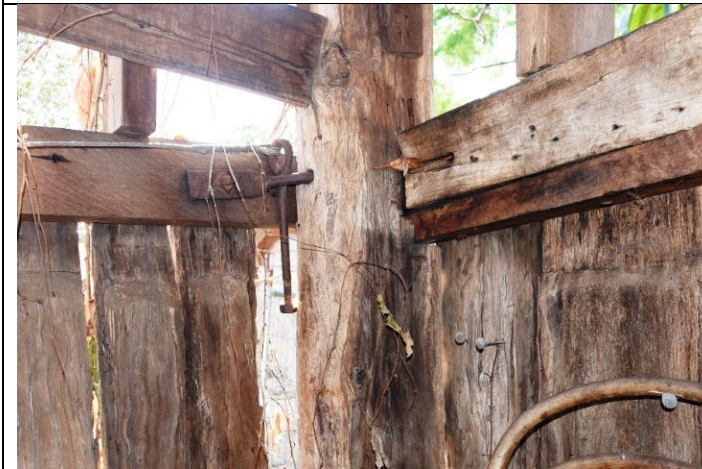
Caption: The town barn at No. 4 Catherine Street, Windsor (interior detail).
Photographer: S. Johnson
Copyright Owner: Lucas Stapleton Johnson & Partners
Date: May 2023

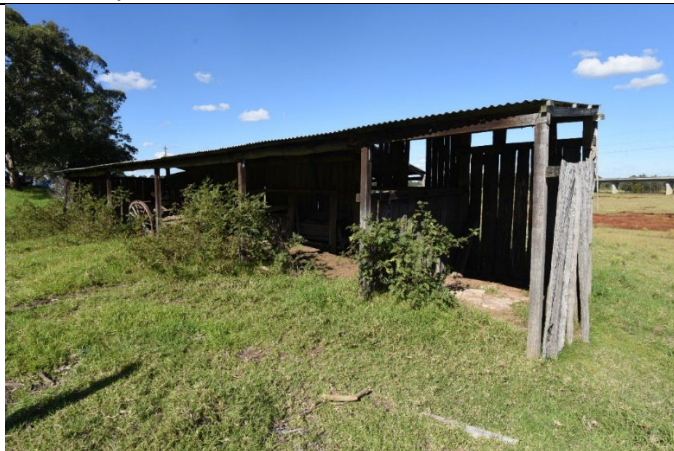
Caption: Milking shed/stables at No. 10 Day Street, Windsor (exterior of stables)
Photographer: S. Johnson
Copyright Owner: Lucas Stapleton Johnson & Partners Pty Ltd
Date: May 2023

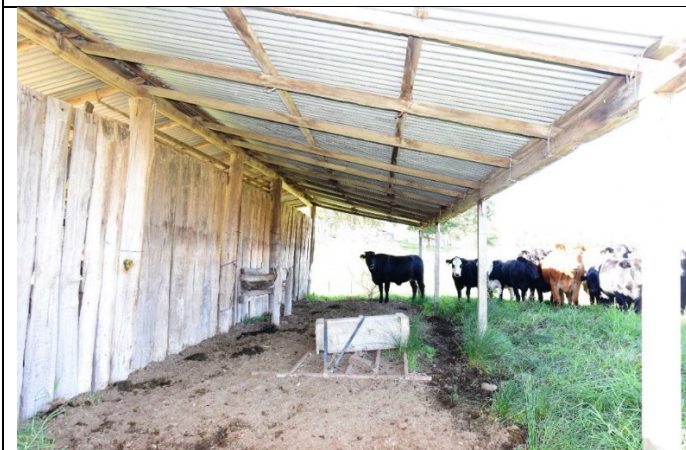
Caption: Milking shed/stables at No. 10 Day Street, Windsor (interior- stables)
Photographer: S. Johnson
Copyright Owner: Lucas Stapleton Johnson & Partners Pty Ltd
Date: May 2023

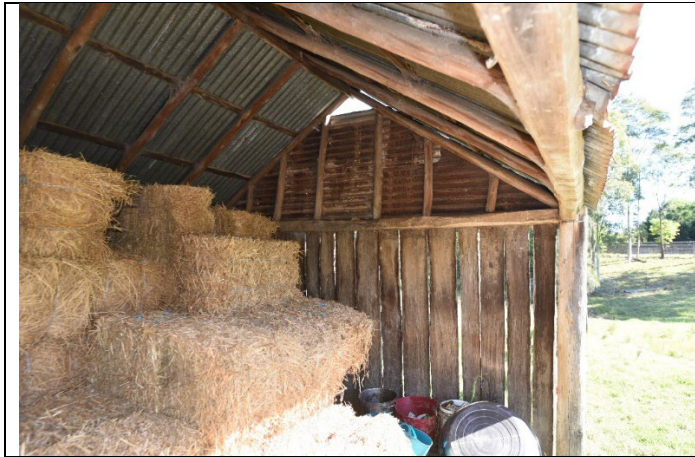
Caption: Timber slab animal shelter/hay shed at No. 10 Day Street, Windsor (interior)
Photographer: S. Johnson
Copyright Owner: Lucas Stapleton Johnson & Partners Pty Ltd
Date: May 2023

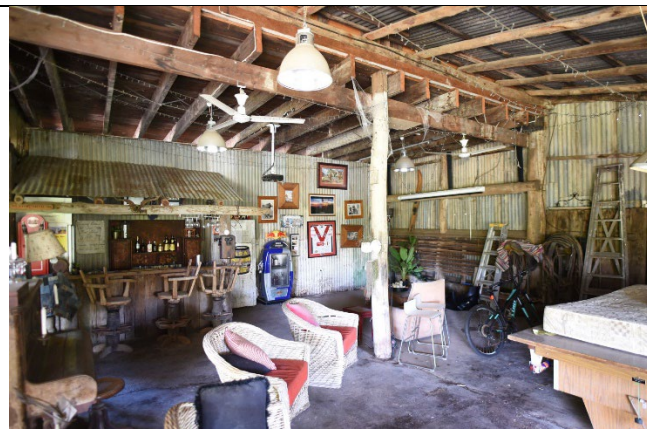
Caption: Barn at 23A George Street, Windsor (interior)
 Photographer: LSJ
 Copyright Owner: Lucas Stapleton Johnson & Partners Pty Ltd
 Date: May 2023

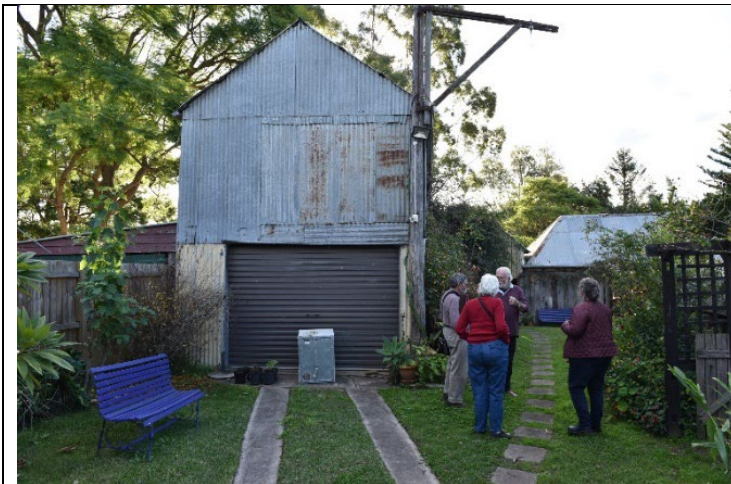
Caption: Barn at 31 George Street, Windsor (exterior)
Photographer: S. Johnson
Copyright Owner: Lucas Stapleton Johnson & Partners Pty Ltd
Date: June 2023
