Windsor Bridge Artefacts Collection

Infrastructure artefacts from the
Thompson Square Conservation Area
found during archaeological salvage for the
Windsor Bridge Replacement Project
2017 to 2021
that are still in situ or are
in storage outside
the Wilberforce HCC Depot.

For the Windsor Bridge Replacement Project
Artefacts Working Group
of Hawkesbury City Council

July 2024

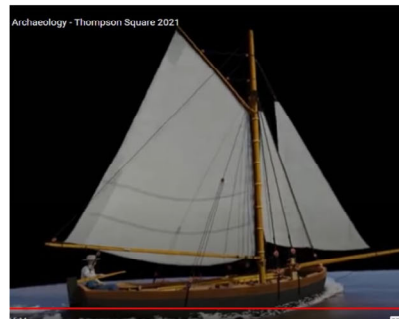
Still from digital animation on Thompson Square website, based on the cutter remains, matches historical descriptions of the small vessels used for trading supplies between Sydney Cove and the Green Hills settlement.

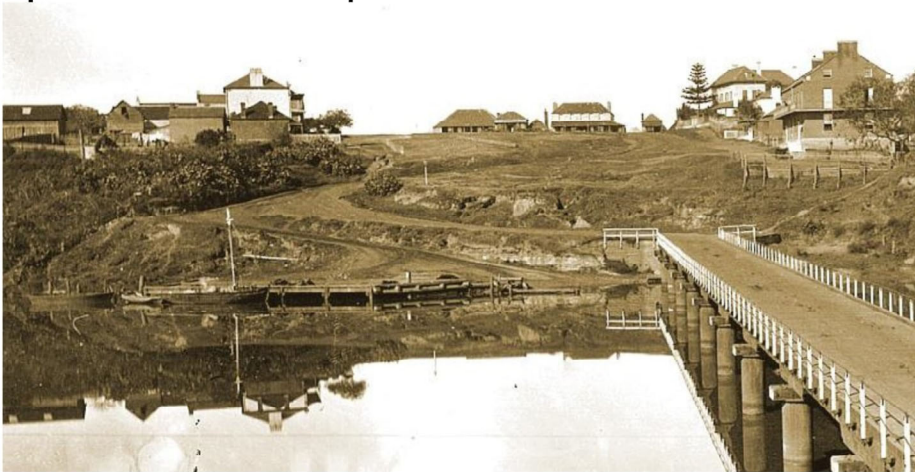
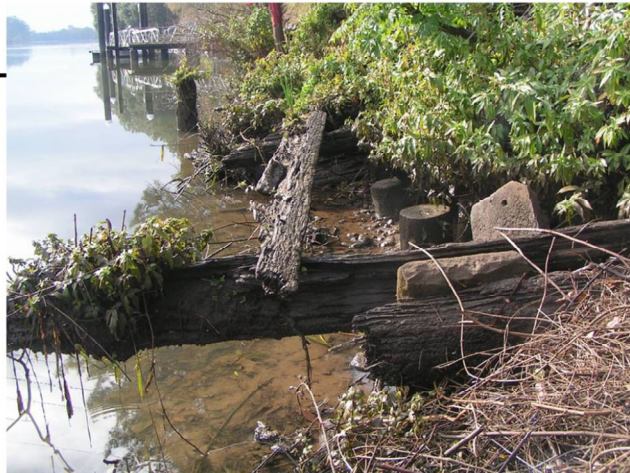
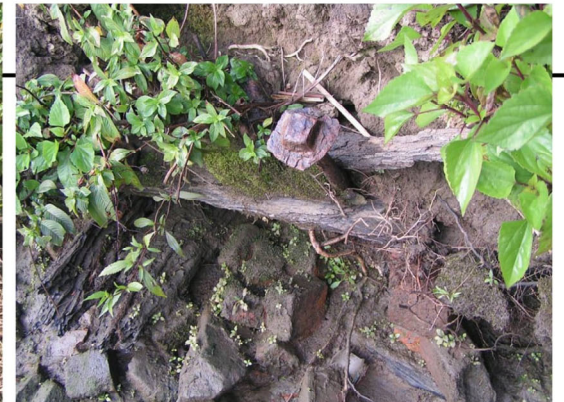
3 Historic Windsor wharf

<p>Location known</p>	<p>In situ on riverbank between current Windsor wharf and the historic bridge viewing platform, partly under the new bridge.</p>
<p>Description: first recorded</p>	
<p>Historical confirmation</p>	<p>In 1814, Governor Macquarie had set about 'filling up Thompson's Square and erecting a Wharf' using local contractors, John Howe and James McGrath. [<i>L. Macquarie, Journal of his Tours in New South Wales and Van Diemen's Land 1810-1822, Library of Australian History in association with the Library Council of New South Wales, Sydney, 1979; Sydney Gazette, 12 November 1814, the Trustees of the Police Fund in Account (Quarter ended 30 September, 1814) paid £100; Sydney Gazette, 28 January 1815, the Trustees of the Police Fund in Account (Quarter ended 30 September, 1814) paid second instalment £75, Sydney Gazette, 5 August 1815-£100.</i>]</p> <p>The construction projected into the river for 8.5 metres, was almost 2 metres high and was 20 metres in length running along beside the bank alongside the Square. It was in use by March 1815, when Lawrence May advertised to his customers that transport for their grain was available from there to his George Street horse-operated flour mill. [<i>Sydney Gazette, 4 March 1815.</i>]</p> <p>Almost immediately, an upgrading to continue the wharf along 'the whole extent of the square' was undertaken, projecting the jetty just over 9 metres into the river, one metre above that of 1814, and over four times longer to around 85 metres. Such a strong wharf was to entail placing 560 massive piles in three rows and require 5,000 spikes from government stores [<i>Sydney Gazette, 3 June 1815</i>]. The payment made at the end of the September Quarter to Howe and McGrath was listed as 'the first instalment of the contract for enlarging and improving the wharf' and was followed by one other payment. [<i>Sydney Gazette, 4 November 1815-£200, 11 May 1816-part of £200</i>]</p> <p>The construction was to create a new wooden 'platform' with the piles on the landward side, taking the full weight of the infill, which was to reach the top of the new wharf. The piles were to be 'well-secured with Land Ties and Caps and planked with sound two inch Planks and not more than six inches wide to be spiked with five inch spikes.</p>

Although the dimensions of the vertical piles were not specified in the 1815 contract, the earlier contract stipulated that each pile should measure between 16 and 18 inches and that the piles should be placed from three to four feet apart. Standing at least three feet above the surface, the reinforced landward side of the wharf was a substantial buffer for the weight of the fill required to diminish the slope.

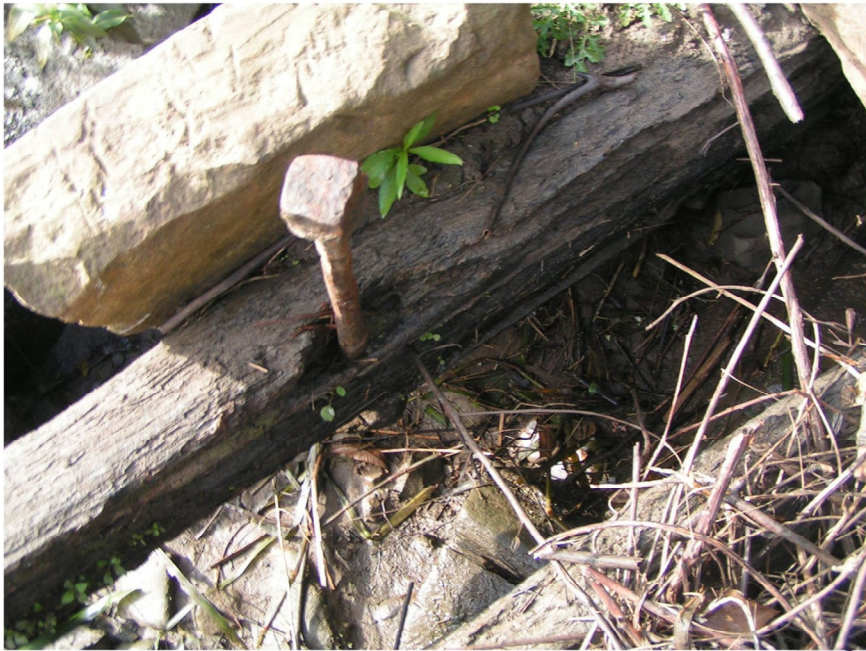
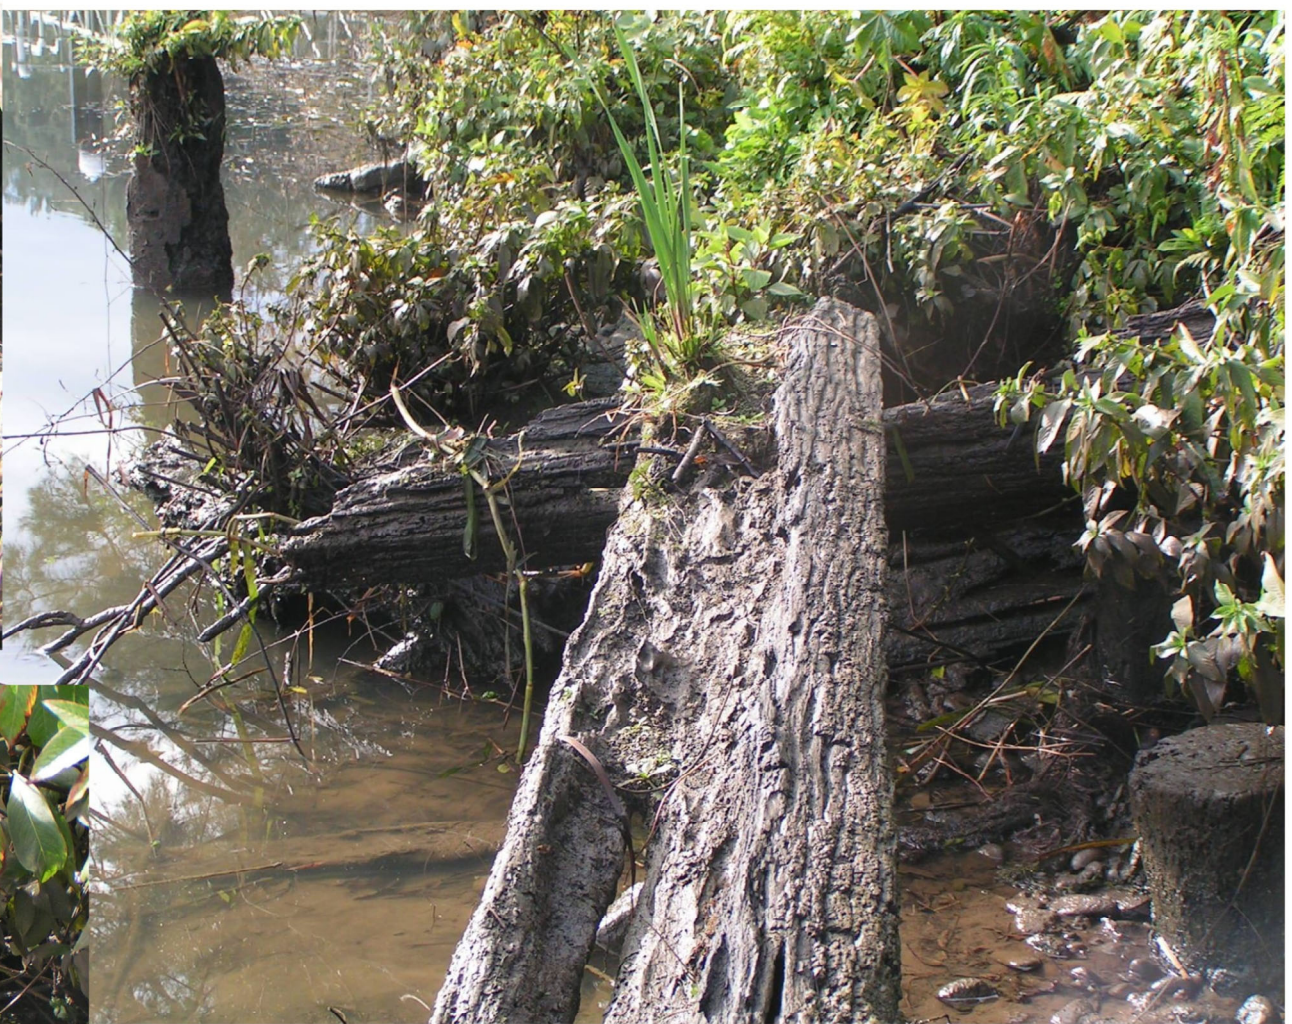
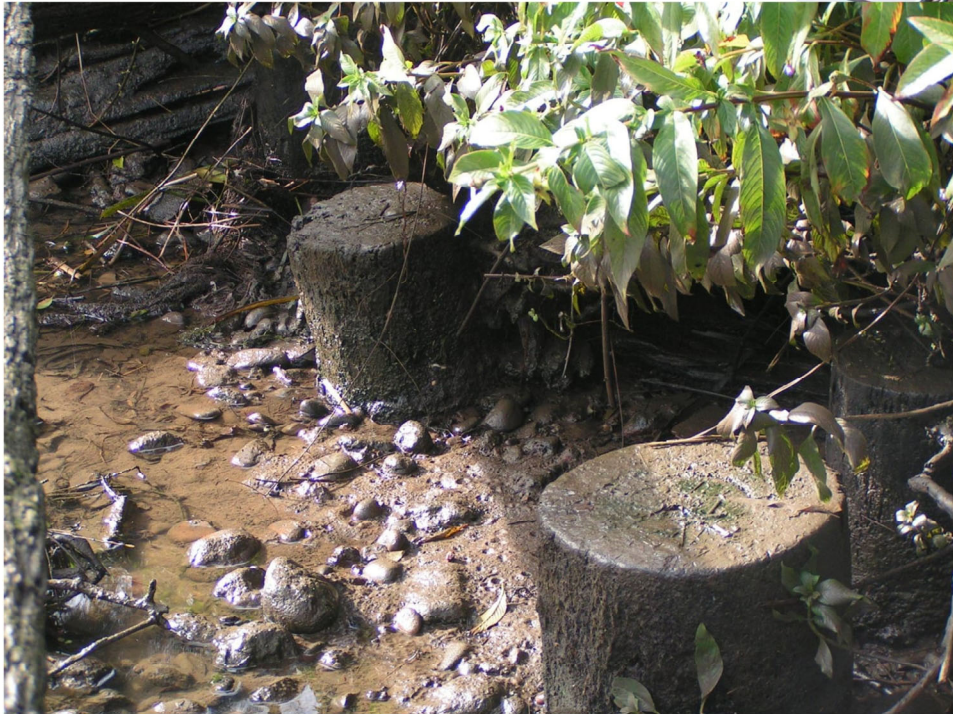
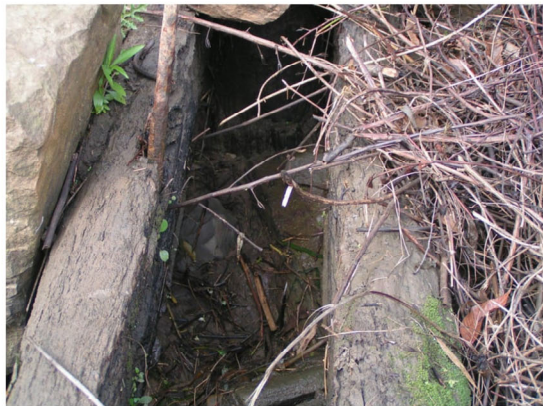
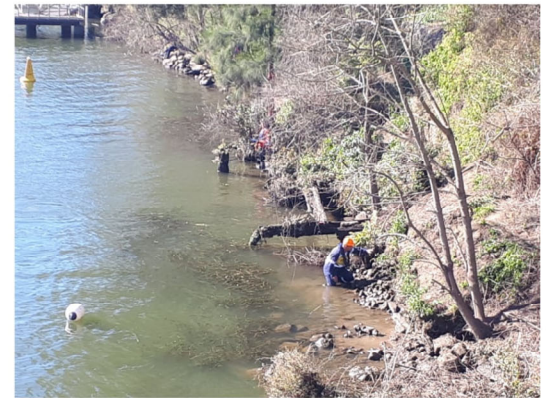
2 Historic Windsor wharf

The 1815 floods severely damaged the wharf and it was reported that 'all the planking is carried away and there is no part of the wharf that can be built on again'. *(Report by Cox, Mileham and Fitzgerald, 4 July 1816, State Archives NSW, Reel 4045, 4/1735, p. 83; Bowd, Macquarie Country, rev. ed., 1973, p. 42)*

The June 1816 floods destroyed the works, leaving only a mess of tangled posts visible in the river, shown graphically in Captain Wallis' painting at that time. *[Sydney Gazette 8 June 1816, 29 June 1816; Captain James Wallis, 'A View of the Hawkesbury and the Blue Mountains', 1816, engraved by William Preston in 1820]*

Francis Greenway was called in to design the fifth government wharf at Hawkesbury in 21 years. The new strengthening measures, together with the contractor's extra work, cost an additional £120 [\$250]. This included 'payment [...for] such Iron & Spike Nails from the Store as can be spared – with a Carpenter and Pair of Sawyers off the Store'. Completion was to be in eight months, but it appears to have been completed early, as the final payment was made in the September Quarter's payments. *[Sydney Gazette, 8 February 1817- £150.]*

The Greenway Quay^[xii] finally completed the early Windsor wharf saga and it entered into long-term use around early 1817, having cost in total almost £900. *[1816 Sydney Gazette, 11 May 1816.?? 4 Nov??]* The high floods of June 1816 and February 1817 damaged the wharves yet again and payment was not finalised until 1820 after another flood in 1819.

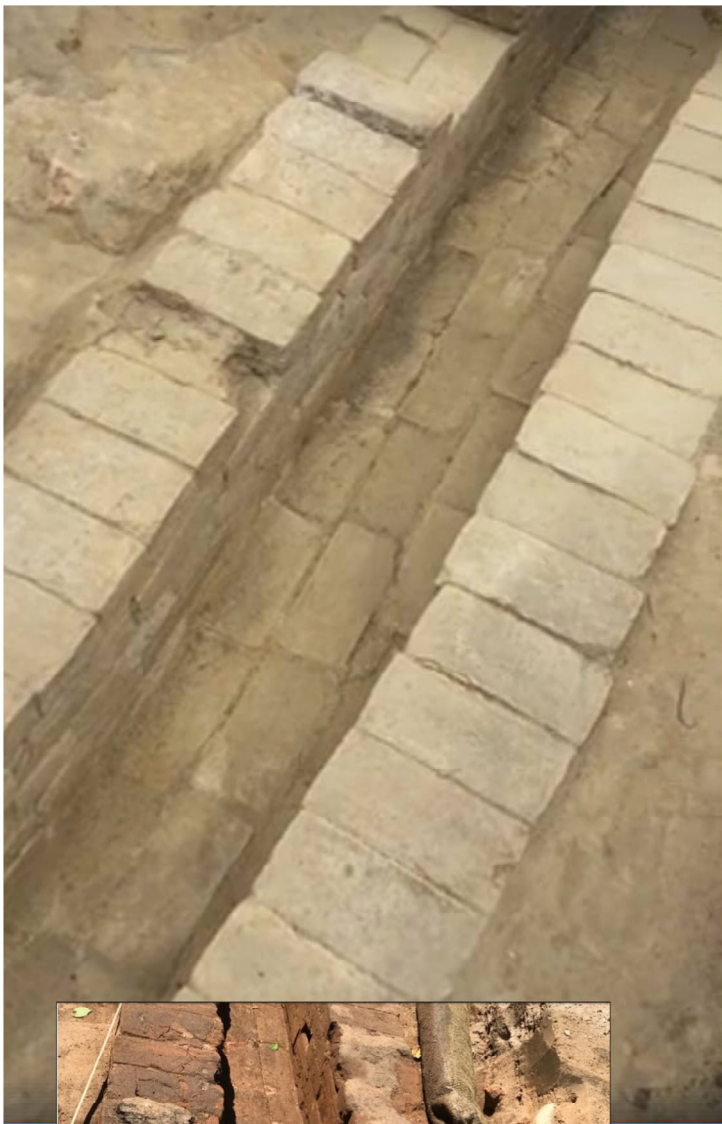
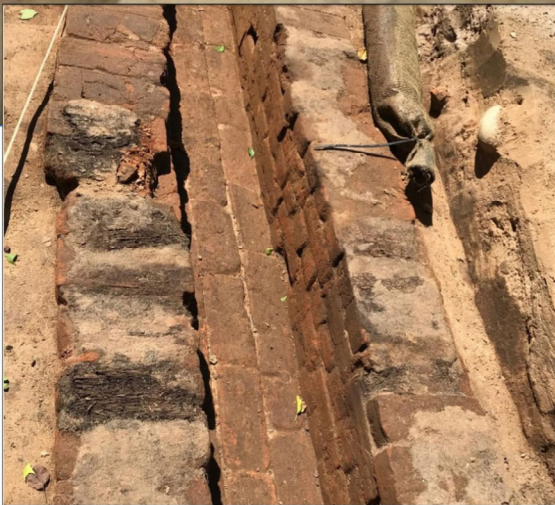
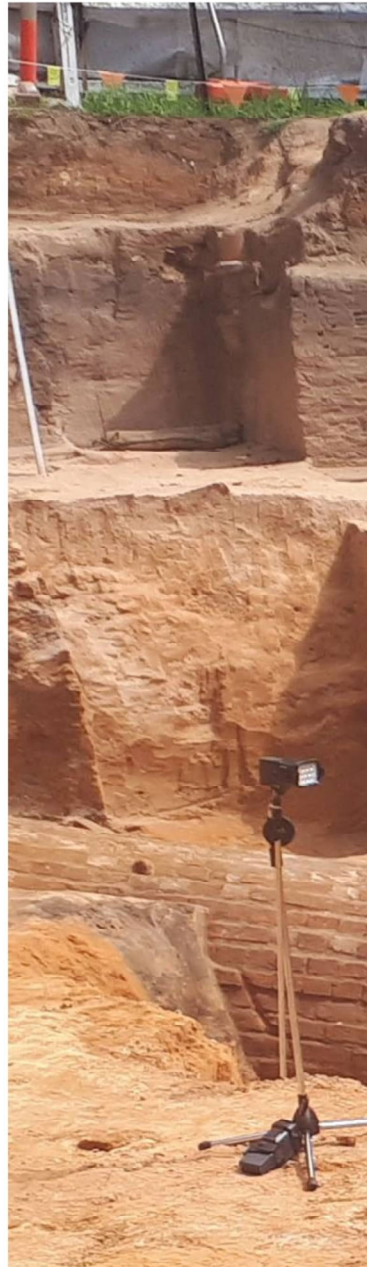
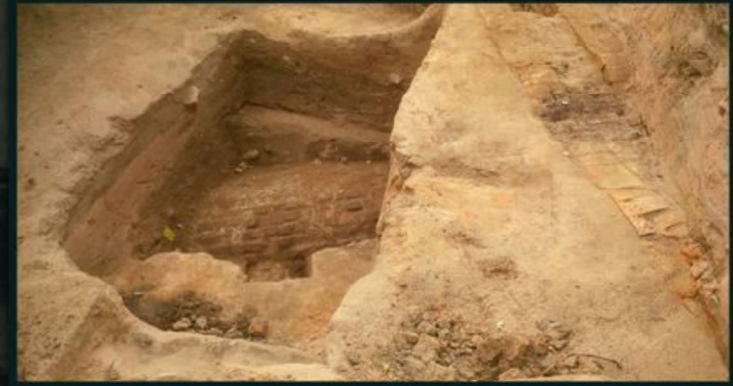
3. Thompson Square land drainage system

<p>Location known</p>	<p>Thompson Square Conservation Area</p>
<p>Description: first recorded</p>	<p>The intact land drainage system, as ordered to be built by Gov Lachlan Macquarie in 1814, comprising of brick barrel drain, brick sumps and brick box channels, was uncovered during WBRP salvage archaeology in the Lower Reserve compound in early 2018. The brick barrel drain is heritage listed as Highly Significant, so it was left in situ but the box channels were all dismantled, the bricks being packed up in crates. All of the bricks are now at the HCC storage depots at East Kurrajong and Wilberforce. A small section of box channel still exists under the grass verge outside Herbie Weller’s cottage on Bridge Street, possibly underneath that cottage.</p>
<p>Historical confirmation</p>	<p>[Associate Professor Ian Jack:] The heritage significance of Windsor’s civic square was dramatically enhanced in 2018 by the archaeological excavation of its early drainage system. The complex system of brick drains are the earliest public works of this sort surviving in NSW and the John Howe and James McGrath were commissioned in 1814 to carry out substantial works within the newly named Thompson Square. The steepness of the slope was to be diminished by putting piles in the lower sector of the square near the river and then using fill to reduce it to ‘a gradual slope’. The contractors also made between 120,000 and 150,000 bricks in Windsor to construct the drainage works in 1814-1815. [State Library of NSW, Mitchell Library, MLMSS 106] They were ‘to sink a Sewer in the middle of the Square with channels leading to it or to ...erect two sewers one on each side of the Square...’ Current excavations show that only the central drain and channels were built. By 24 April 1815, the barrel drain had been completed. [The completion of one barrel brick drain is inferred because it is not mentioned in the second contract] It is the levelling of Thompson Square that explains why the barrel drain was found no less than 3.5 metres under the present surface. It also offers a satisfactory interpretation of the archaeologists’ discovery of a series of brick-lined sump-walls going vertically up some two metres from the barrel drain to a brick box drain on the surface. The nature of the bricks found in all three strata is consistent with a Macquarie-period date. The greatest amount of fill would be required in the lower part of the square. Howe had already in 1814 and early in 1815 built the large barrel drain just below the original surface. To maintain an efficient drainage system, as the barrel drain was to be covered with a great deal of fill, an additional drainage channel to the surface would be necessary, connected to the barrel drain by a series of brick-lined sumps. The box drain now excavated was therefore added by Howe once the land-fill had altered the landscape of the square, particularly the part closer to the river. Further minor brick drains running to the surface box drain have been identified by the archaeologists. These are the ‘Channels’ stipulated in 1814 but first constructed only after the initial levelling of the square was completed in 1815. The drainage was probably impacted in the next series of floods as the final payment was not completed in 1820. <i>(Col. Secretary’s Correspondence, State Archives NSW, Reel 6050,4/1746, p. 209.)</i></p>

<p>Conserved</p>	<p>See the WBRP TfNSW Drain Mitigation report. The exposed section of the Brick Barrel Drain impacted by the new bridge abutment was covered in polystyrene (see images on following page). The new bridge abutment now sits over the top of this Highly Significant piece of early colonial infrastructure.</p>

"WHAT HAS BEEN PARTIALLY UNCOVERED IN THOMPSON SQUARE EARLY IN 2018 SHOULD BE UNDERSTOOD AS REMARKABLE PHYSICAL EVIDENCE OF A COMPLEX DRAINAGE AND LAND-FILL SYSTEM CONCEIVED UNDER GOVERNOR MACQUARIE IN 1814 AND COMPLETED BY 1820 THROUGH THE ENERGY OF JOHN HOWE AND JAMES MCGRATH. THIS IS THE EARLIEST PUBLIC WORKS OF ITS SORT SURVIVING IN THE COLONY AND THE BARREL DRAIN IS THE KEY ELEMENT IN THE SOPHISTICATED WATER MANAGEMENT SYSTEM. THERE IS AN OVERWHELMING CASE FOR CONSERVATION, PRESERVATION AND DISPLAY". PROF. IAN JACK, , MA, PHD, FRHISTS, FRAHS

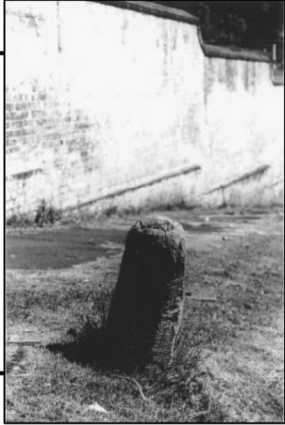
5. Marker stones

<p>Location known</p>	<p>Wilberforce Council Depot</p>	
<p>Description: first recorded</p>	<p>Three marker stones were removed from the WBRP archaeological salvage compound (the Thompson Square Conservation Area Lower Reserve) in early 2018 .</p>	
<p>Historical confirmation</p>	<p>Edward Higginbotham archaeologist, wrote about the significance of the marker stone outside Maquarie Arms Hotel, when he made a report for HCC in the 1980s and made Thompson Square a Conservation area, . That stone had the same appearance as the two marker stones removed by TfNSW from the Lower Reeserve.</p> <p>“</p>

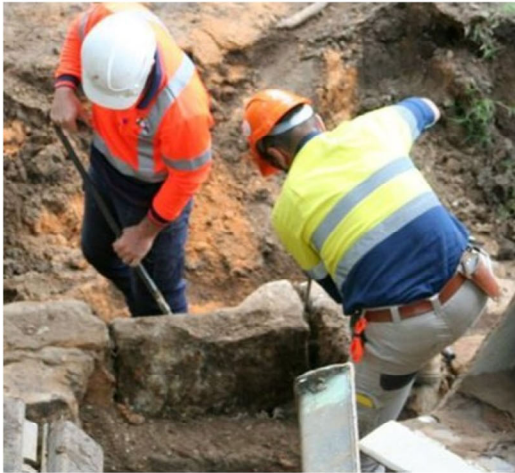
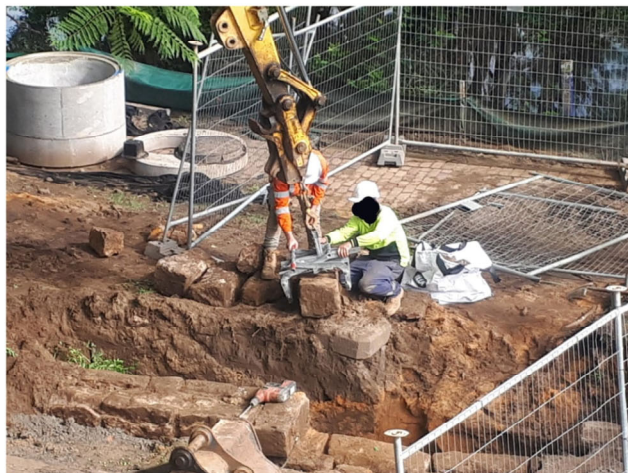
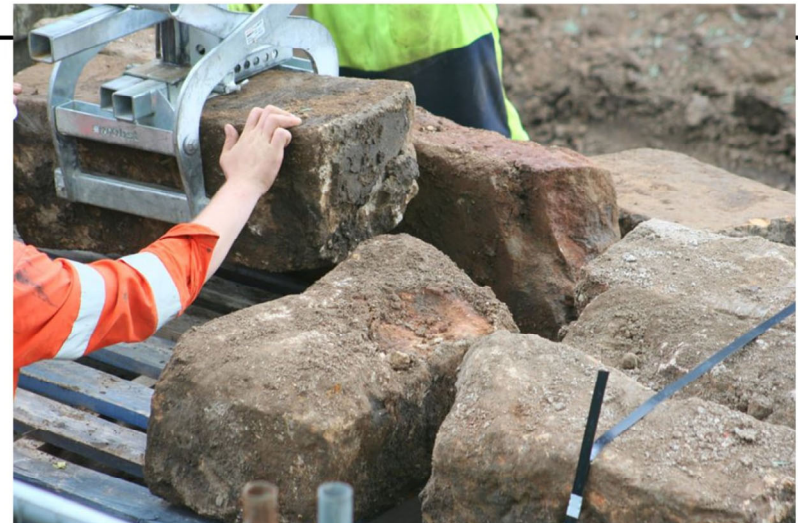
6. Sandstone wall on the Terrace

Location known	Beneath the Doctor's House on the Terrace next to historic bridge viewing platform.
Description: first recorded	Wall found during electrical work for the WBRP made of re-used blocks of sandstone believed to be from Cadell's Brewery or the Punt House, according to Trove newspaper article.
Historical confirmation	
Conserved	Some of this wall has been removed, a small part remains, underneath the road surface of the Terrace.

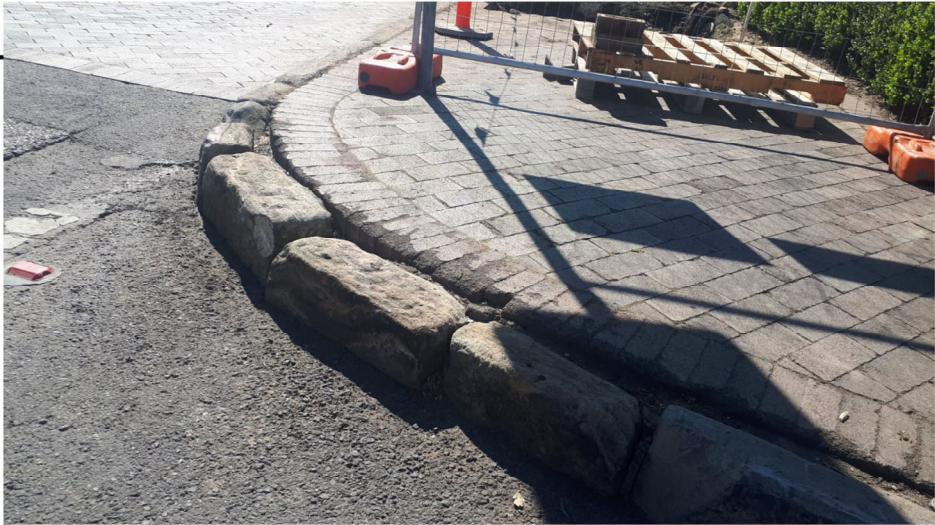
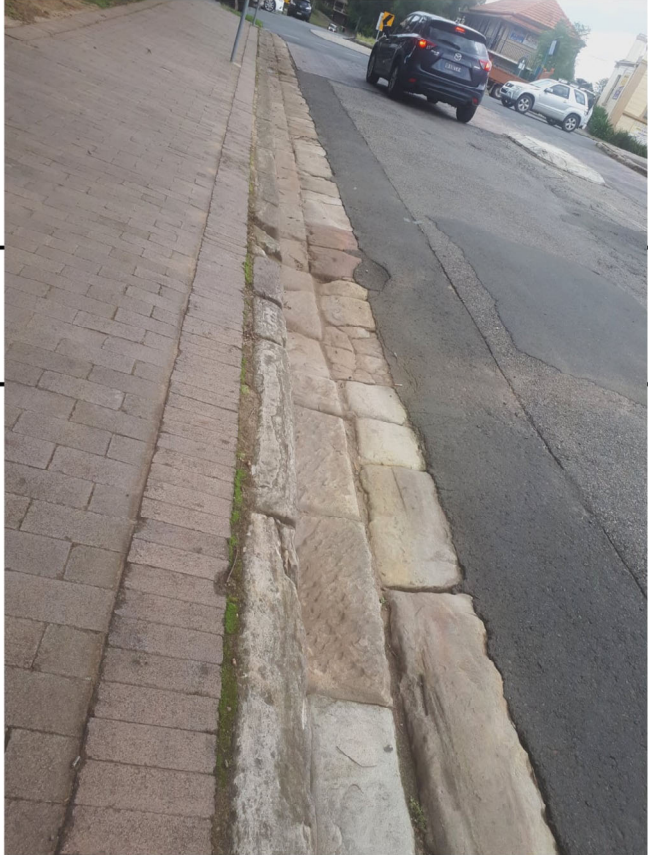
7. Sandstone kerb and guttering

Location known	HCC storage depot
Description: first recorded	Removed by TfNSW during WBRP
Historical confirmation	
Conserved
