## 9 | IA1 Central Drainage Route West

### 9.1 Drainage Issues

# 10 | IA1 Central Drainage Route East

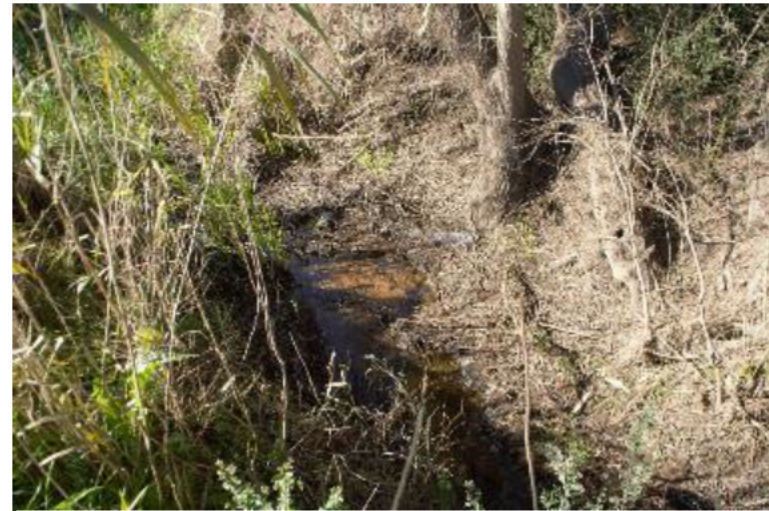
Photo 147

Where standing water was creating problems for property owners was on the southern branch immediately east of Cupitts Lane where there was standing water across the paddocks. This appears to be caused by the ill-defined outlet from the body of standing water (Photo 144 and Photo 145) as well as siltation further downstream in the channel which may have been triggered by a willow growing from the bank into the channel (Photo 147).

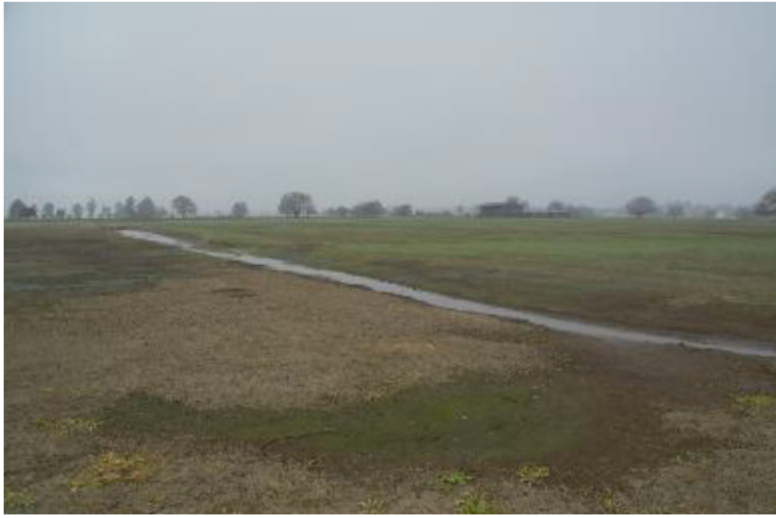
Photo 171

There is a drain through a turf paddock east of Onus Lane which marks the beginning of this drainage line (Photo 171). The drain heads east and after a pipe crossing is full of grass (Photo 172) and no flow could be detected. When it reaches the property boundary there is a raised access road embankment on the neighbouring property and the drainage diverts north along the western side of this embankment (Photo 173). It passes under the embankment via a pipe (Photo 174) which is not sufficiently lower than the surrounding paddocks for them to completely drain.

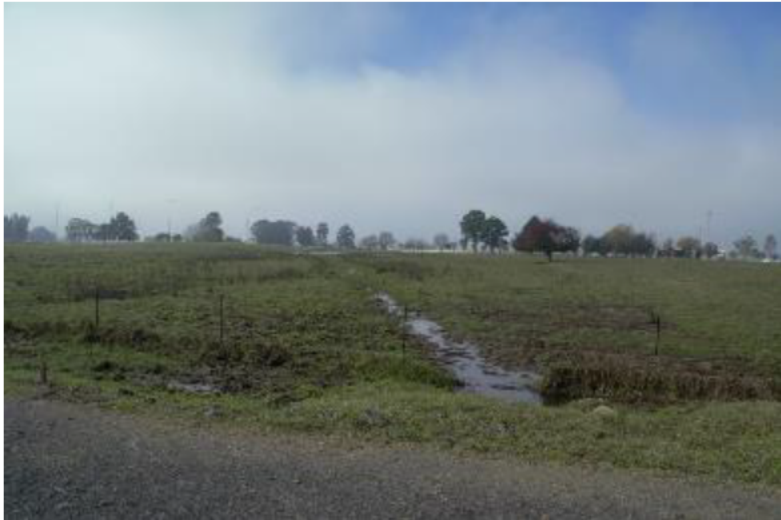
Photo 175

It is from this point that the drainage line (Photo 175) is marked on maps as Cooley Creek and it flows through a series of three ponds before passing under Bensons Lane through a piped culvert (Photo 176). Water sat ponded in the drain downstream and many parts of the surrounding paddocks were below the water level of the drain (Photo 177). The drain passes under an access road culvert (Photo 178) with noticeable but shallow flow within the drain (Photo 179). It then discharges into another pond (Photo 180). The pond has a piped outlet and the water flows through a more defined drain which was flowing on the day (Photo 181). After going around a 90 degree bend the water appeared to be more ponded and there are several piped crossings for travelling irrigators (Photo 182). Despite what appeared to be a fall in the gradient of the channel there was no drop in the water level moving downstream (Photo 183 and Photo 184). The drainage from this area appears to be controlled by a small gap through the grass (Photo 185). This is constricting the flow and causing much of the ponding upstream.

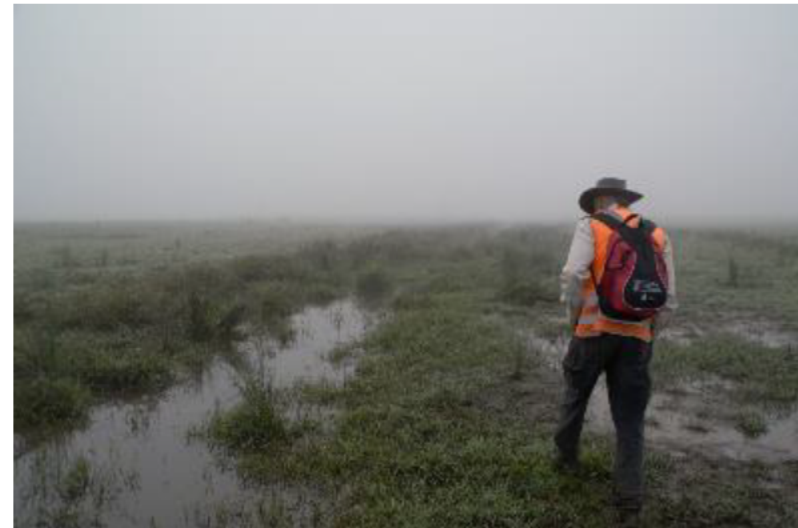
Photo 186

However, downstream of this point the water in the channel was also ponded to a level similar to that of the surrounding paddocks (Photo 186). The drain passes under Sandstone Place via a large culvert (Photo 187) but flow into the culvert appeared to be inhibited by stones upstream of the headwall (Photo 188). The water level was the same on both sides of the culvert (Photo 189) and the downstream riprap did not appear to be restricting flow at this level (Photo 189).

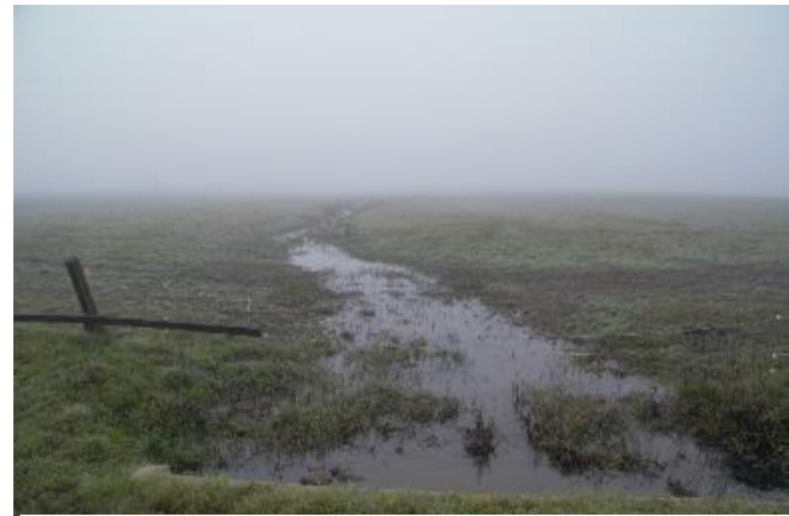
Photo 190

Drainage continued through a shallow drain (Photo 190) which as ponded to the level of the small lagoon into which it drained (Photo 191). There is an access track across the lagoon (Photo 192) and there would appear to be two small pipes providing a hydraulic connection under it (Photo 193). There appeared to be some flow through the pipes, suggesting that the downstream part of the lagoon was slightly lower than that upstream.

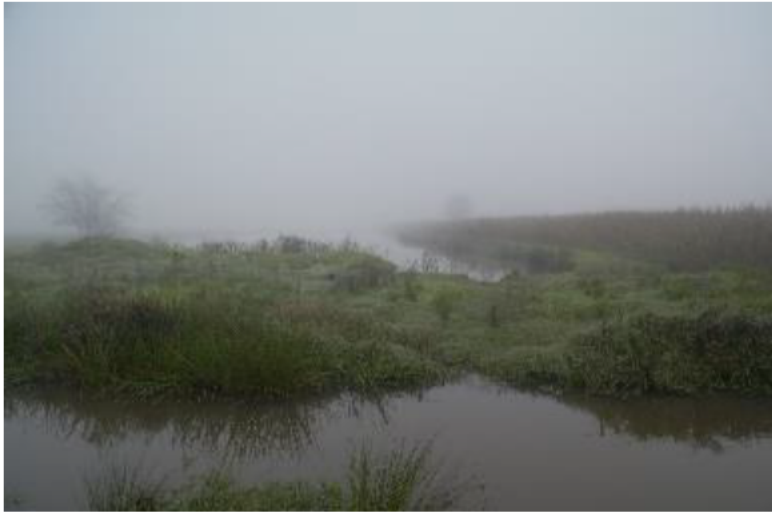
Photo 194

Downstream of the lagoon there is a channel which would appear to be hydraulically connected to the lagoon although it was not visible on the day (Photo 194). This channel had a poorly defined overflow point into a depression in a paddock (Photo 195) which appeared to be controlling the level in the channel and therefore the lagoon. The drainage path through this paddock was poorly defined and was essentially a broad area of saturated ground (Photo 196) which gradually becomes a more discernible drainage line within the landscape (Photo 197 and Photo 198). There then appeared to be noticeable fall and flow in the channel (Photo 199) although it was silted in places (Photo 200).

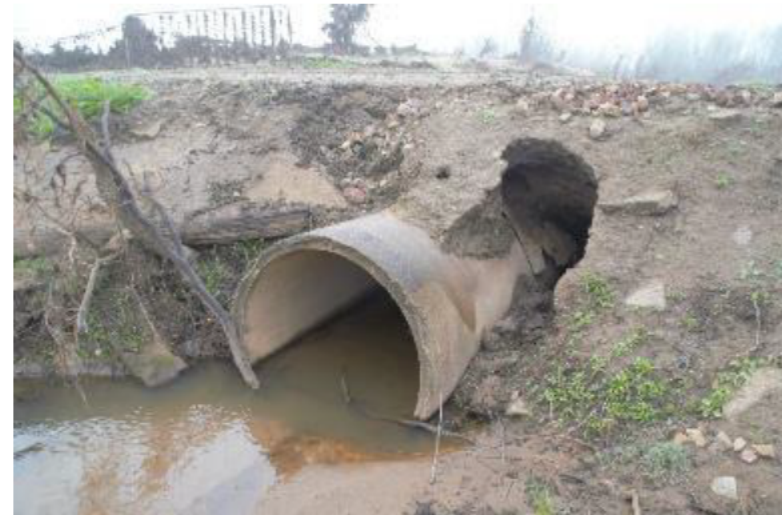
Photo 201

The channel flowed under a badly eroded culvert crossing (Photo 201) before entering Bakers Lagoon (Photo 202 and Photo 203). Some of the paddocks surrounding Bakers Lagoon were poorly drained because they sat below the surrounding paddocks or the banks of the lagoon (Photo 204).

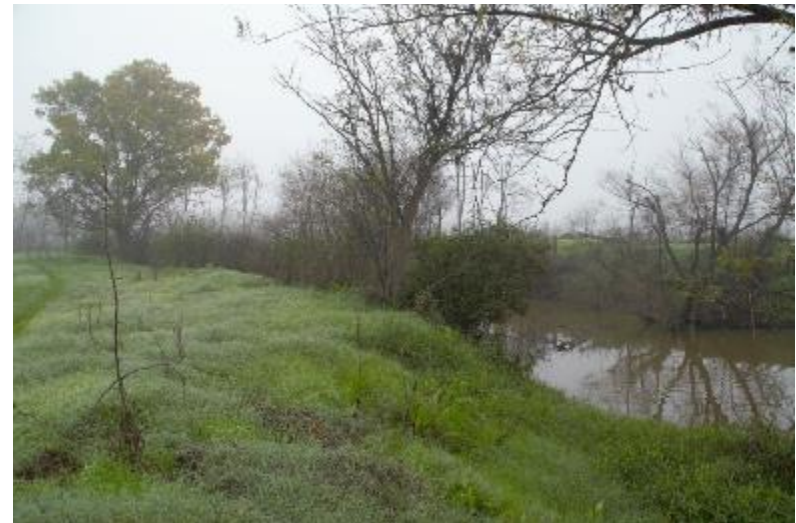
Photo 205

The outlet to Bakers Lagoon is a wide, deep channel (Photo 205), the banks of which support native vegetation such as casuarinas and paperbarks but is also infested with weeds, particularly privet. There is a connection between Cooley Creek and the southern drainage network along this reach (Photo 206 and Photo 207). Moving downstream along Cooley Creek it becomes quite clogged with reeds (Photo 208) before it passes under a bridge at Cuppits Lane.

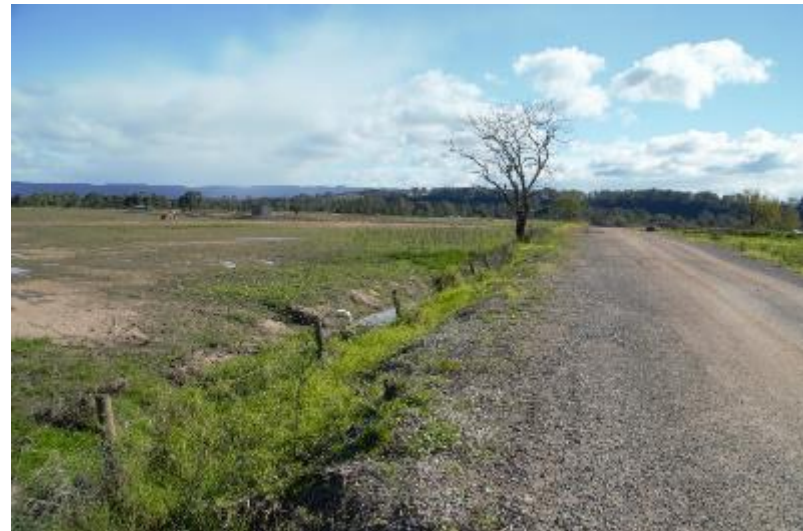
Photo 209

The short section of drain which enters the northern end of Bakers Lagoon begins upstream of a section of road embankment which is raised at least 1.5m above the floodplain (Photo 209). There is a pipe under this embankment (Photo 210) which discharges into a poorly defined depression through a paddock (Photo 211). This drains to some ponds (Photo 212) which overflow into a ponded channel which passes under an access road via pipe (Photo 213). This channel is obstructed by sediment in places (Photo 214). Water then makes its way through a paddock without there being a particularly well defined course (Photo 215) before ponding in the paddock and then passing under an access road through two separate culverts (Photo 216). The piped water from these culverts discharges into a low depression through a series of horse paddocks (Photo 217) which discharges directly into Bakers Lagoon (Photo 218).

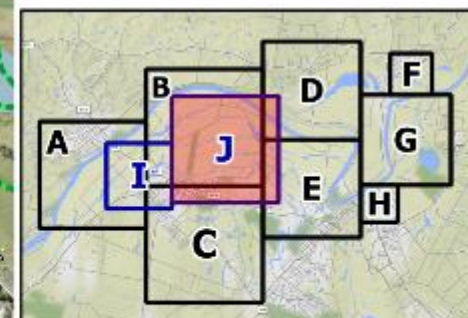
Figure 84: Solutions for IA1CW

Possible solutions for IA1CW are shown in Figure 84.

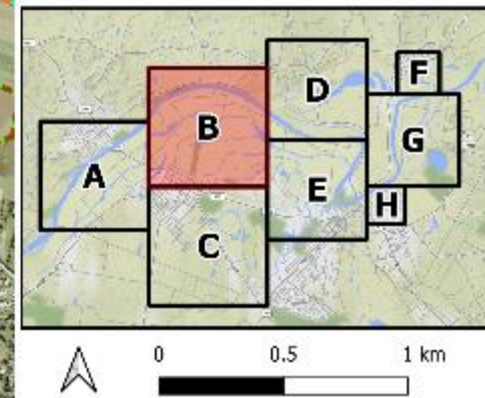
Figure 85: Contaminated Lands (Extent B)

There is a single EPA contaminated land record of notice in the vicinity of the Cooley Creek Drainage Route at 532 Cornwallis Road, Cornwallis, however regulation under the *Contaminated Land Management Act 1997* (CLM Act) is not required for this site (Figure 85). This location is downstream of where the drainage problems occur in IA1CW.

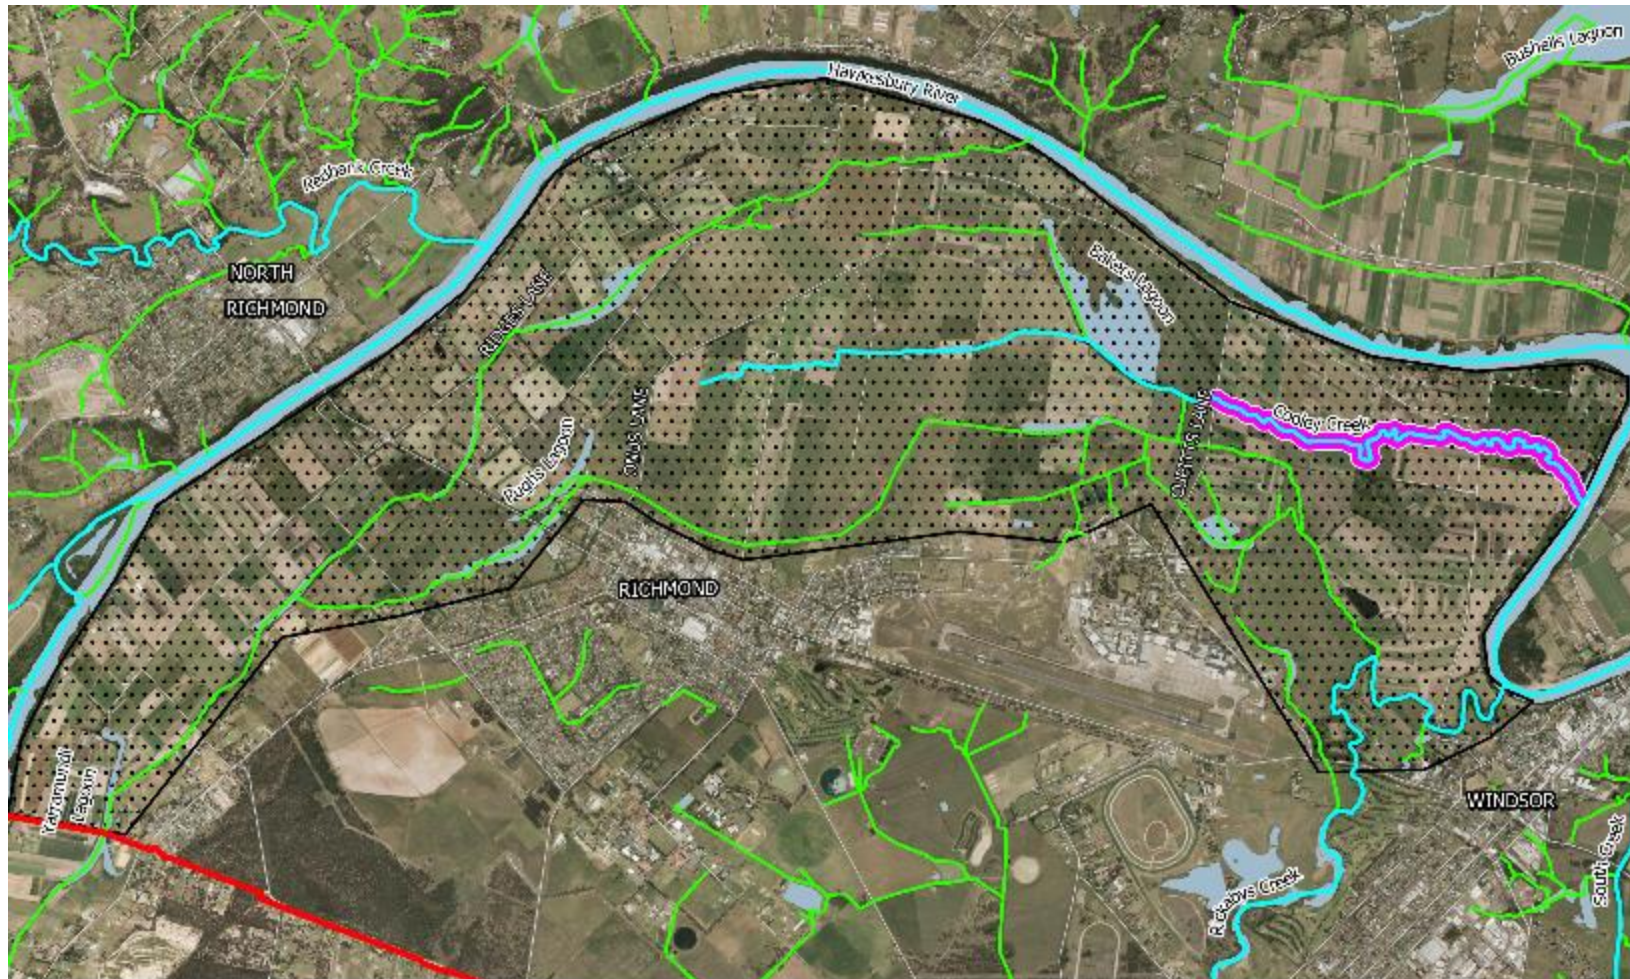
Figure 87: Investigation Area 1 Central Drainage Route East (IA1CE)

The IA1 Central drainage route east (IA1CE) follows Cooley Creek from Cupitts Lane to where it enters the Hawkesbury River (Figure 87). The photograph locations referred to in the text can be found in Figure 88.

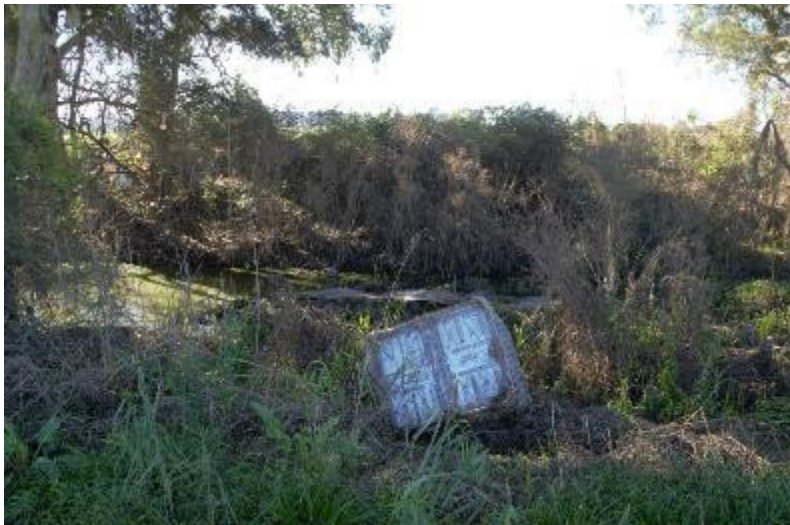
Photo 222

Downstream of Cupitts Lane the channel becomes narrower and the channel and its banks are heavily vegetated (Photo 219) much of which is native vegetation (Photo 220). There is an increase the amount of flood debris deposited in the creek (Photo 221) along with silt which is inhibiting flow. In places the channel is quite clear and predominantly lined with native vegetation although there are occasional large debris items in the creek (Photo 222). There is a crossing of the creek which is piped (Photo 223) and 150m downstream of this there is sediment blocking the drain (Photo 224). Further downstream there is evidence of the bank slumping into the drain (Photo 225). It then passes under an access track through two pipes (Photo 226) downstream of which the water is ponded in the creek (Photo 227).

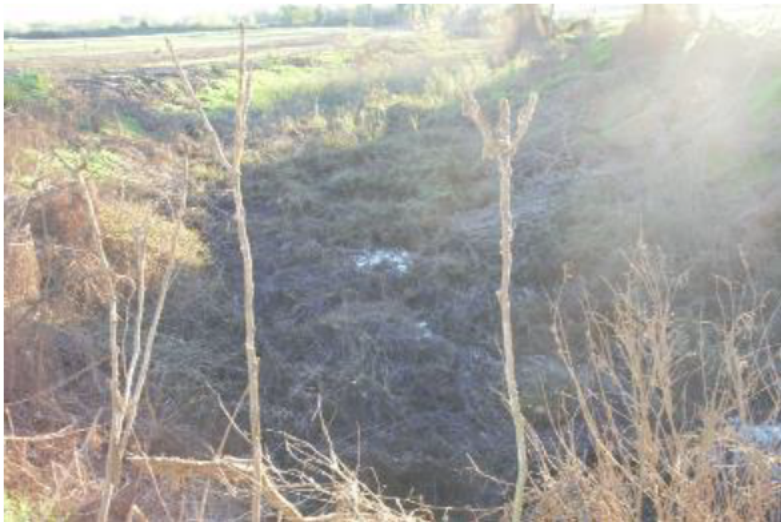
Photo 230

Downstream of here the banks of the creek were so overgrown with Small-leaf Privet, honey locust and other weeds (Photo 228) it was not possible to get close enough to the creek to observe its condition until 400m upstream of Cornwallis Road. At this location the channel is choked with weeds (Photo 229) and littered with debris (Photo 230). This continues under the bridge at Cornwallis Road (Photo 231) and further downstream (Photo 232). As the creek gets closer to the river is becomes deeper and wider and there are several large trees which have been felled and have fallen into the creek. These logs, trees growing in the channel and vines growing over it all has caught a lot of debris (Photo 233 and Photo 234 and Photo 235). Near the river there was no flow in the creek whatsoever nor any ponded water (Photo 236 and Photo 237).
