13 | Investigation Area 4

13.1 Drainage Issues

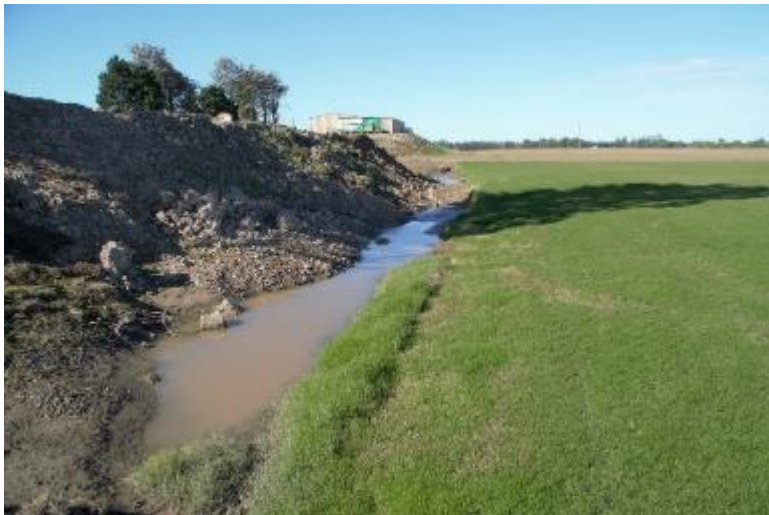
Photo 311

Downstream from here the drain is wide and shallow and full of water (Photo 309) because it has been blocked with fill (Photo 310 and Photo 311). The end of this reach is defined by another major access track with a 600mm pipe under (Photo 312).

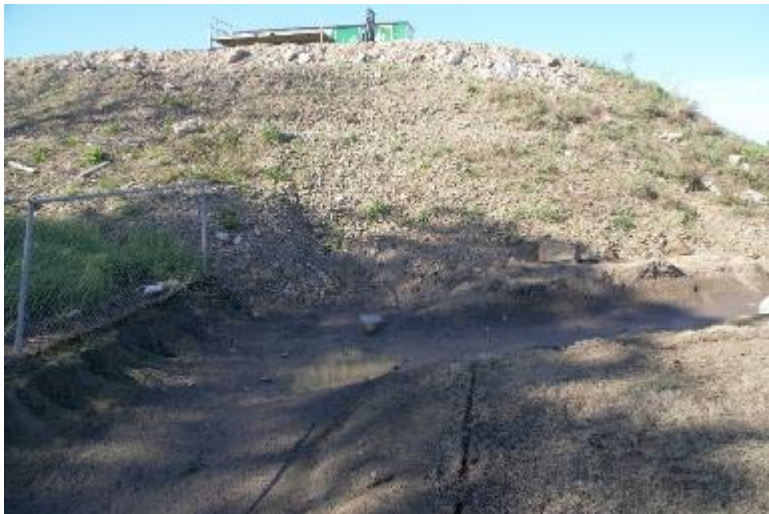
Photo 315

From this point the flow is directed immediately north (Photo 313) and then along a well-defined, shallow drain (Photo 314) before diverting south around a large area of fill (Photo 315 and Photo 316). This whole length is unobstructed by crossings (Photo 317) until it is crossed by another farm access track with two 300mm pipes (Photo 318). From here it continues as a wide, shallow drain which is generally unobstructed (Photo 319) before it has to divert south around what appears to be a stockpile of topsoil (Photo 320) and under a farm access through a 300mm diameter pipe (Photo 321).

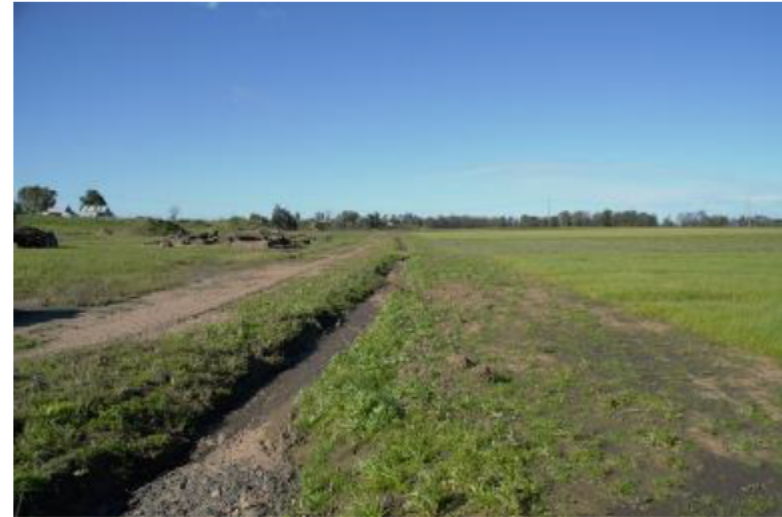
Photo 322

Downstream of the access track the channel is narrower and appears to be silting up (Photo 322 and Photo 323). Towards the end of this reach there is a 900mm diameter pipe (Photo 324) which diverts the flow north into a pond (Photo 325), the outlet of which is a vegetated spillway channel (Photo 326) heading east and under an access road (Photo 327).

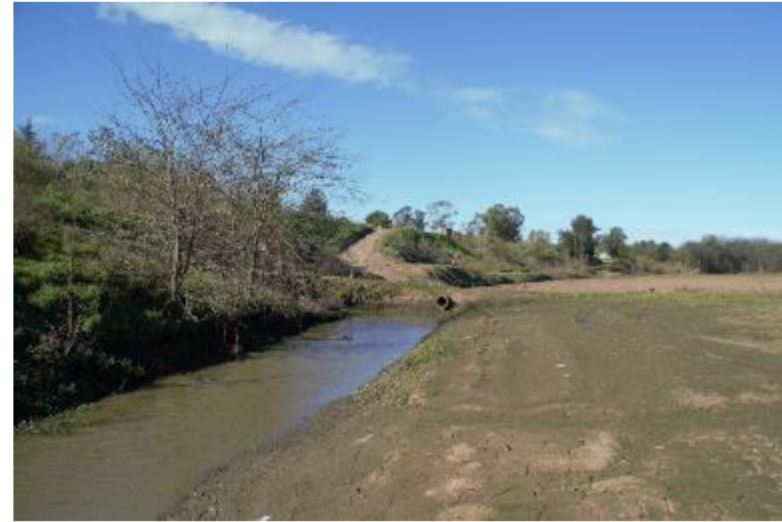
Photo 334

Downstream of the access road the channel is wide and deep but initially littered with large woody debris (Photo 333). Water was ponded in this reach because the pipe under the next access road has its invert above the invert of the channel (Photo 334). There appears to be permanent pump infrastructure to extract water from this pond (Photo 335). Recent earthworks downstream of this outlet appears to force water to pond and overflow the access road (Photo 336 and Photo 337) before following the lowest part of the landscape along the toe of a steep batter of fill (Photo 338). This leads to another pond which appears to be used for water supply (Photo 339). No outlet or spillway for this pond was observed so it must simply overflow across the lowest point of the access track at the eastern end of the pond.

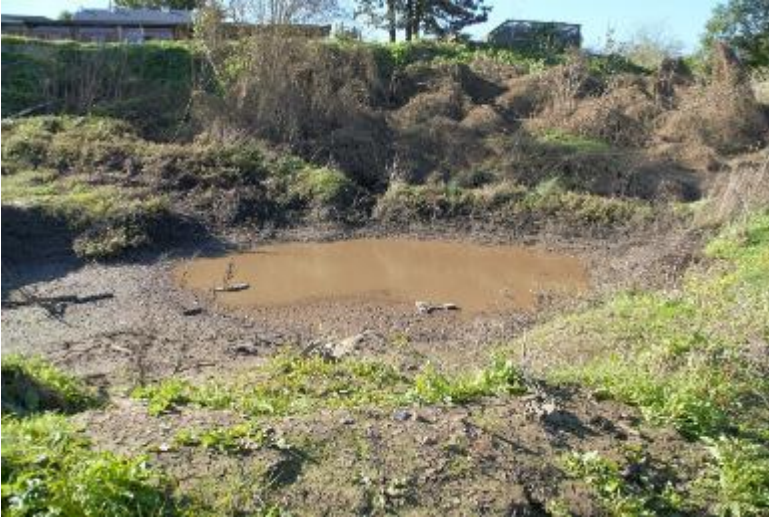
Photo 341

Past this access track there was no well-defined channel (Photo 340) until a pond was reached (Photo 341). The overflow from this is a shallow channel (Photo 342) which flows through a pipe under an access road (Photo 343) the continues as a cleared, shallow channel until it enters a thicket of trees (mostly Honey Locust). Here it turns sharply south and enters the river but its condition was not observed because of the thickets of thorny weeds (Honey Locust) which prevented access (Photo 344).

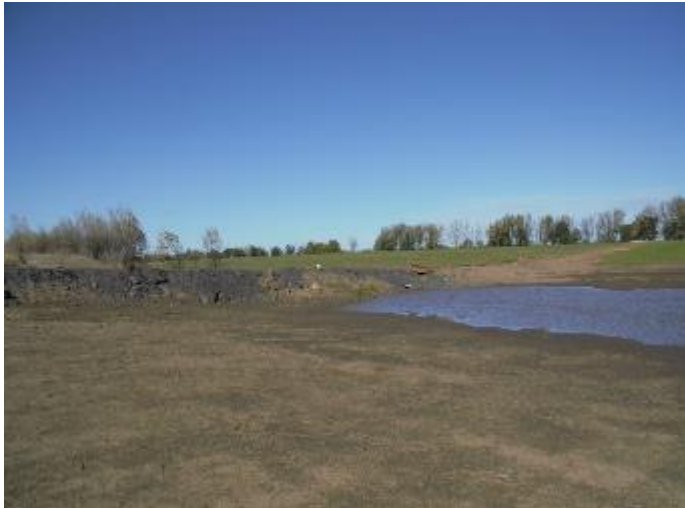
Photo 345

However, apart from the road embankment at the upper end of the drain which had no pipe under it (Photo 345), there was no evidence that the various contributors to the slowing of the drainage have caused any noticeable incremental damage. This is because most of the crossings (other than the aforementioned one) are not much higher than the top of the channel and so the channel itself is mostly only draining the remnants of the flood waters which have not drained freely overland.

The damage caused to the two upstream properties from the aforementioned road embankment are extensive because the embankments stands a couple of metres higher than the floodplain and it has not pipe outlet through it. It effectively forms a porous (leaky) dam across that part of the floodplain and when it gets filled with water overflowing from the Hawkesbury River it can take a long time to drain.
